Technical Service Information

G.M. 4L60/65/70E P0894 TRANSMISSION COMPONENT SLIP

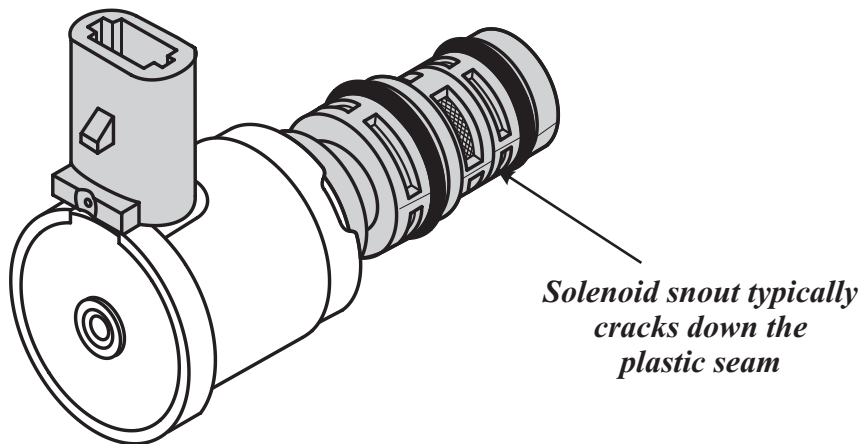
Figure 1

CAUSE: The cause may be, that during the rebuild process, the TCC PWM solenoid was not replaced, as the symptom mimicked that of a worn out TCC regulator bore, as shown in Figure 2. A closer inspection of the solenoid snout, as shown in Figure 1, shows that a hairline crack caused a loss of solenoid pressure acting on the TCC regulator valve causing the Torque Converter to slip.

TCC PWM SOLENOID

CORRECTION: Replace the TCC PWM solenoid.

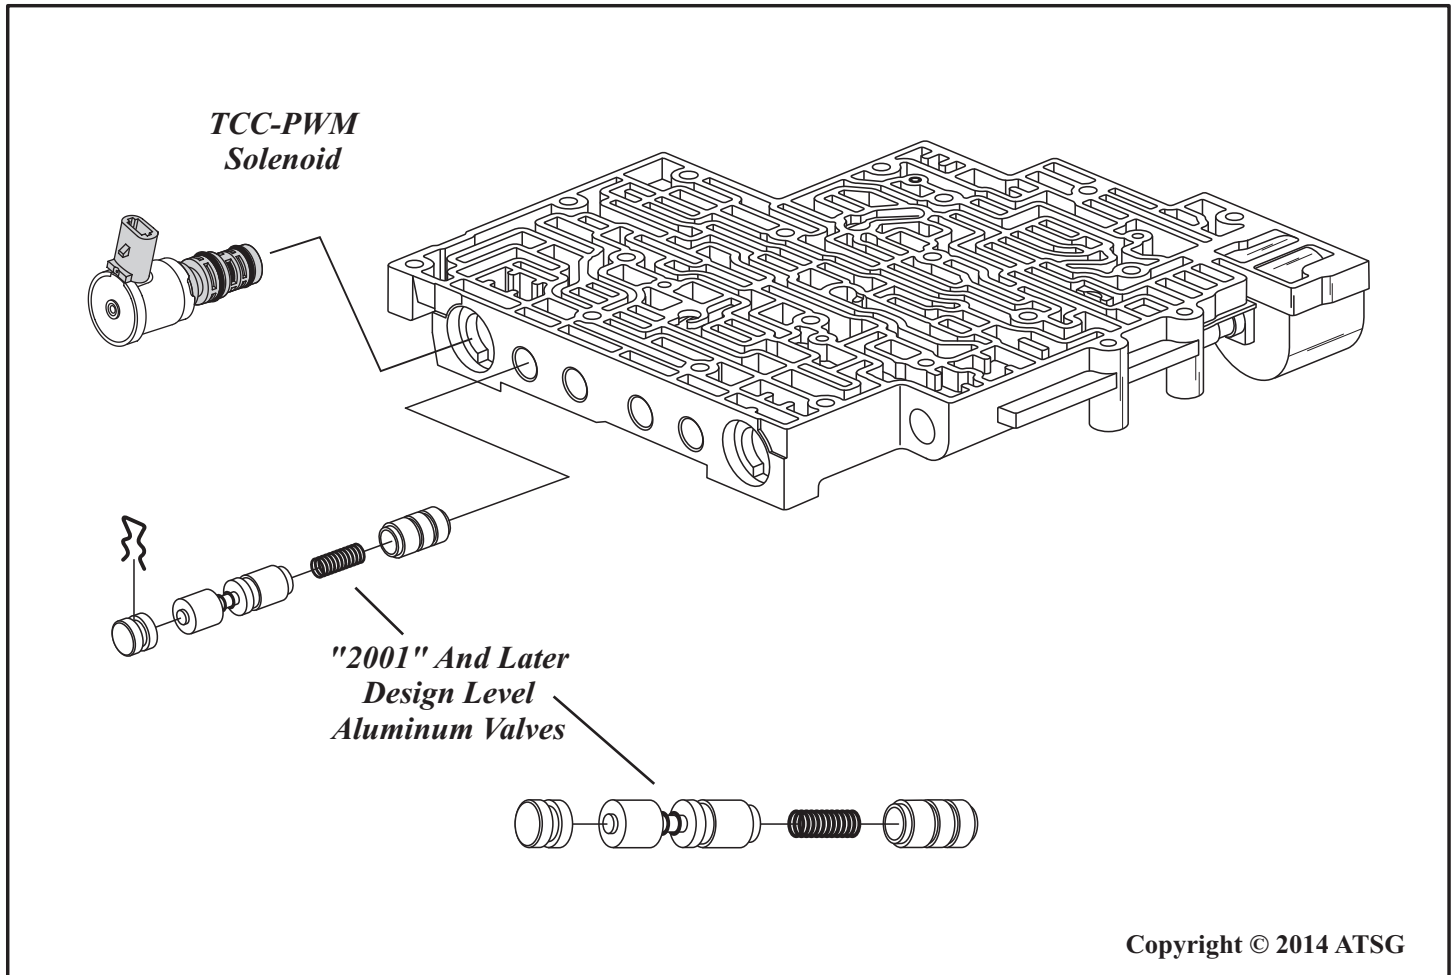
Figure 2

CONVERTER CLUTCH REGULATOR VALVE LINE-UP
