Technical Service Information

DODGE 68RFE CLUNK NOISE FROM DRIVE TO NEUTRAL

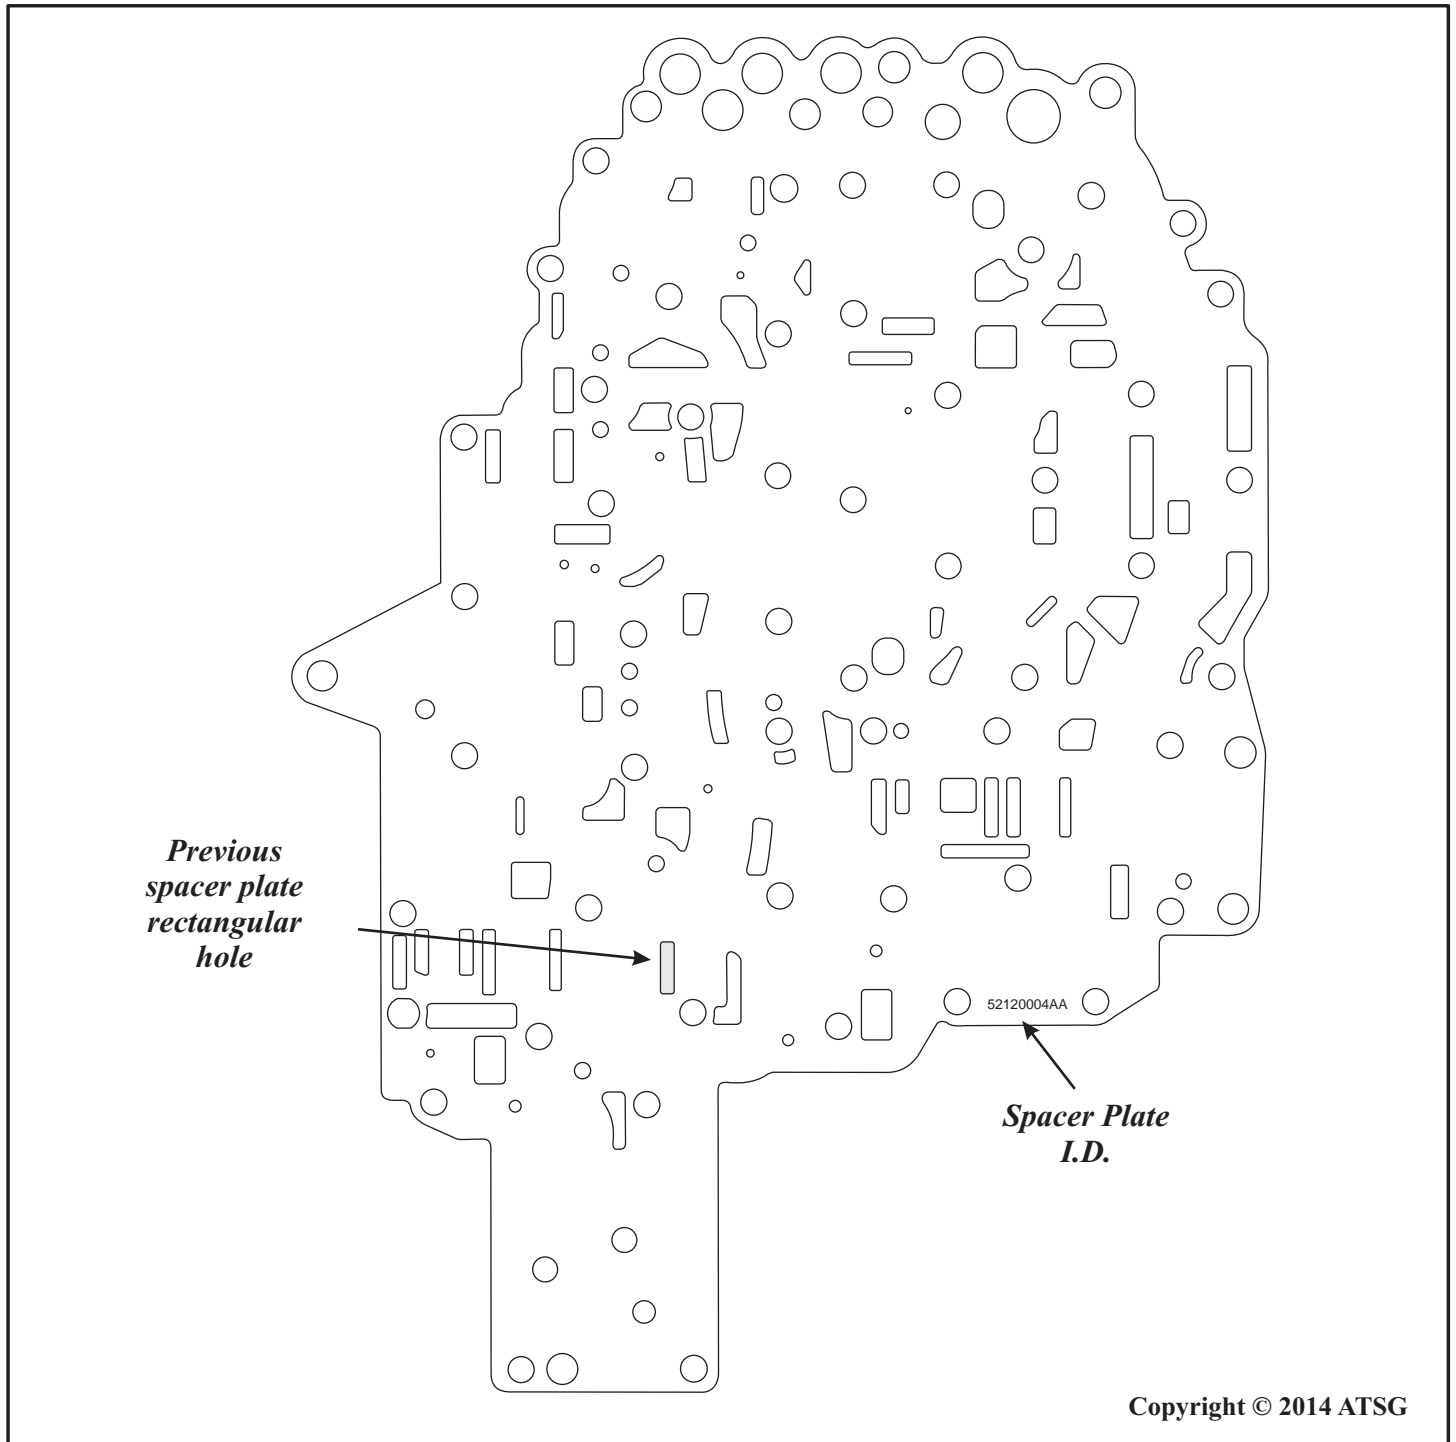
Figure 2

PREVIOUS DESIGN SPACER PLATE

CORRECTION: To correct this condition, install the new design spacer plate as listed in service information below. This new spacer plate provides a .090" orifice to slow down the release of the Underdrive Clutch when the selector is moved from Drive to Neutral. See Figures 2 and 3 for the location of the exhaust in the spacer plate and for spacer plate I.D. number location. Note: This new spacer plate is only for 2011 and up models that do not use the number 6 and 7 check balls as shown in Figure 4. See Figure 5 for the location of the exhaust passage in the channel plate. Refer to Figures 6 and 7 to see the location of the orifice in an oil circuit diagram from the Drive position to the Neutral position.

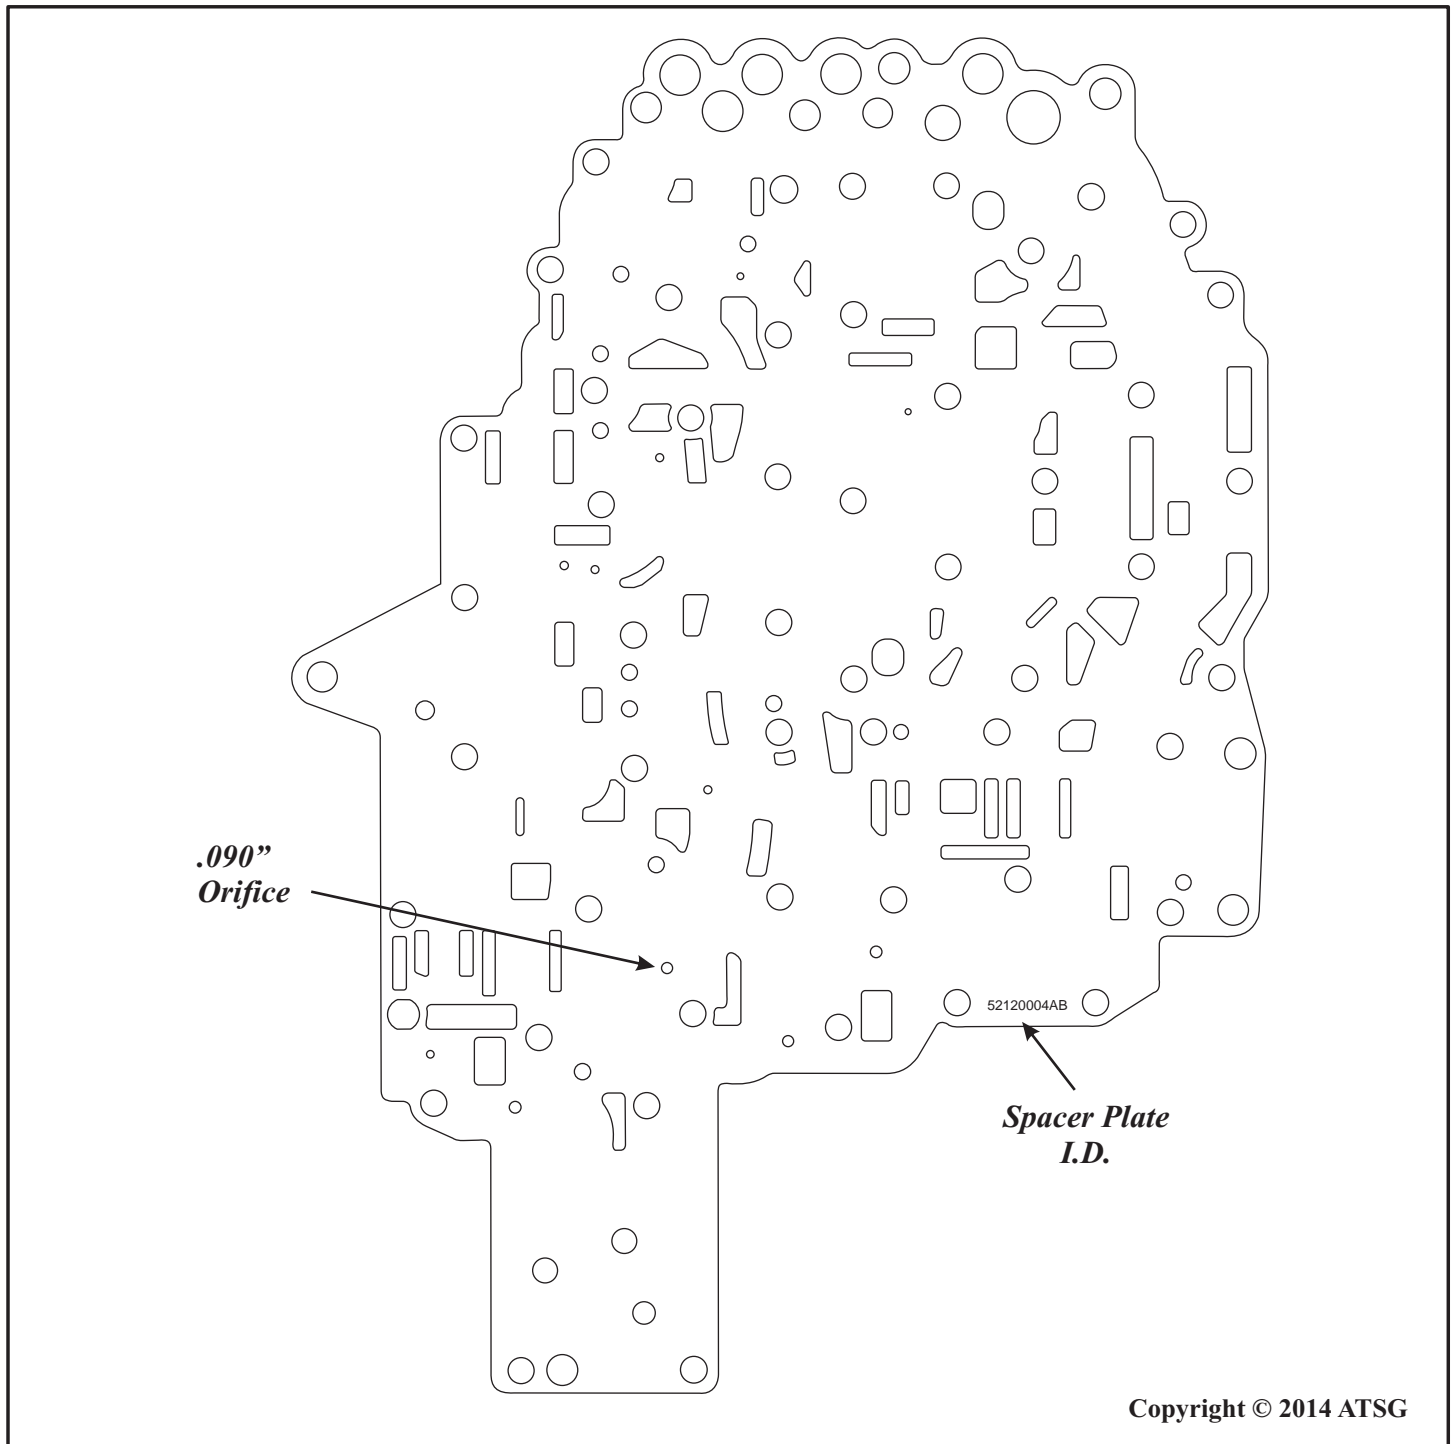
Figure 3

NEW DESIGN SPACER PLATE

VALVE BODY SPACER PLATE (Dodge part no.).....52120004AB

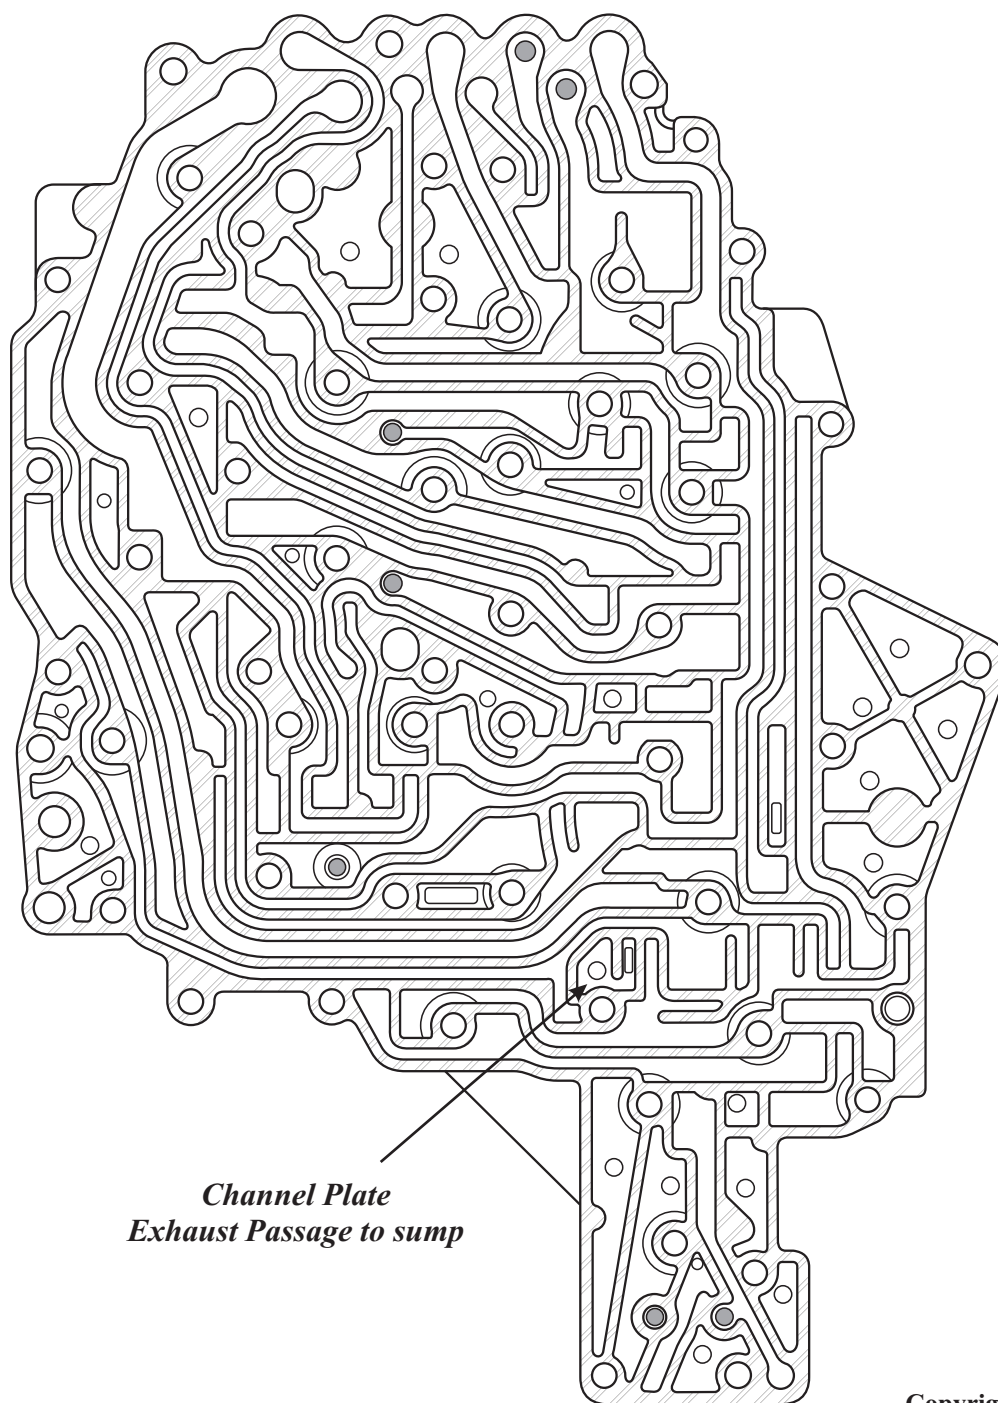
Figure 5

CHANNEL PLATE EXHAUST PASSAGE I.D.
