Technical Service Information

GENERAL MOTORS ELECTRICAL MALFUNCTIONS WITH MULTIPLE DTCs

GM ELECTRICAL MALFUNCTIONS WITH MULTIPLE DTCs

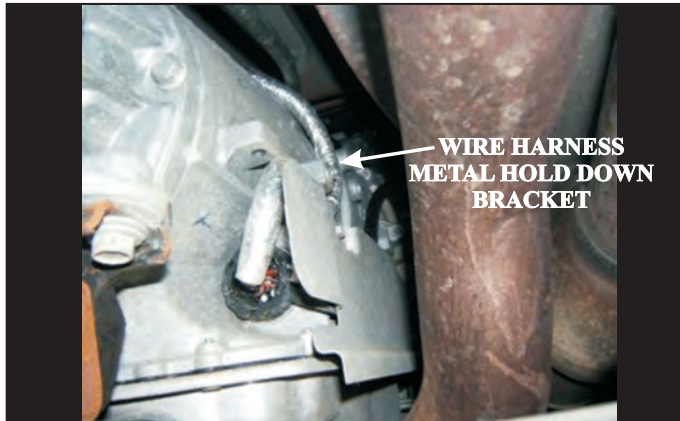
Figure 1

Locate the transmission case connector wiring harness and inspect the harness for chafing at heat shield or hold down bracket or heat damage from exhaust system components.

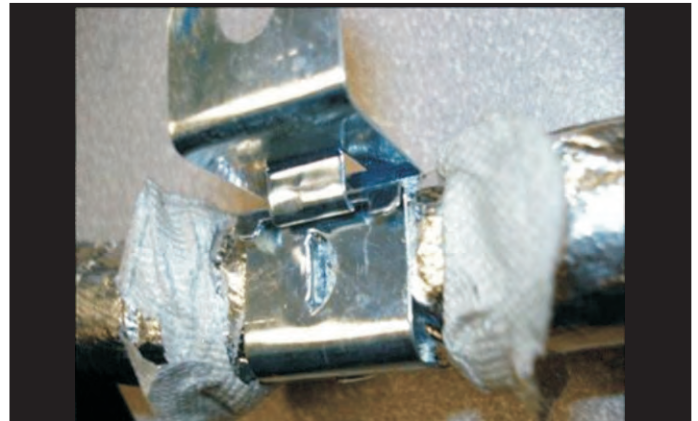
Figure 2

Inspect transmission wire harness for damage where it is clamped by the metal hold down bracket. After wire repairs be sure to wrap wires with a heat resistant material.

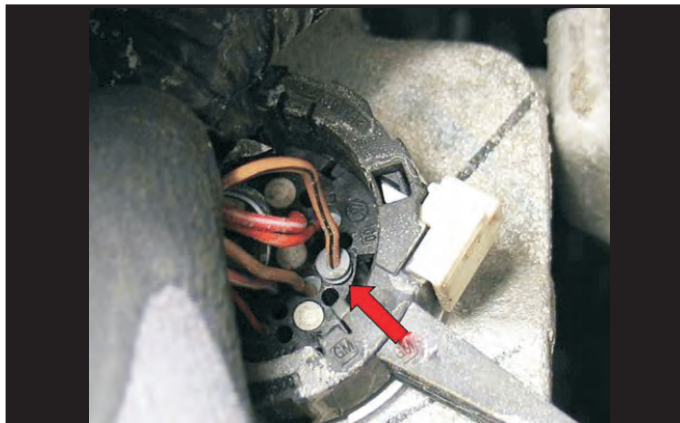
Figure 3

Before disconnecting the 16 pin transmission connector, inspect the wire entry points for poor weather seals or backed out wire terminals.

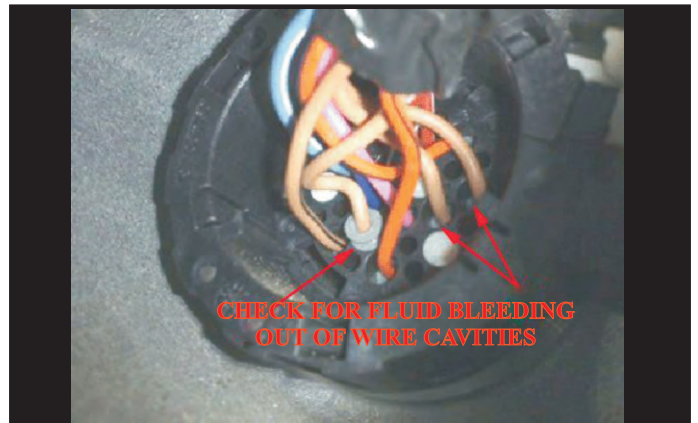
Figure 4

Inspect wire insulation for damage or the presence of transmission fluid bleeding out of the connector.

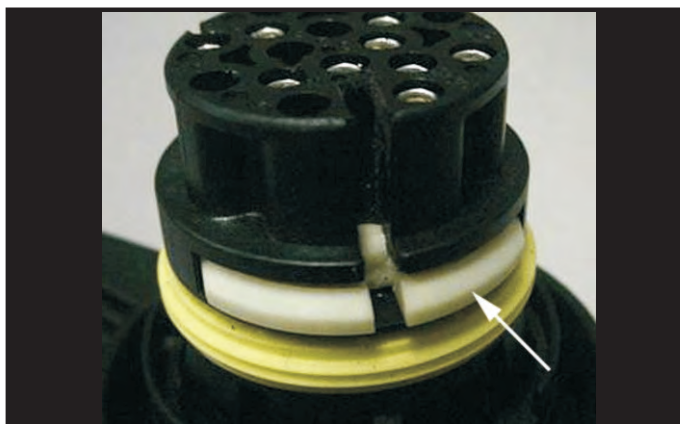
Figure 5

When the TPA Lock sticks out as shown by the arrow, the TPA Lock is not seated. It can be reseated with a small bladed screwdriver. Also check pin cavity fit.

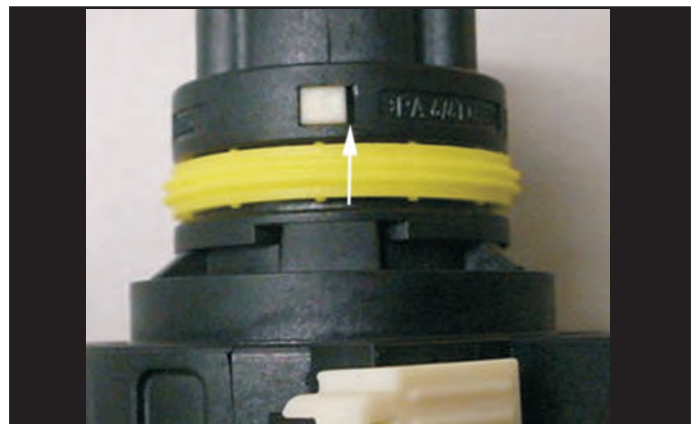
Figure 6

If the Terminal Position Assurance (TPA) Lock is off center in the connector check window as shown by the gap at the arrow, then it is only partially seated.

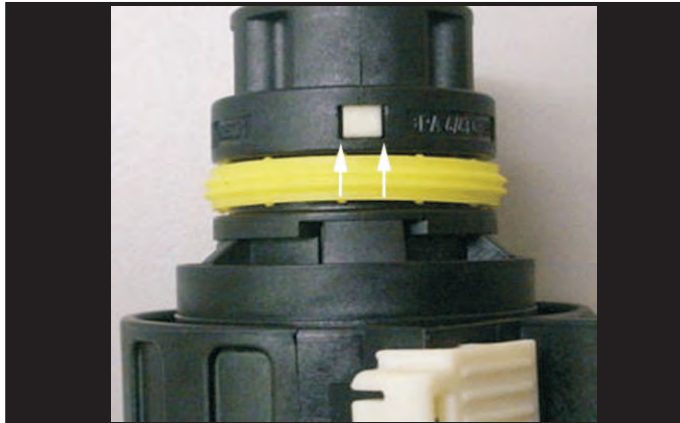
Figure 7

When the TPA Lock is centered in the check window as indicated by the arrows, the lock is fully seated.

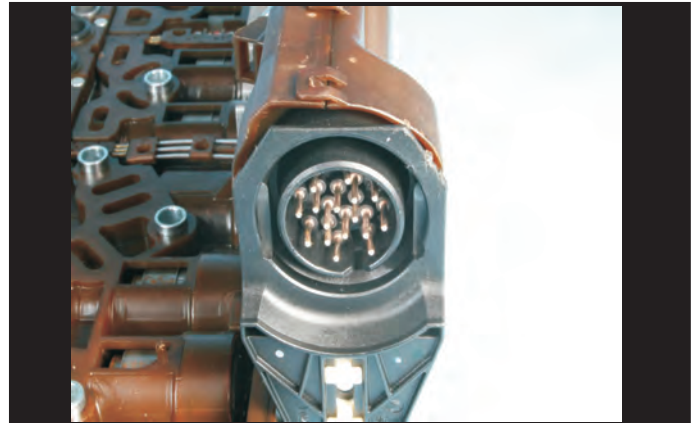
Figure 8

Check the pin condition in the transmission control unit connector.

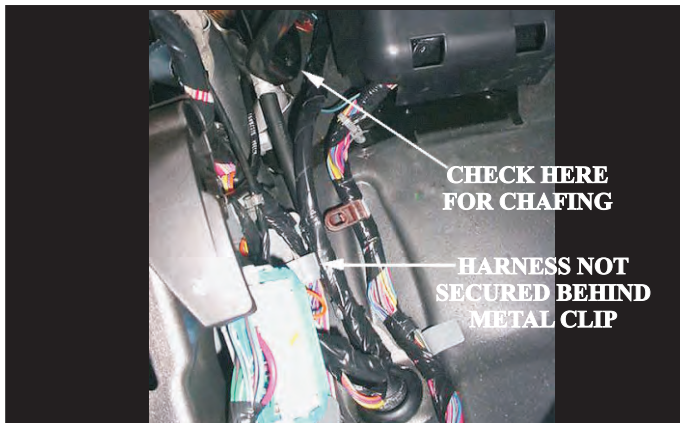
Figure 9

The instrument panel wiring harness has been routed outboard of the metal harness retaining clip which can cut into the wiring. The incorrectly routed harness creates a possible chafe point.

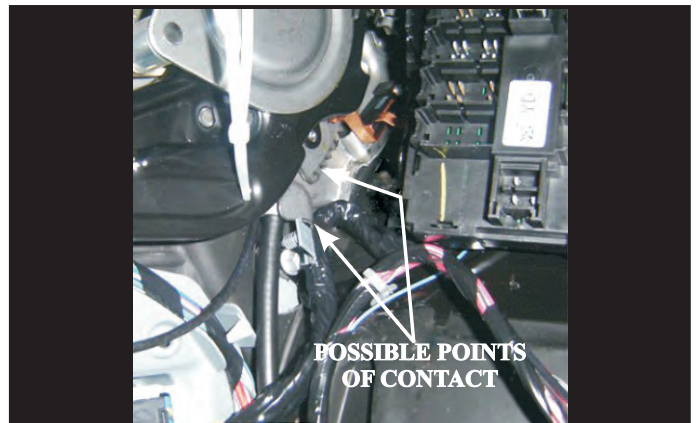
Figure 10

The instrument panel wire harness may be pushed up & forward until contact with the parking brake bracket, check for blown fuses.

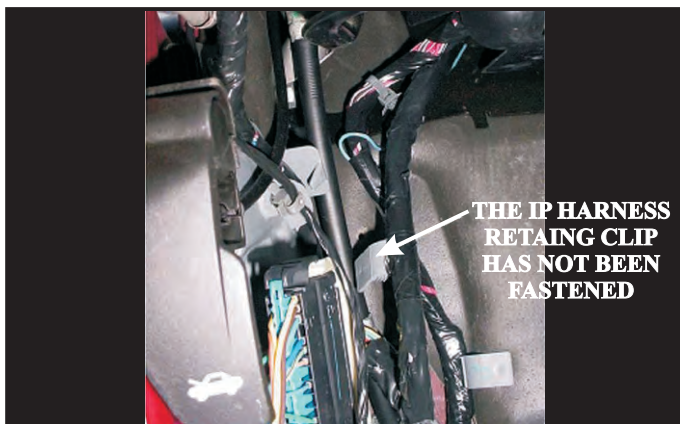
Figure 11

The instrument panel wire harness is secured by a Gray retaining clip which snaps closed, the clip has been left open creating a possible harness contact point.

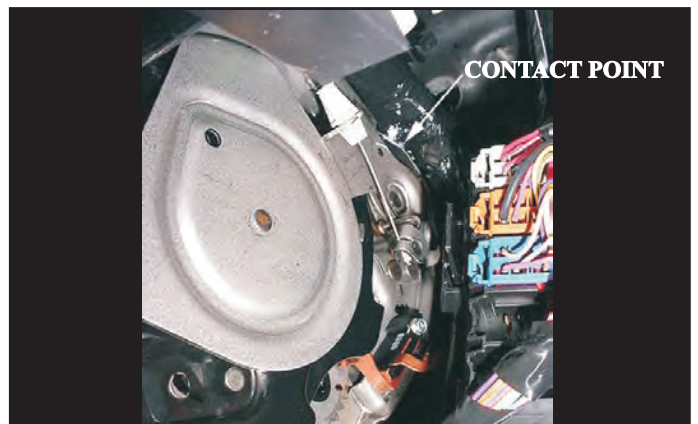
Figure 12

The instrument panel harness may be in hard contact with the top rear edge of the parking brake assembly.

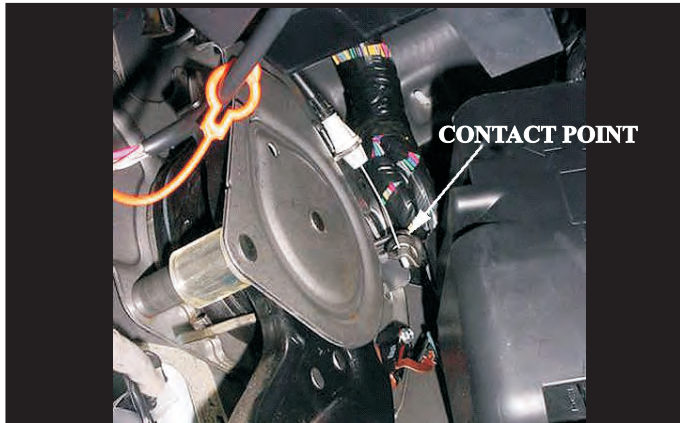
Figure 13

When releasing the parking brake pedal, the moving part at the end of the parking brake cable can come into hard contact with the instrument panel wire harness.

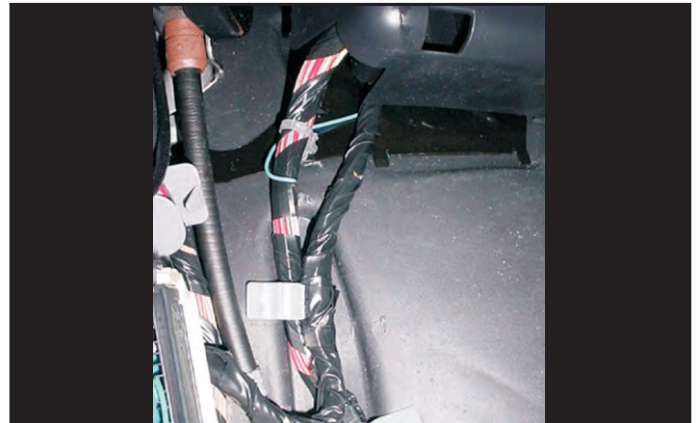
Figure 14

This is the correct routing path of the instrument panel wire harness which insures that it is not close to anything that can create a contact point resulting in wire harness damage.

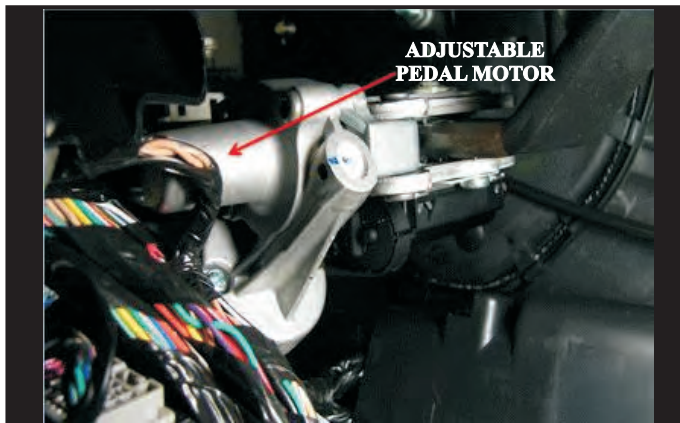
Figure 15

Inspect for chafed, damaged or pinched wires at the adjustable pedal motor as shown above.

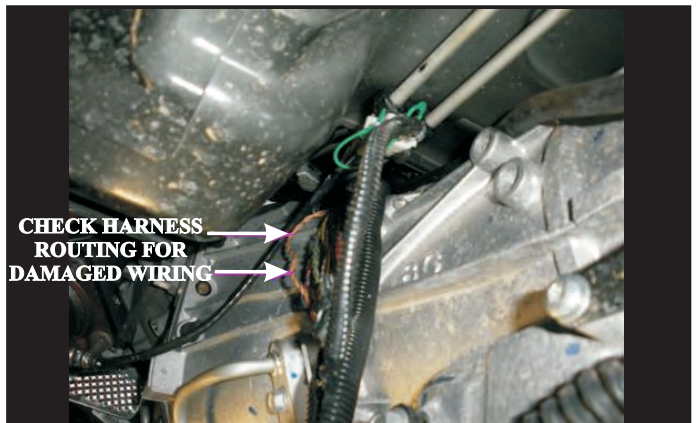
Figure 16

Inspect for chafed, damaged or pinched wires that are outside the conduit where the harness is routed over the top of the transmission towards the top of the engine.

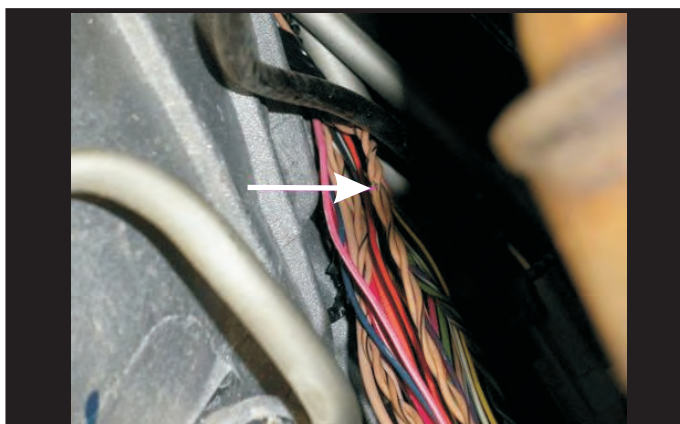
Figure 17

Inspect for chafed, damaged or pinched wires in areas where the protective conduit shows signs of damage by removing the wires from the plastic conduit.

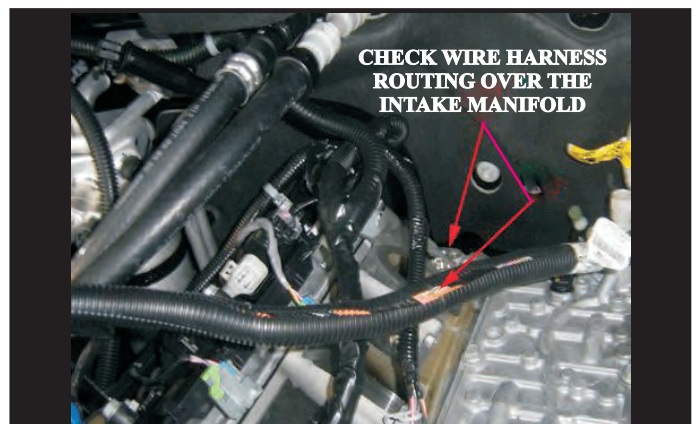
Figure 18

Inspect for chafed, damaged or pinched wires that are outside the conduit where the harness is routed over the intake manifold which has been removed for clarity.

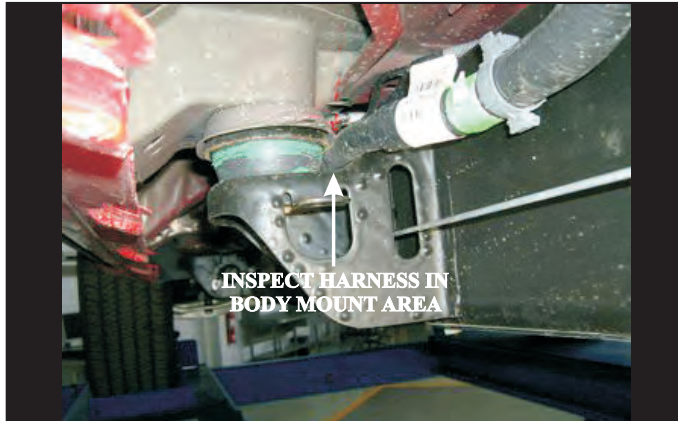
Figure 19

Inspect for chafed, damaged or pinched wires where the wire harness passes through the body mount on the left side of frame rail.

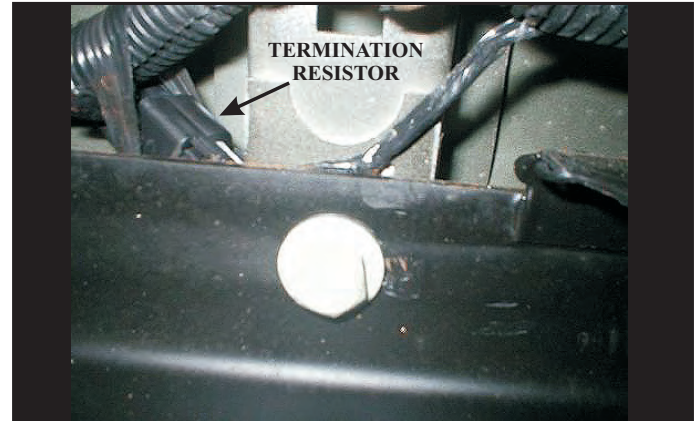
Figure 20

Termination Resistors that have become shorted or open will cause loss of communications. The resistors are difficult to find due to the fact that they are located within the vehicles framework. A good Termination Resistor will have a resistance of between 110 to 130 Ohms. If the resistor is open then the bus circuit that is affected will be open at some point in the harness but not else where in that circuit. A good tool for this purpose would be an audible circuit fault tester sometimes referred to as the "Fox & Hound" Tester.

The Termination Resistor is very difficult to locate because it is typically located somewhere in the vehicle framework. Typically it is located on the rear cross member or inside frame rail.

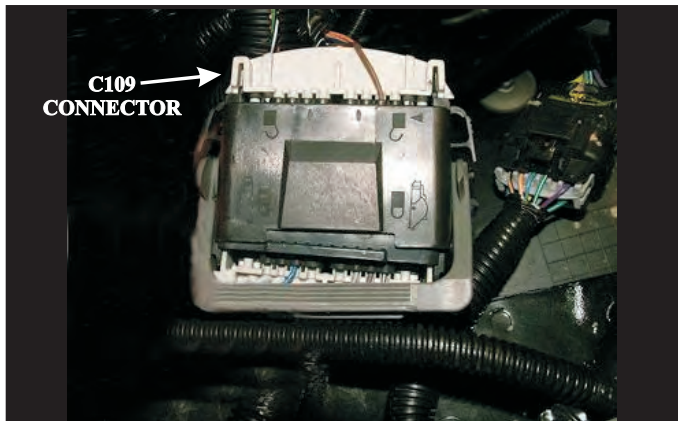
Figure 21

Check for corroded or damaged terminal ends in the C109 connector located beneath the underhood fuse box. Check that the connector is fully seated even though the lever is locked down.

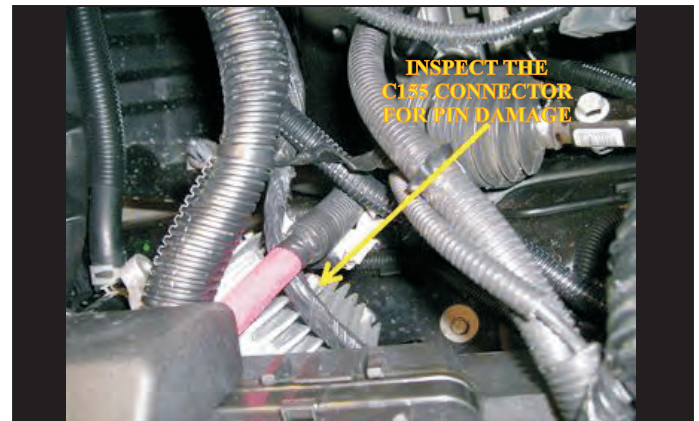
Figure 22

Inspect the C115 Connector located above the driver side shock tower beneath the underhood fuse box for corrosion or other types of terminal end damage.

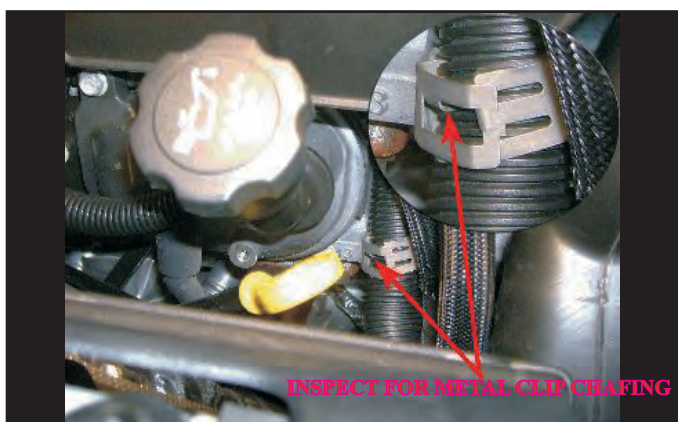
Figure 23

Where the engine harness is routed around the engine oil fill stand pipe, inspect the harness for damage caused by the metal retaining clip.

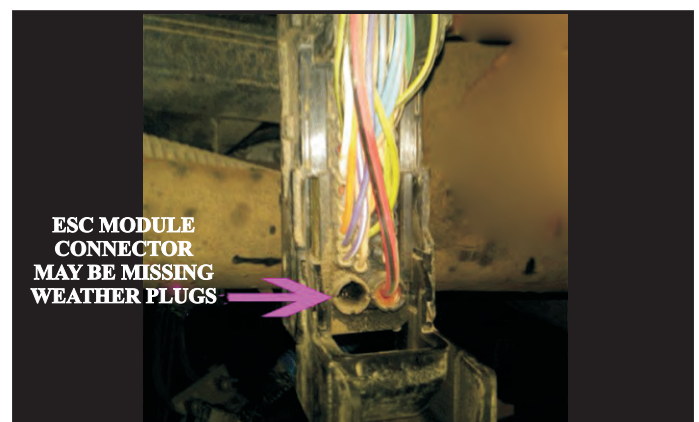
Figure 24

Locate the Electronic Suspension Control Module (ESC) under the rear of the vehicle, above the spare tire carrier & check for missing weather plugs which permit water intrusion.

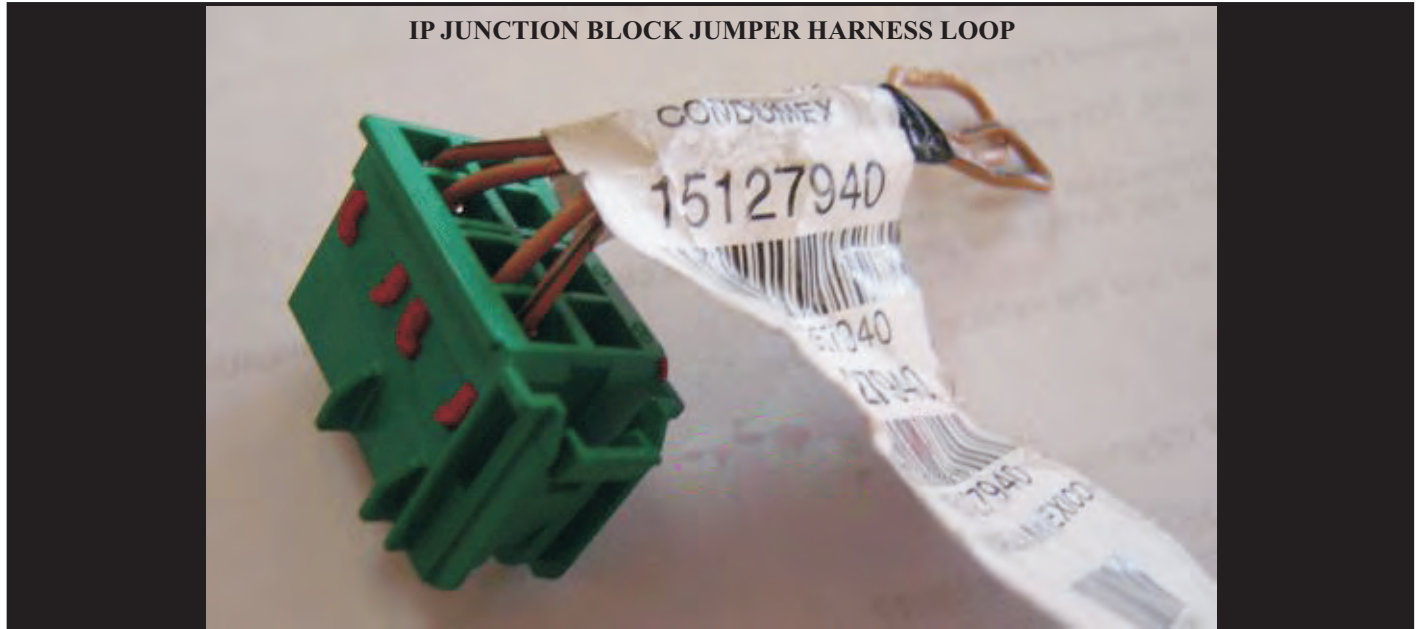
Figure 25

When the Instrument Panel Jumper Harness Loop Connector (PN 15127940) is faulty it can cause DTCs C0242, P0700, P0AC4, U0293, U0100, U0109, U0129, U0140 U1862, U186B, U1886 or U1888 to set. The loop connector will require replacement using the above listed GM part number.

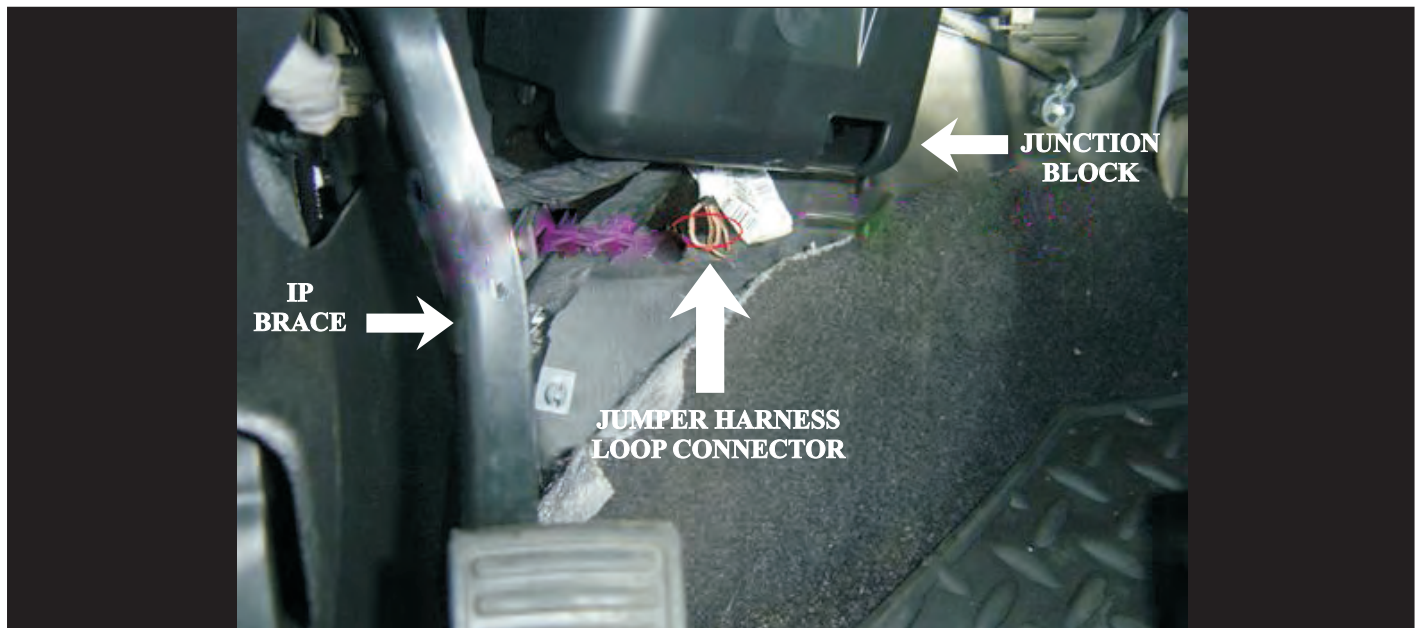
Figure 26

Inspect the Junction Block Jumper Harness Loop Connector for chafing on the instrument panel brace. The loop connector connects to the lower rear of the junction block and is routed to the harness at the instrument panel steel support brace.
