Technical Service Information

4L60E/4L65E/4L70E

WATER CONTAMINATION

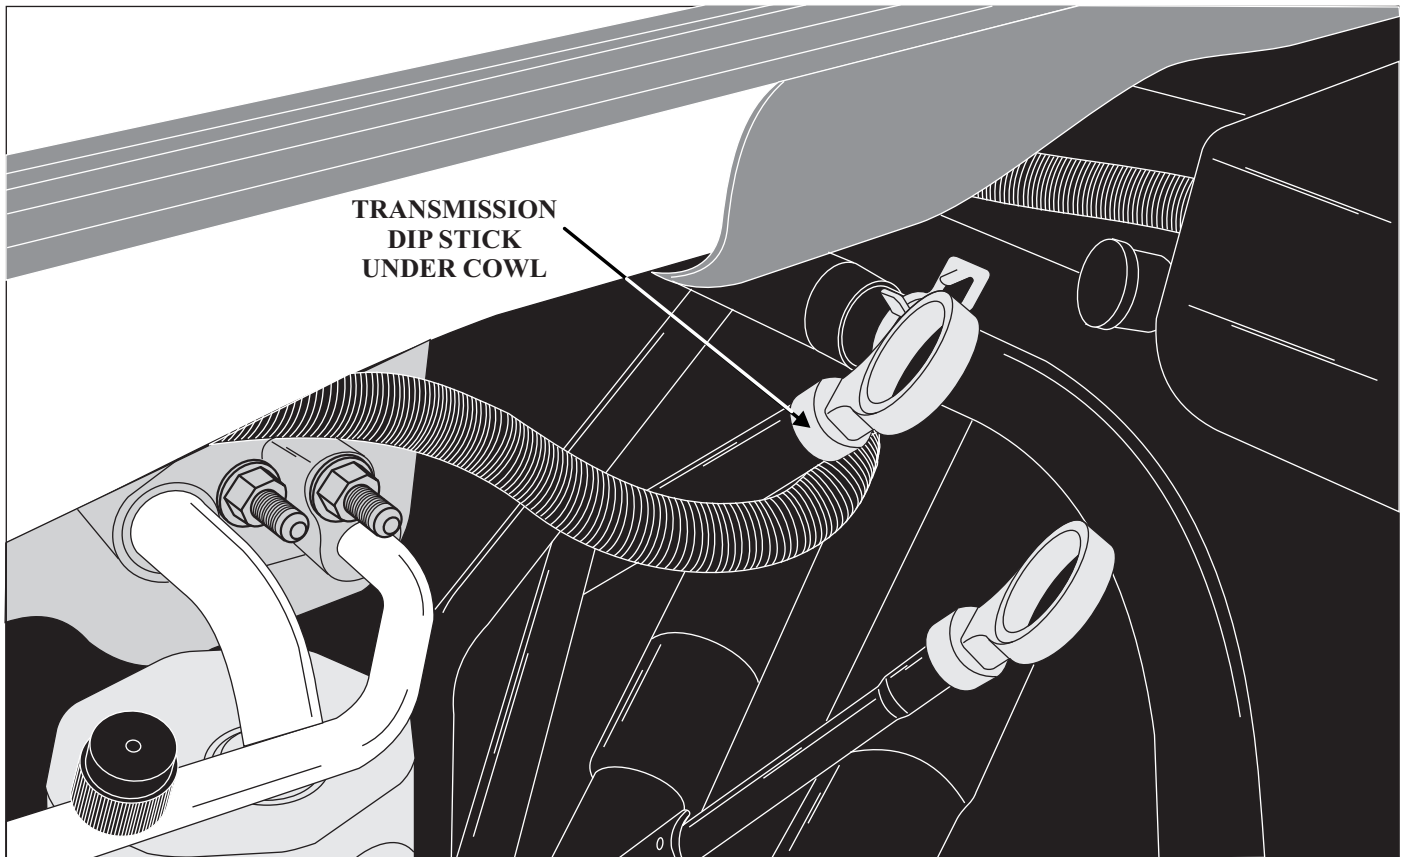
Figure 1

CAUSE: Water has entered the transmission by water dripping from the cowl area onto the transmission dipstick due to a poor seal between the air inlet grille panel and the hood, (Refer to Figure 1).
