# Technical Service Information

## GM 4L70E INPUT SPEED SENSOR FAULT

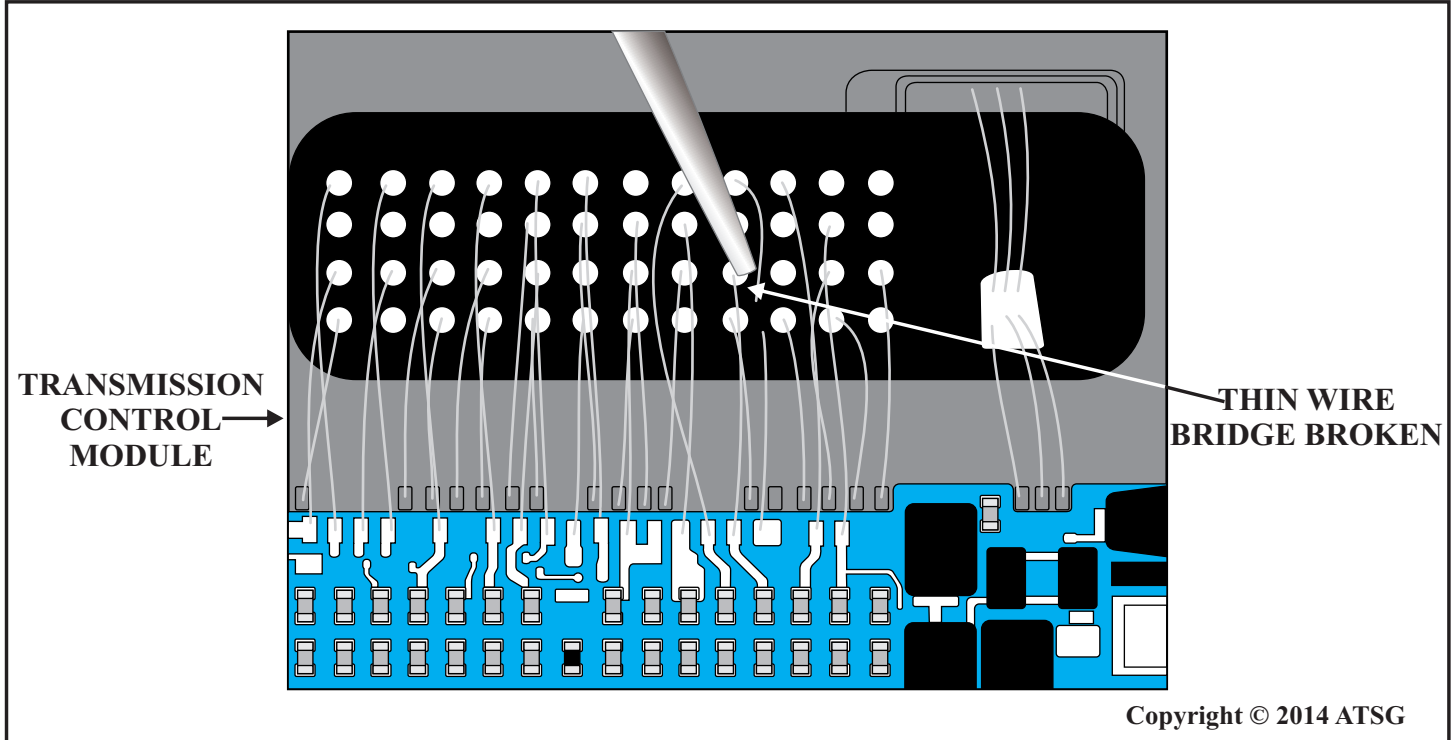
Figure 1

With the cover removed from the TCM, Figure 1, one can see the very fine wires (.010") that connect the circuit board to the connector pins.

What has happened is the fine wire that provides the ground circuit for the input speed sensor has broken which results in the above complaint.

**CORRECTION:** Since this is a computer supplied ground, the proper repair would be to replace the TCM, however, if soldering skills are good, the original TCM could be repaired.

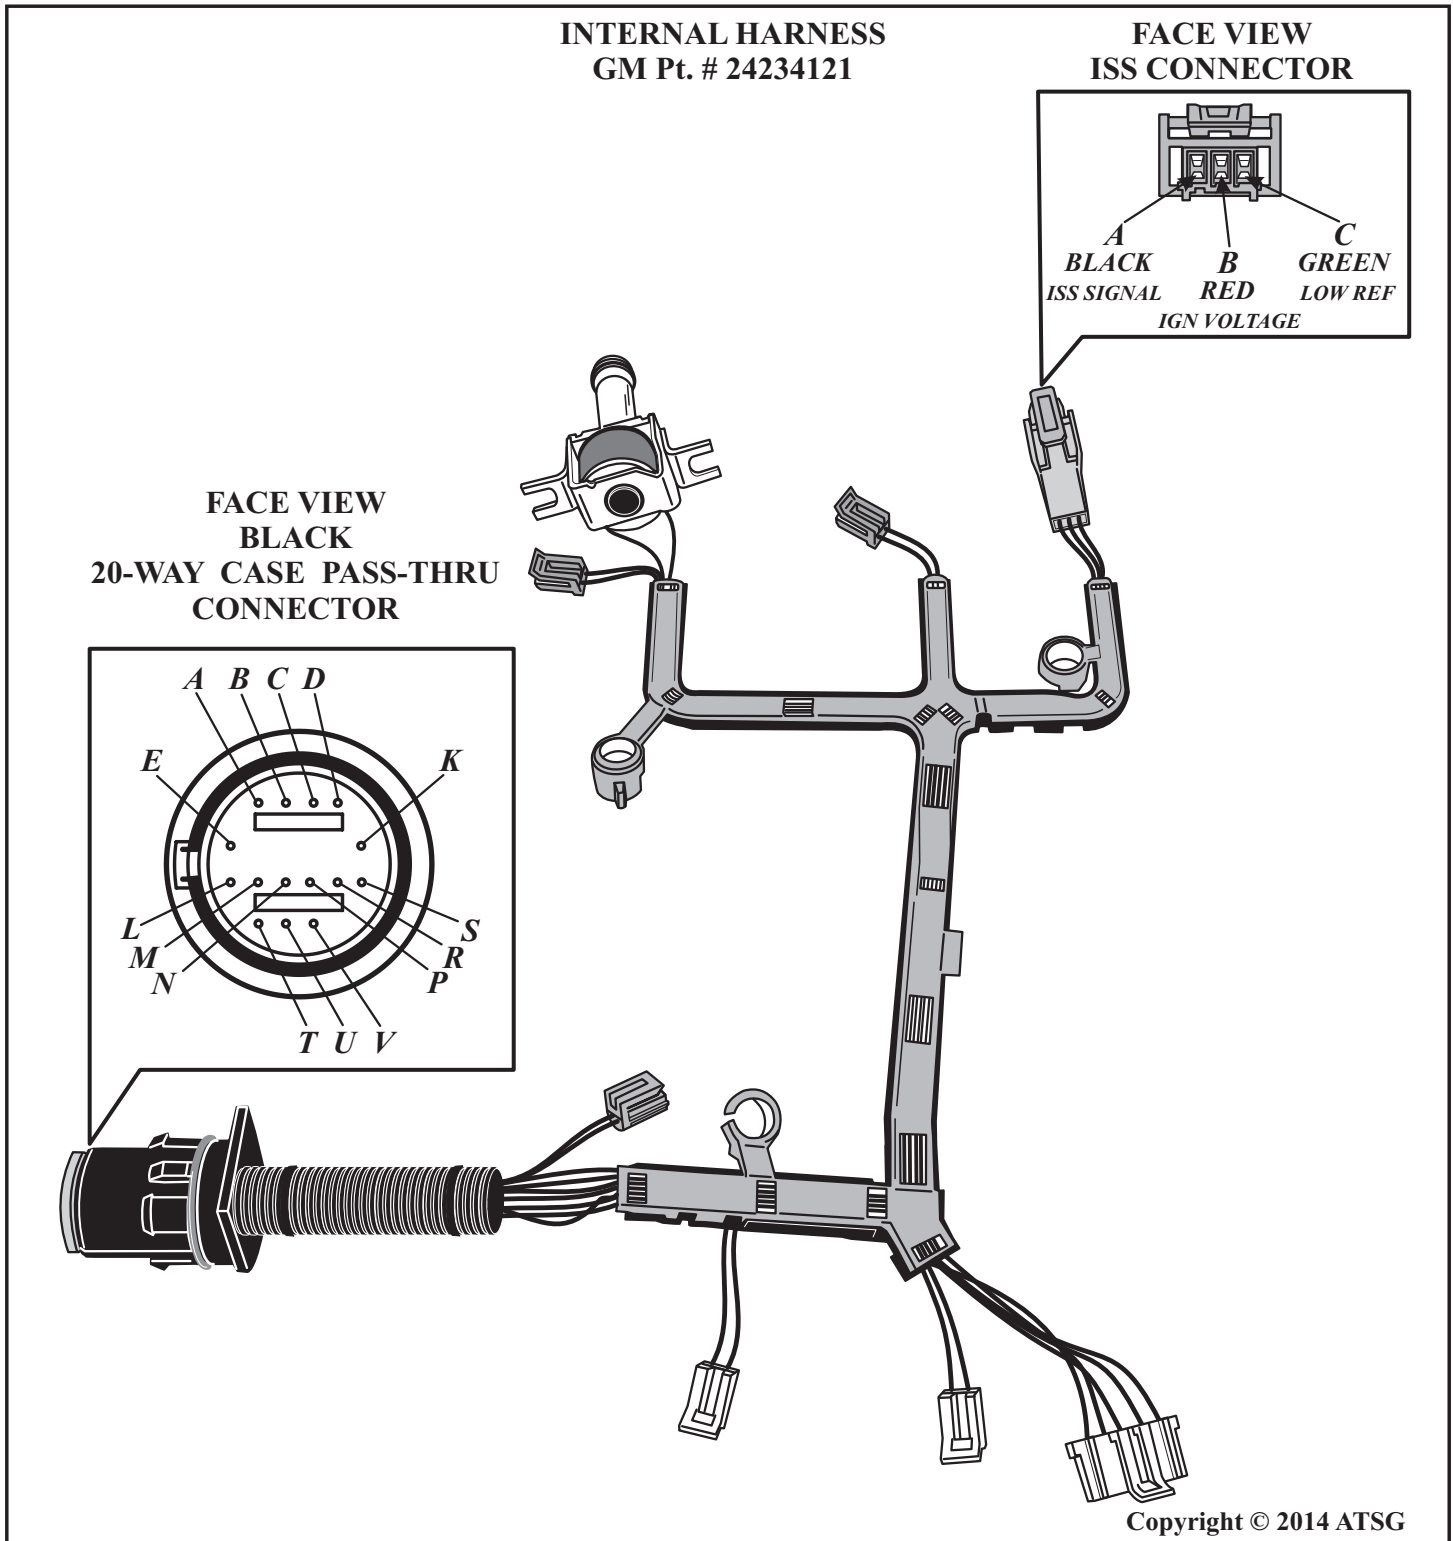
The input speed sensor circuits are identified in Figure 3 and the internal wire harness that accommodates the ISS is also shown in Figure 3. The location of the ISS and how its wire harness is routed on the back of the pump cover is shown in Figure 4.
