Technical Service Information

AUDI 09L -ZF6HP19A GEAR NOISE-TRANSFER CASE GEARTRAIN FAILURE

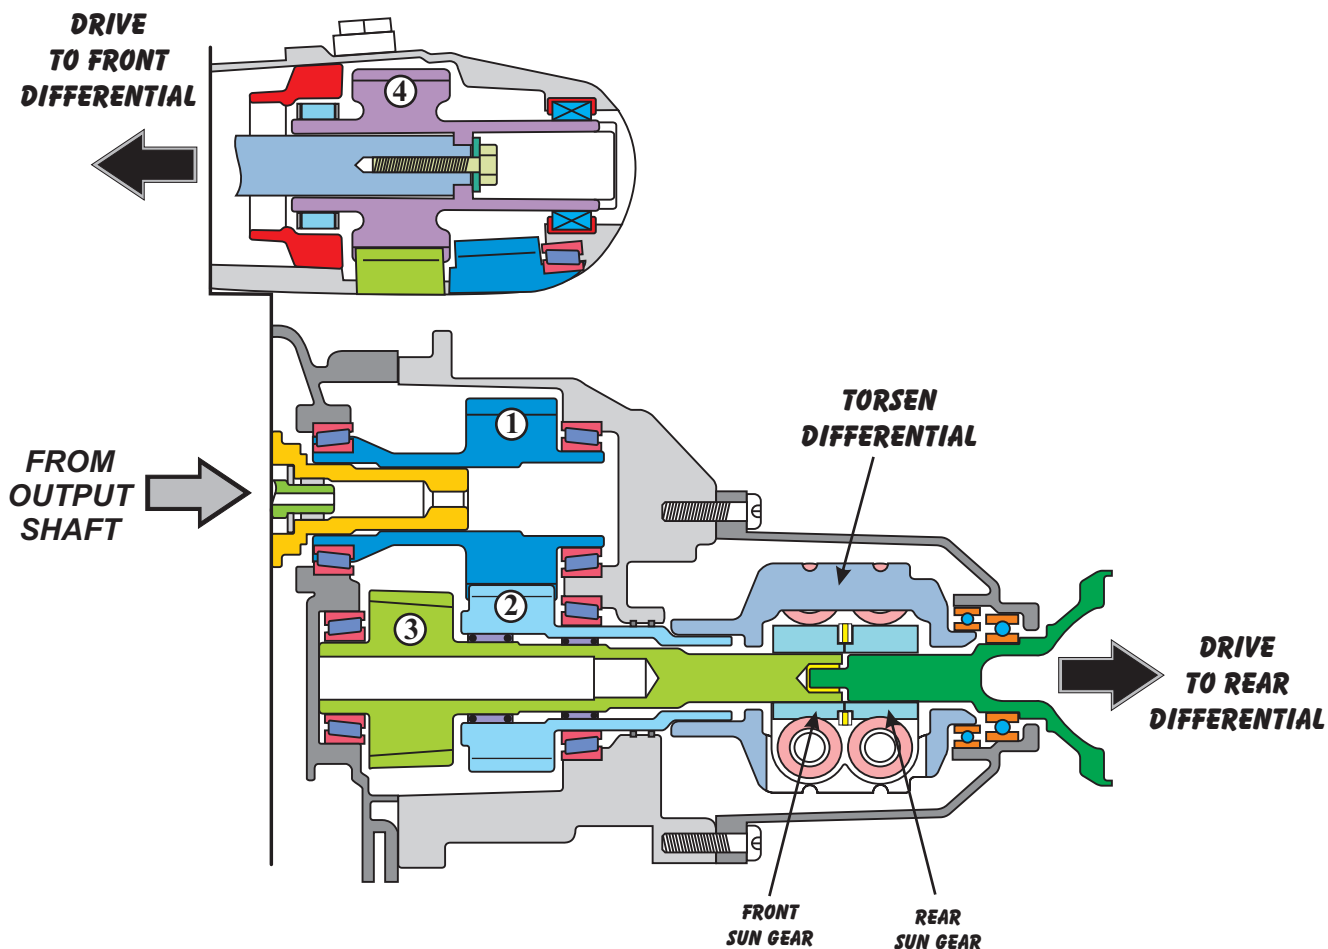
Figure 1

09L TRANSFER CASE CROSS-SECTIONAL VIEW

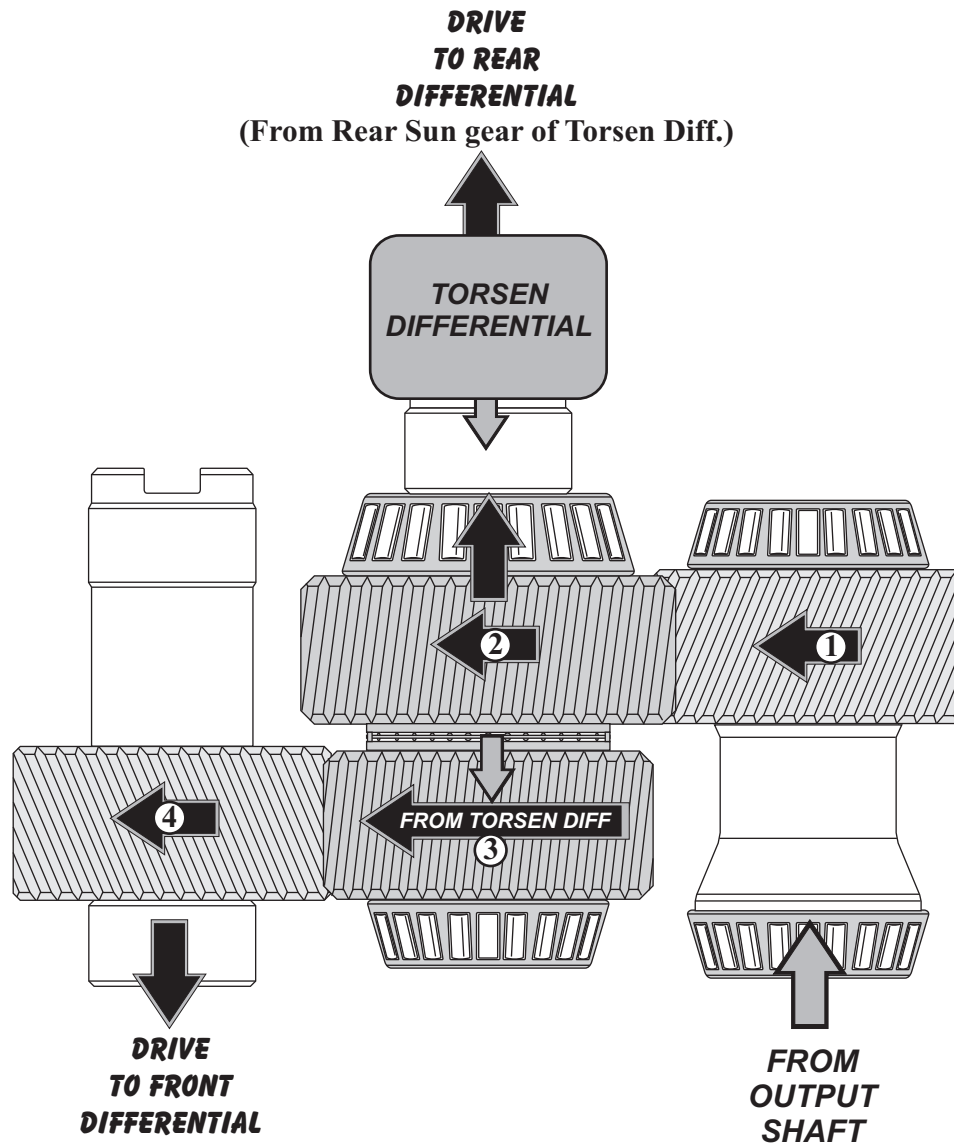
09L TRANSFER CASE- “CORRECT ASSEMBLY”

CORRECTION: To correct this condition, refer to Figure 2 for an illustration of the correct placement of the Drive transfer gear. Repair or replace gear train as necessary.

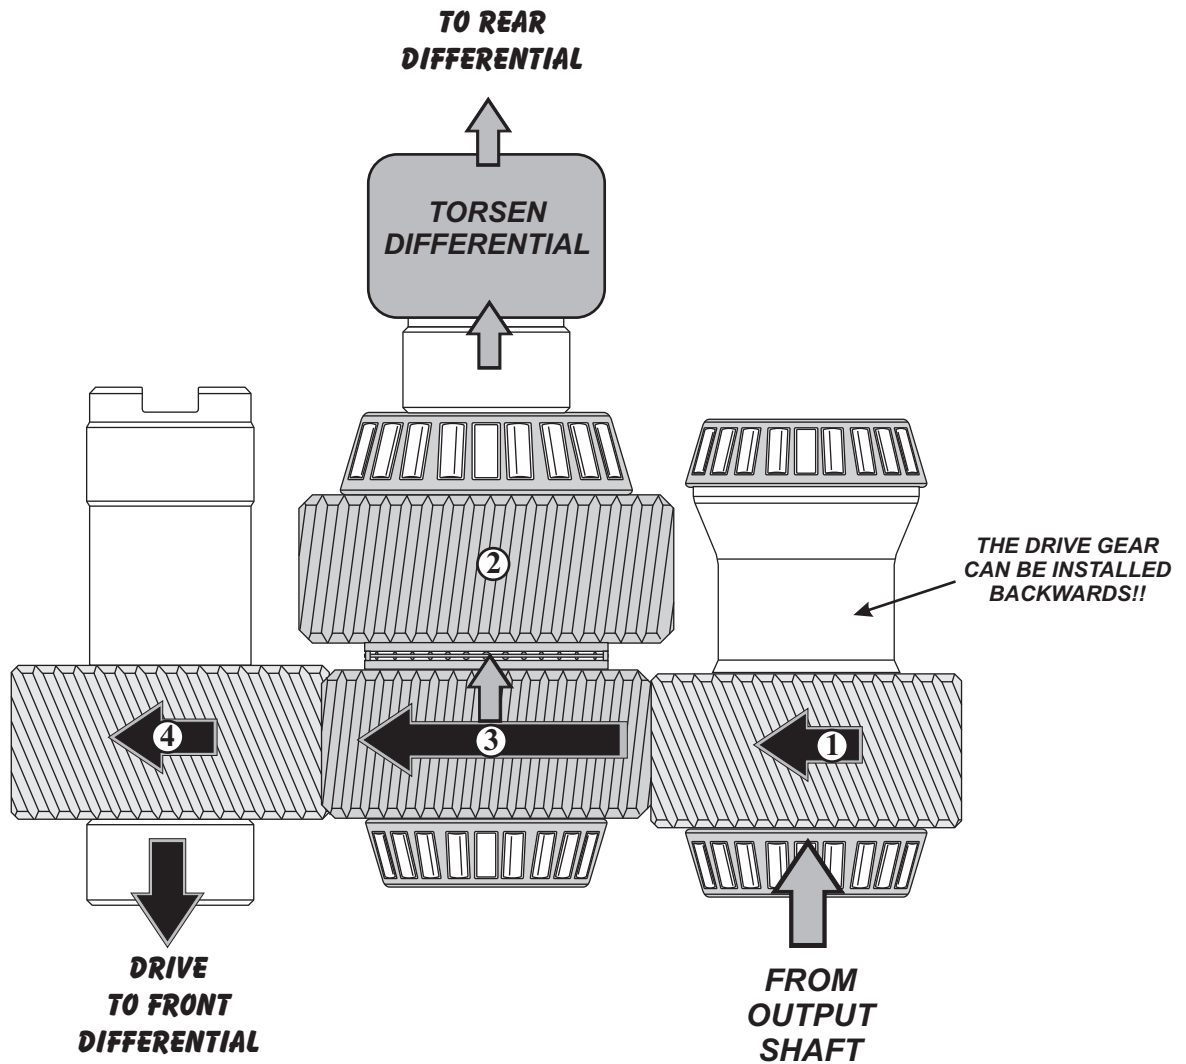
Figure 3

CAUSE: The cause may be, that during transmission overhaul, the Drive transfer gear, connected to the output shaft of the transmission was installed backwards, meshing with the Driven transfer gear, connected to the Torsen Differential, leading to the Front Drive Shaft drive gear. When this gear is installed backwards, the gear mesh is off significantly causing the gear noise. Notice in Figure 1 in the cross-sectional view that gear 3 has a smaller diameter than gear 2, which creates the gear mesh problem and gear train destruction. Figure 1 also shows the gear train of the transfer case assembly including the Torsen Differential. Refer to Figures 2 and 3 for a description of power-flow and illustrations of the correct and in-correct assembly.

09L TRANSFER CASE- "IN-CORRECT ASSEMBLY"

- Drive Gear ① is connected to the Output shaft of the Transmission*
- Driven Gear ③ is connected to the Inner Spline of the Torsen Differential*
- Driven Gear ④ is connected to the Front Drive shaft*
- Driven Gear ② is connected to the Outer Spline of the Torsen Differential but is not driven by the correct geartrain.*

NOTE: Drive Gear 1 can be installed backwards, as the tapered bearing is the same on both ends. Notice that Gear 2 and 3 have different diameters, this is what causes the gear noise, and will quickly destroy the gear set.
