# Technical Service Information

## GM 4T65E TCC SURGE OR CYCLING

**COMPLAINT:** General Motors vehicles equipped with the 4T65E transaxle can exhibit a TCC surge or cycling condition before or after overhaul. The condition occurs to quickly too store a trouble code however if the signal to the TCC Solenoid is checked during this condition the ON/Off cadence of the signal matches what the converter clutch is doing.

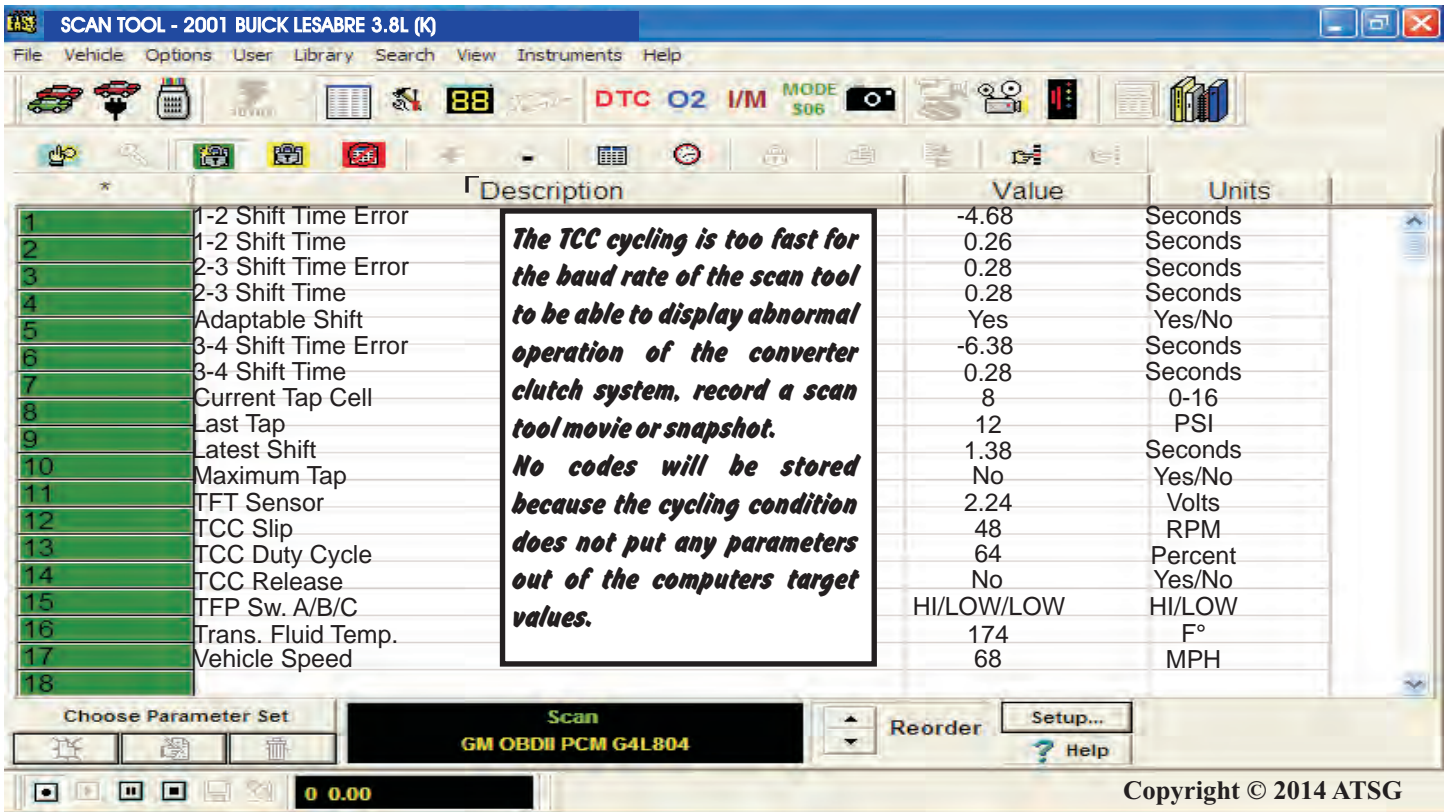
Figure 1

- 1 - Some GM vehicles that have the “Active Fuel Management” feature will give the perception that the converter clutch is cycling.
- 2 - The “Shift Adapts” have not been successfully reset.
- 3 - A computer reprogramming may be necessary.
- 4 - The TCC PWM Solenoid is faulty.
- 5 - The TCC Regulator Apply Valve or valve body bore is worn.
- 6 - The TCC Regulator Apply Valve bore plug o-ring is leaking or missing.
- 7 - The TCC Control Valve or valve body bore is worn.
- 8 - The TCC Blow Off Ball in the channel plate is leaking.
- 9 - Vacuum leaks.
- 10 - A dirty or faulty Mass Airflow Sensor or air intake duct is permitting un-metered air to the sensor.
- 11 - A restricted air filter.
- 12 - Faulty tune up items, (spark plugs, plug wires, ignition coils, etc.).

- 2 - Using a capable scan tool, perform a “Shift Adapt” reset and check the 4thGR/TCC Steady State that it is showing zero, Figures 1 and 2.
- 3 - Search for factory TSBs or go to the GM TIS website found At [www.atsg.biz](http://www.atsg.biz) under the “Resources” tab and type in the Vehicle Identification Number and see what reprogramming is available, Figure 3
