ZF5HP-19/FL/FLA LOSS OF 3RD/4TH AND DTC 46 WHEN HOT

COMPLAINT: 1998 and up, Audi or BMW vehicles, equipped with the ZF5HP-19/ FL/FLA may exhibit a condition of a 2-3 upshift flair, or a loss of 3rd and/or 4th gear as well as a two digit diagnostic trouble code of 46 **Gear Monitoring (BMW DTC)**. Note: extreme cases have also caused a complaint of a no move forward when the code 46 sets, as limp home mode is 4th gear.

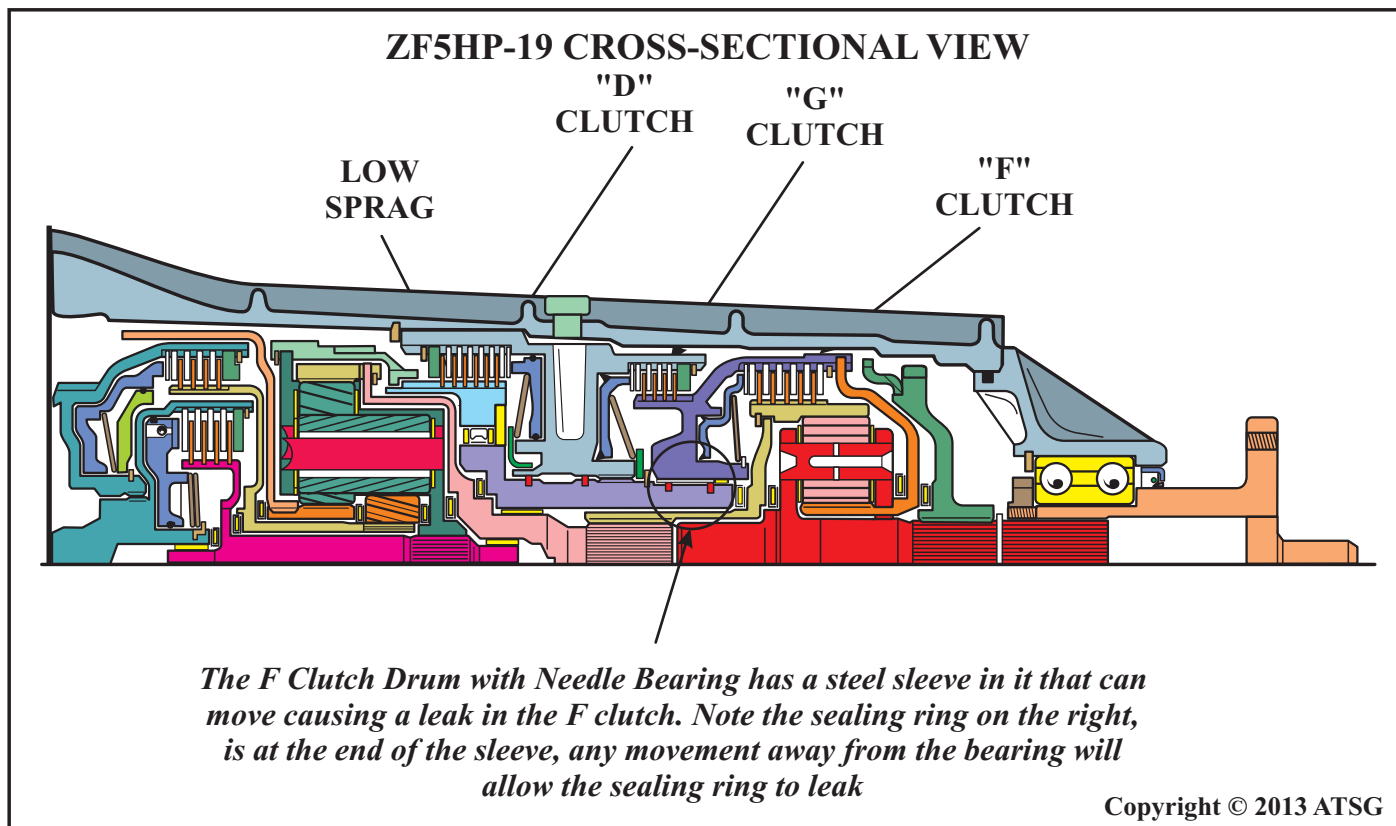
Figure 1

CAUSE: The cause may be, a loss of apply pressure to the F Clutch, as the sleeve in the drum is mis-positioned allowing the sealing ring closest to the bearing to leak, as shown in Figure 1. Refer to Figure 3 for a drawing of the F Clutch drum and the sleeve to verify if the sleeve is in the right place. A small amount of movement of the sleeve can cause a leak in the "F" Clutch. Refer to Figure 2 and note that the F clutch is applied in 3rd, 4th and 5th gear. **Note: 4th gear is limp mode and the application chart shows that if the F clutch is not functional, this could cause it to stop moving.**

CORRECTION: Replace the F Clutch drum with the part number listed below in Service information.

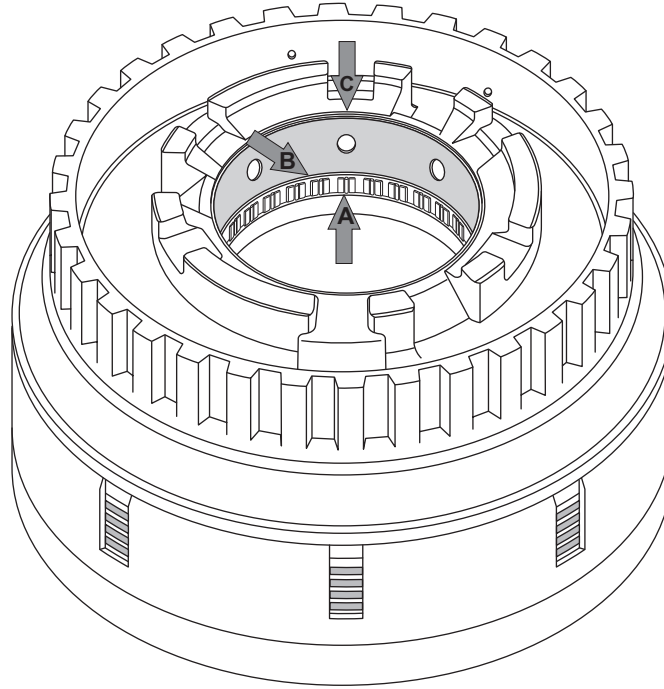
Figure 3

**VERIFY SLEEVE IS IN THE RIGHT POSITION
IN THE F CLUTCH DRUM**

Arrow "A"- Make sure that the Bearing is against the staked area in the drum

Arrow "B"- Make sure that the Sleeve is up against the Bearing

Arrow "C"- Make sure that the Sleeve is approximately .020" above the drum surface

Note: The sealing ring closest to the bearing is extremely close to the edge of the sleeve. Any movement of the sleeve will cause a leak in the "F" Clutch.
