Technical Service Information

GM 6L50/80/90

INTERMITTENT FAILSAFE AFTER PULLING LOAD OR KICK-DOWN

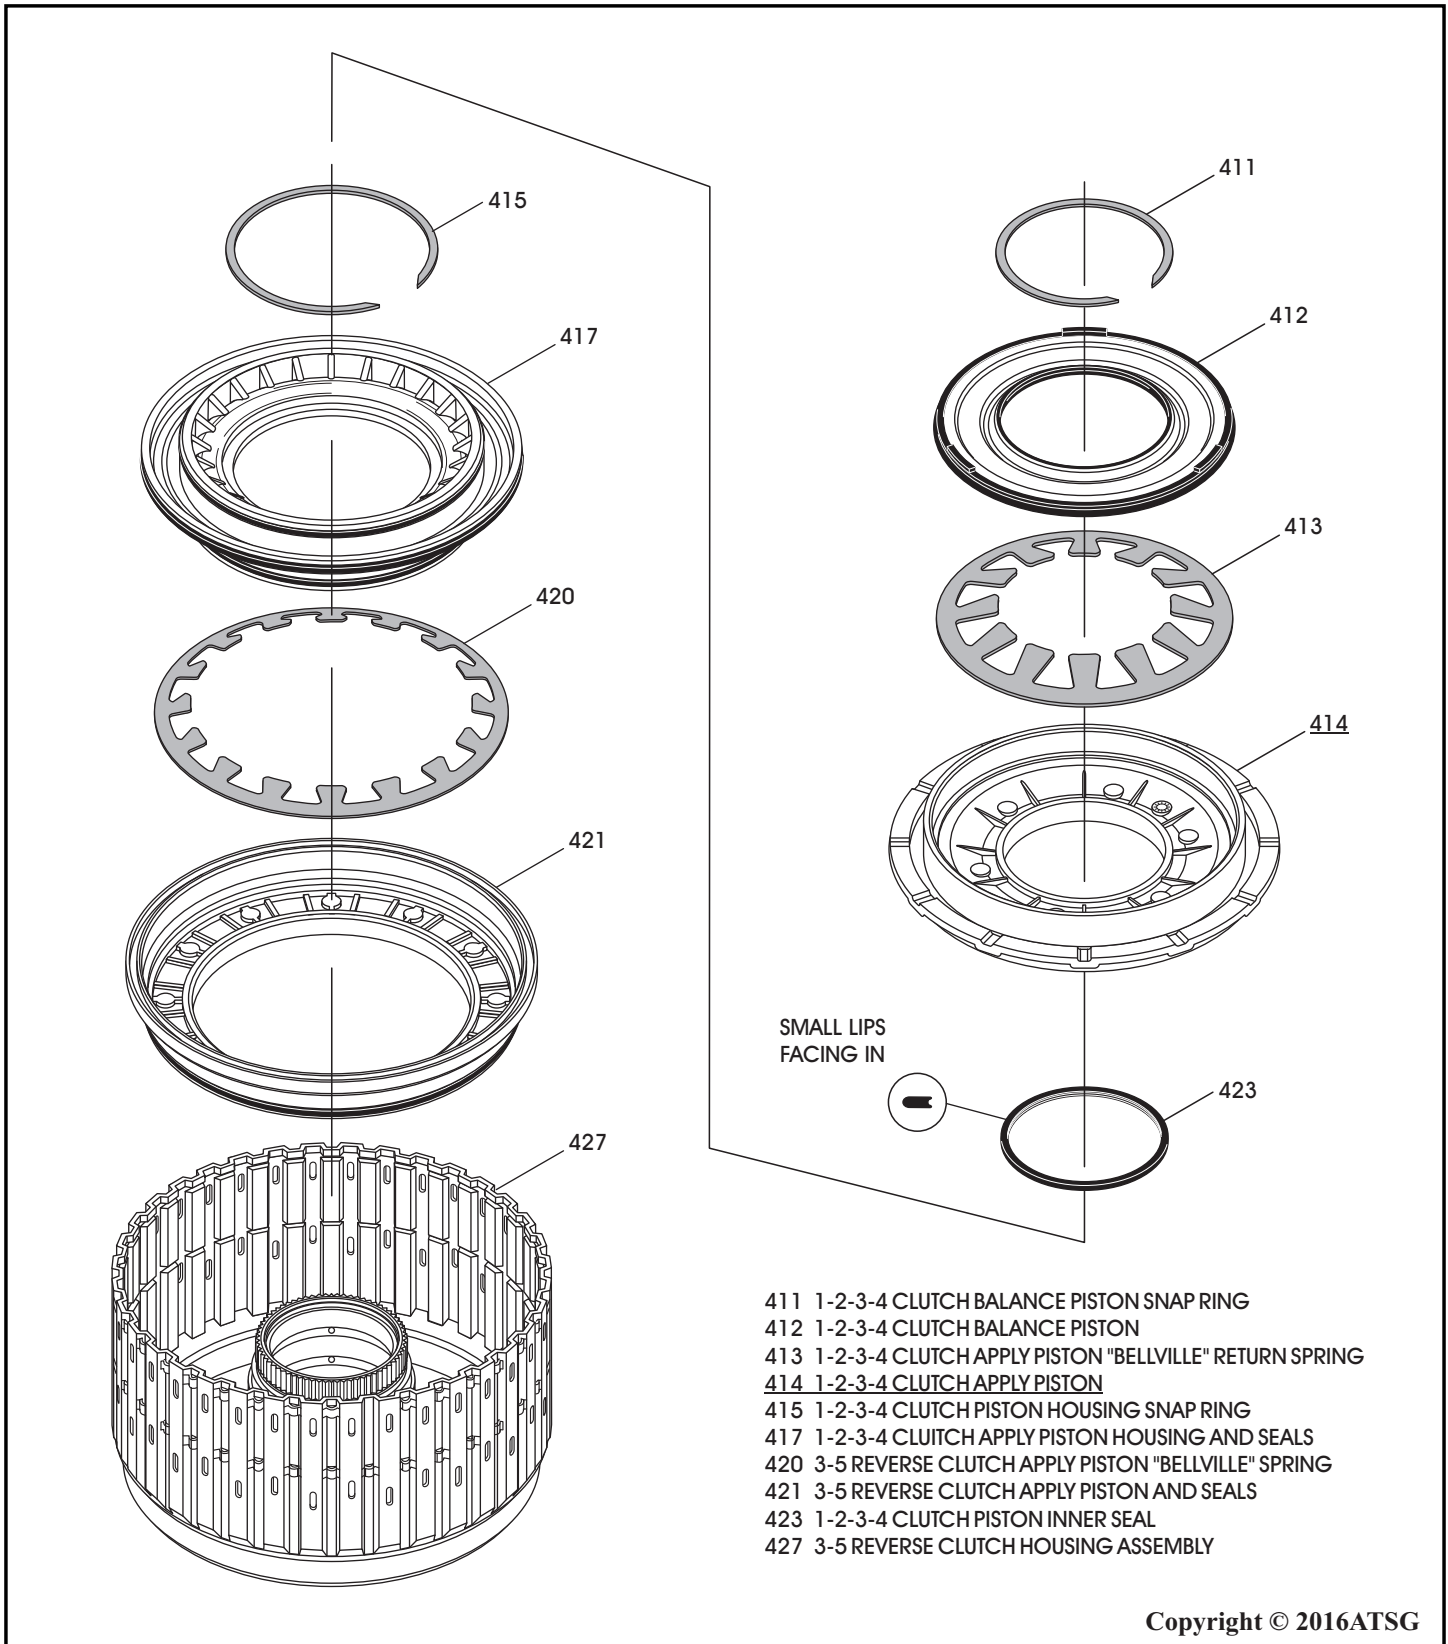
Figure 1

CAUSE: In past seminars, ATSG had provided technical information regarding a common problem with the 1-2-3-4/3-5-Reverse Clutch Drum (Figure 1) developing a crack in the weld area or by the bearing seat where the drum sits against the pump. This crack often times was difficult to see and would not leak with an air test in some cases. This required making a wet air check to the drum when it was hot for the crack to be detected.

One other cause which this bulletin is addressing may be a cracked 1-2-3-4 aluminum piston (# 414 in Figure 1). When you flip this piston over to view the bottom side, a rib type design is noticed. This gives the appearance of a more sturdy type piston when in actuality its design is to make the piston light in weight. As a result, the piston cracks and this crack is also very difficult to see or detect. A typical air test will apply the piston normally with no leak heard. It may take over 120 psi of shop air to open the crack to hear a leak.

CORRECTION: The was to replace the piston and/or drum. The big problem here is in replacing the common ribbed type piston for two reasons. For one, it will crack again in due time. Secondly, this piston lists for over \$400 dollars and wholesales to the shop for near \$300. There is a sturdy no-rib style piston available and it is for much less money (\$25 to \$30) which was thought too resolve the problem but it does not (See Figure 3). But this no-ribbed style piston has been cracking as well. At the time of printing, only Sonnax has a solution with a billet style piston.

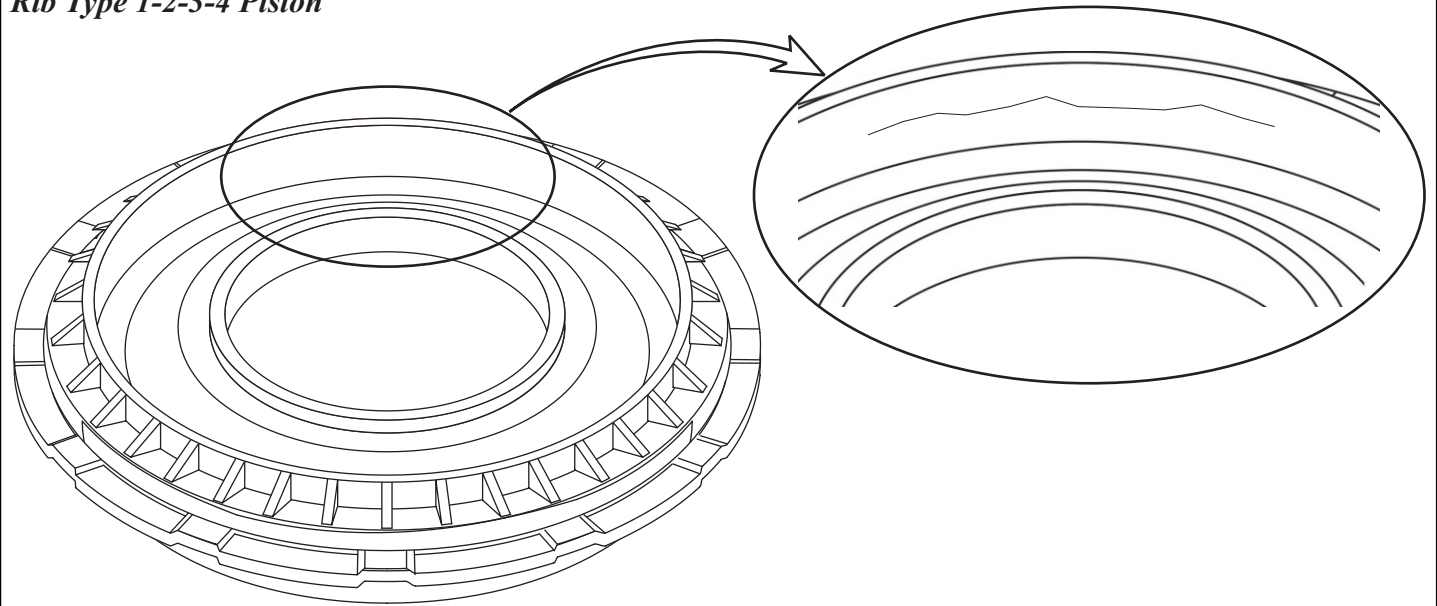
Figure 2

Rib Type 1-2-3-4 Piston

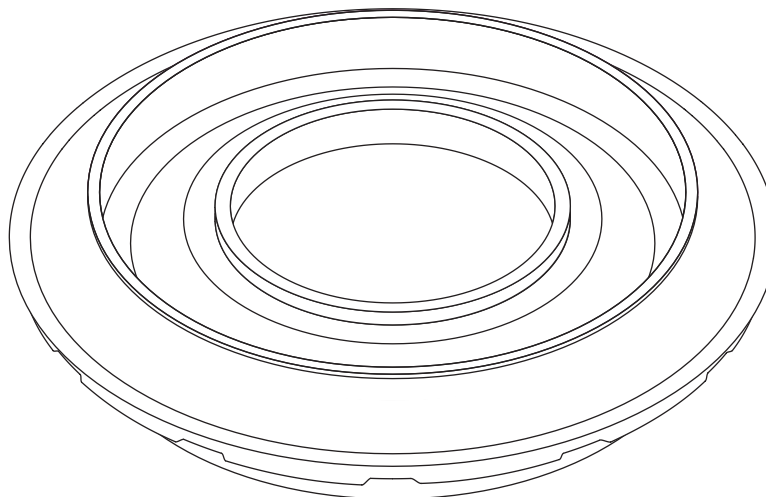
Figure 3

Non-Rib Type 1-2-3-4 Piston
