DODGE 45/545/68RFE DELAY/SHUDDER DURING DRIVE ENGAGEMENT

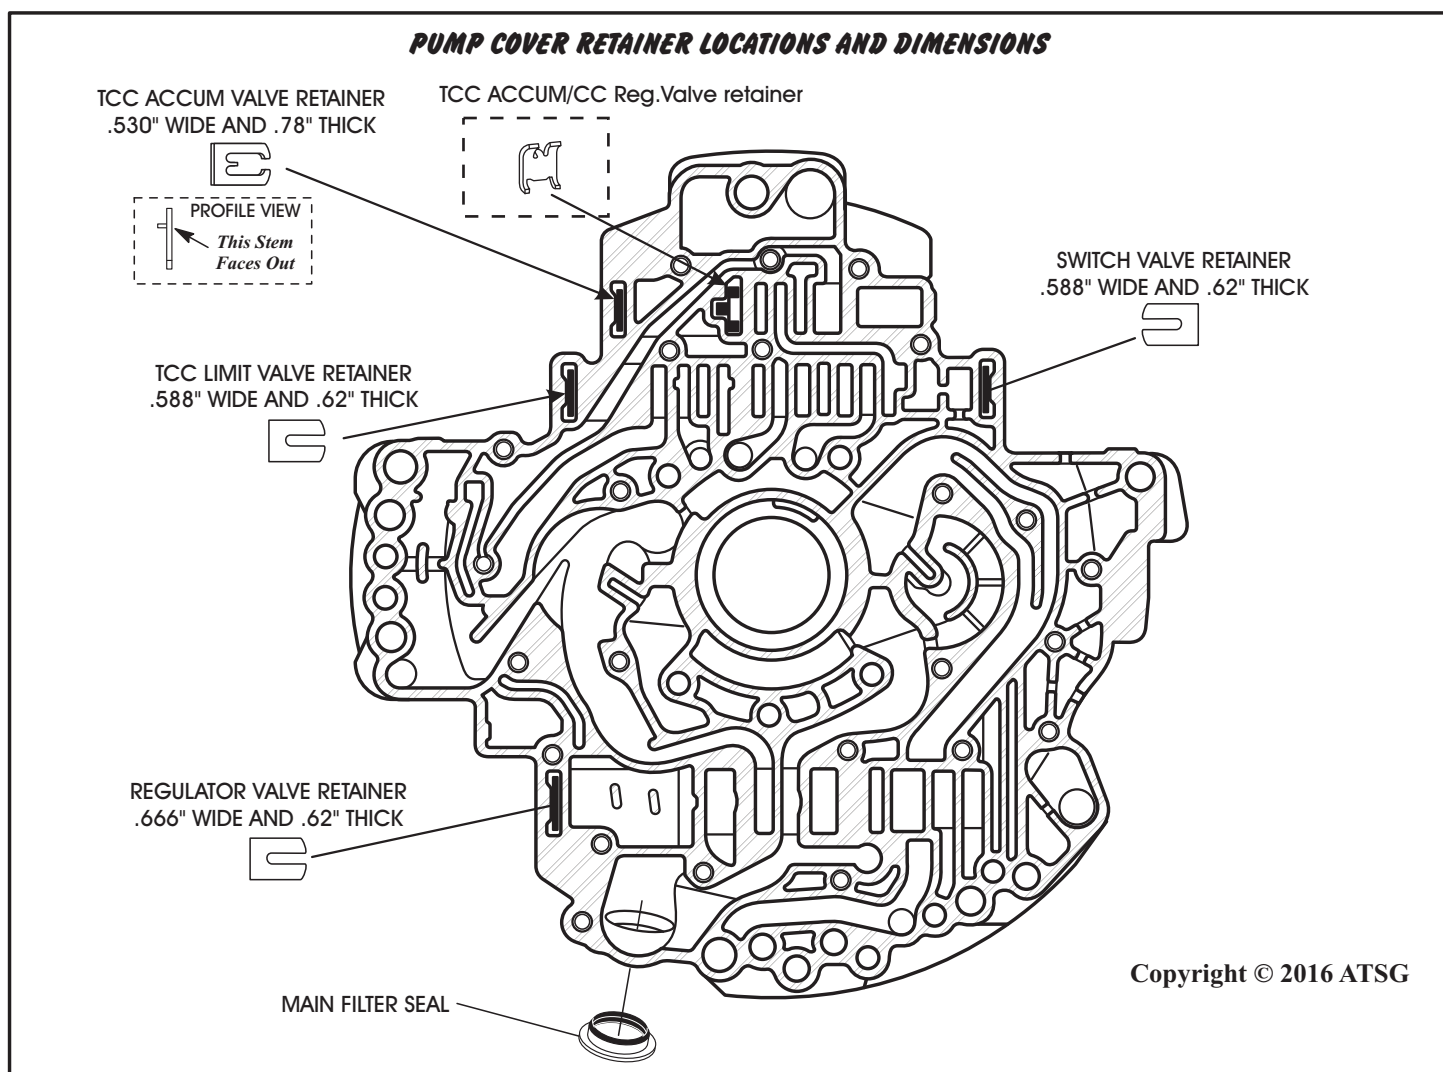
Figure 1

CAUSE: The cause may be, that during pump overhaul the retainer in-between the Converter Clutch Regulator valve and the Torque Converter Clutch accumulator valve, as shown in Figure 1, was mis- placed and not re-installed. When this happens the CC Reg. Valve can move to the left, as shown in the oil circuit diagram in Figure 3, and open up an exhaust path for Drive oil. See Figure 4 for a view of the CC Reg. Valve in the proper position with the retainer in place for a comparison. **Note:** the position of this valve can also cause a severe leak in the Underdrive Clutch causing a slip on take-off.

CORRECTION: Refer to Figures 1 and 2 for the location of the Converter Clutch Regulator Valve and TCC Accumulator Valve and install the retainer in the correct location.
