## DODGE CHARGER NAG 1 DRIVELINE VIBRATION/SHUDDER COMING TO A STOP

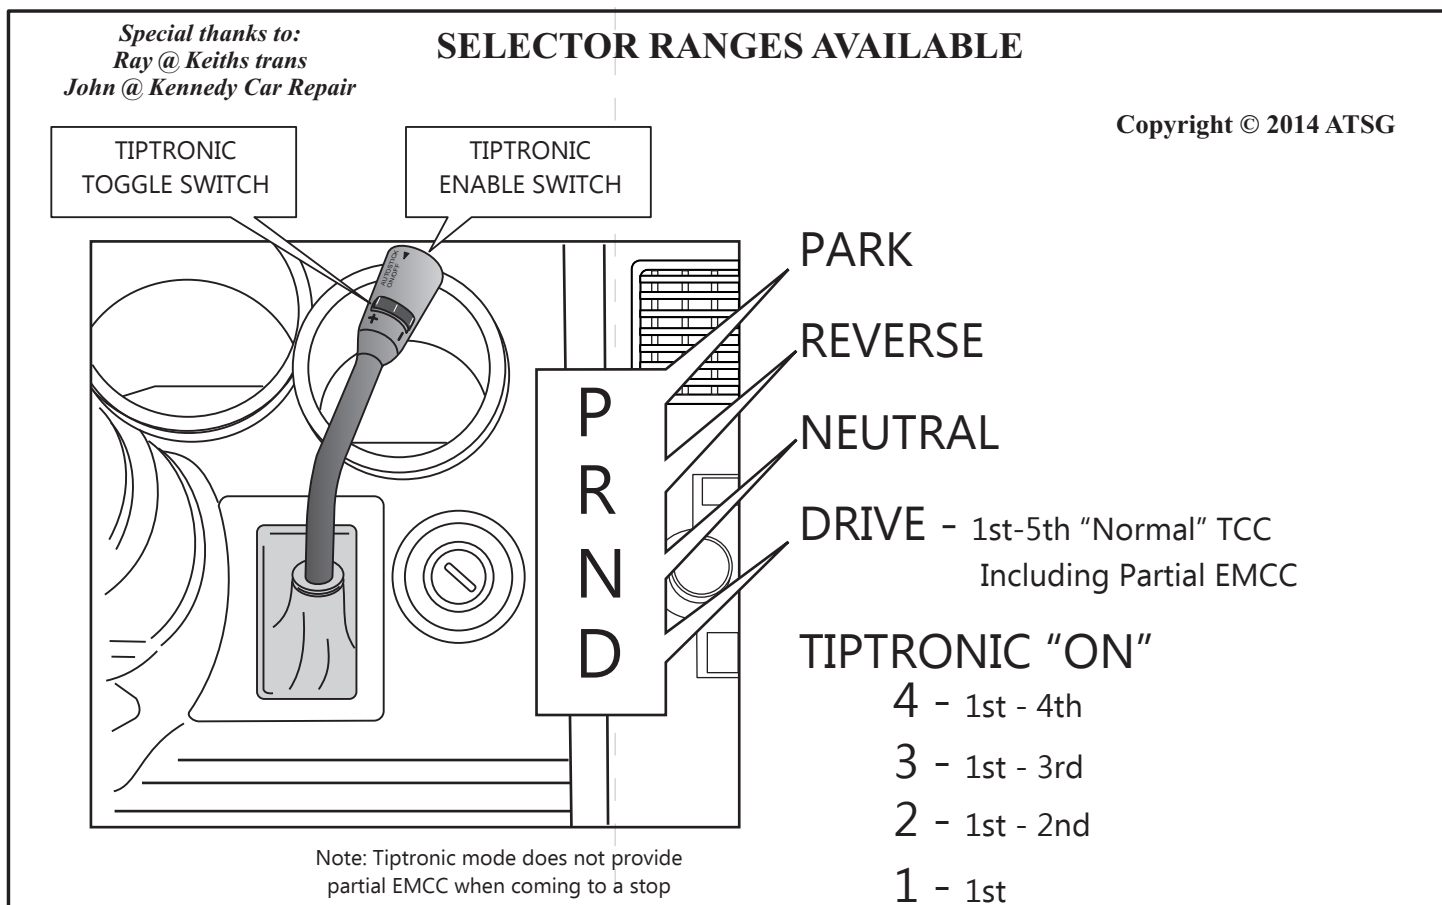
Figure 1

**CAUSE:** The cause may be, that the engine mounts are faulty causing the Partial Electronic Modulated Converter Clutch application to be transferred thru the bad engine mounts creating a vibration when coming to a stop. The reason that the vibration goes away when using the Autostick function is because in this mode, EMCC strategy is delayed and partial EMCC is not provided when coming to a stop, as it is in the Drive position. See Figure 1.
