ZF5HP24

DELAY/SLIPS IN REVERSE

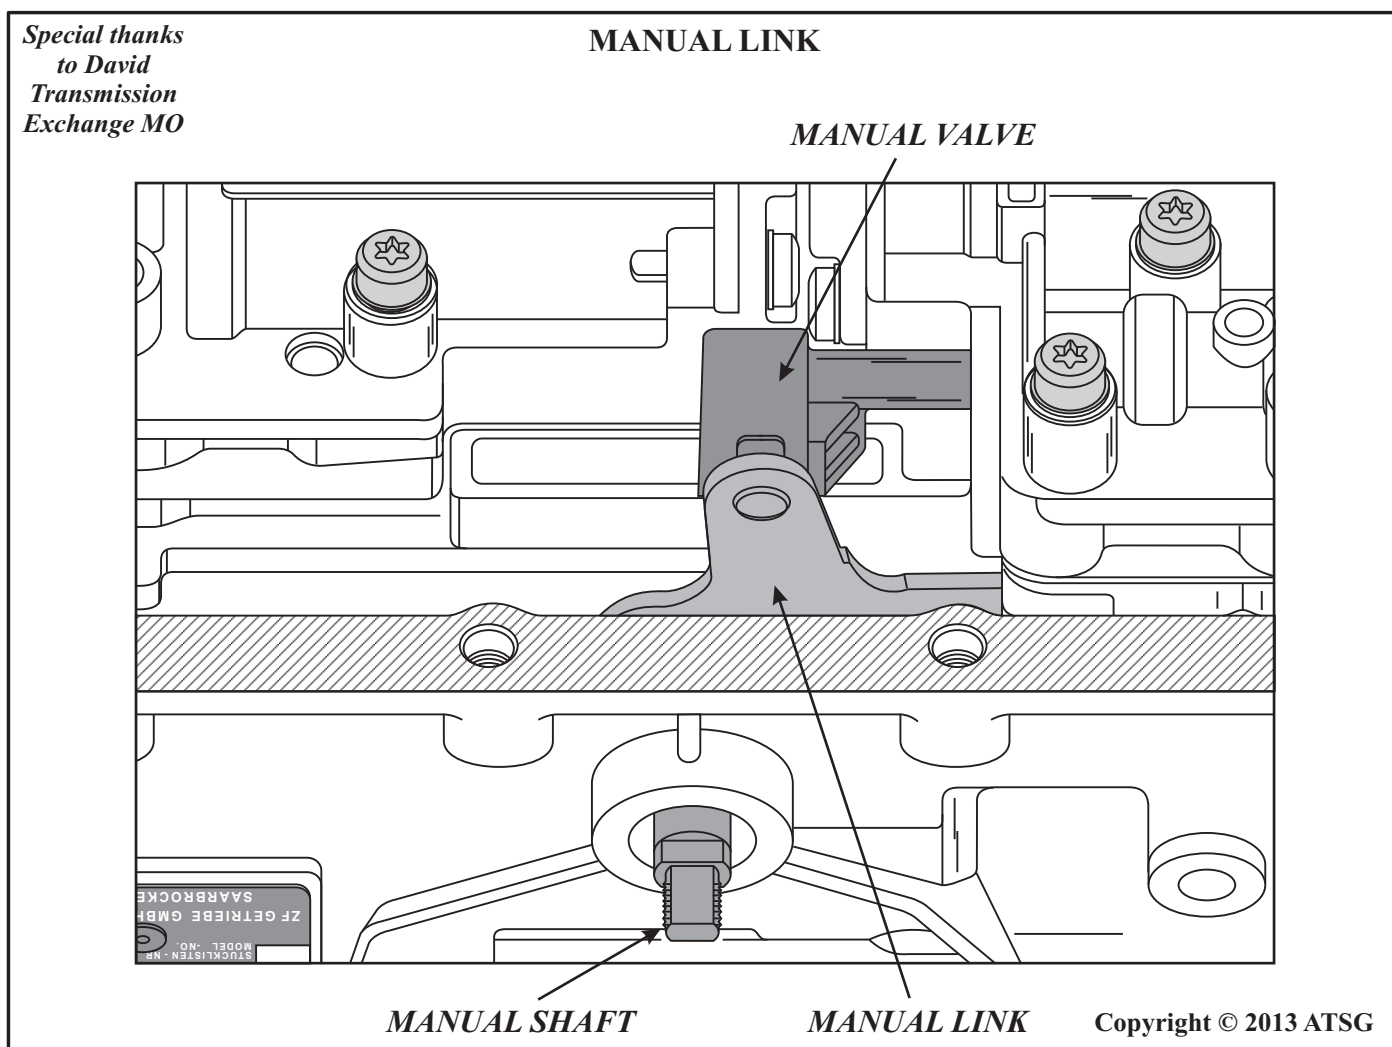
Figure 1

CAUSE: The cause may be, that the Manual Valve, as shown in Figure 1, is mis-aligned to the valve body casting causing a loss of pressure to the Reverse apply circuit. This happens when the Tamper-proof bolts are removed from the detent spring (see Figure 2). Note: There is no alignment when reassembling the detent spring to the case.

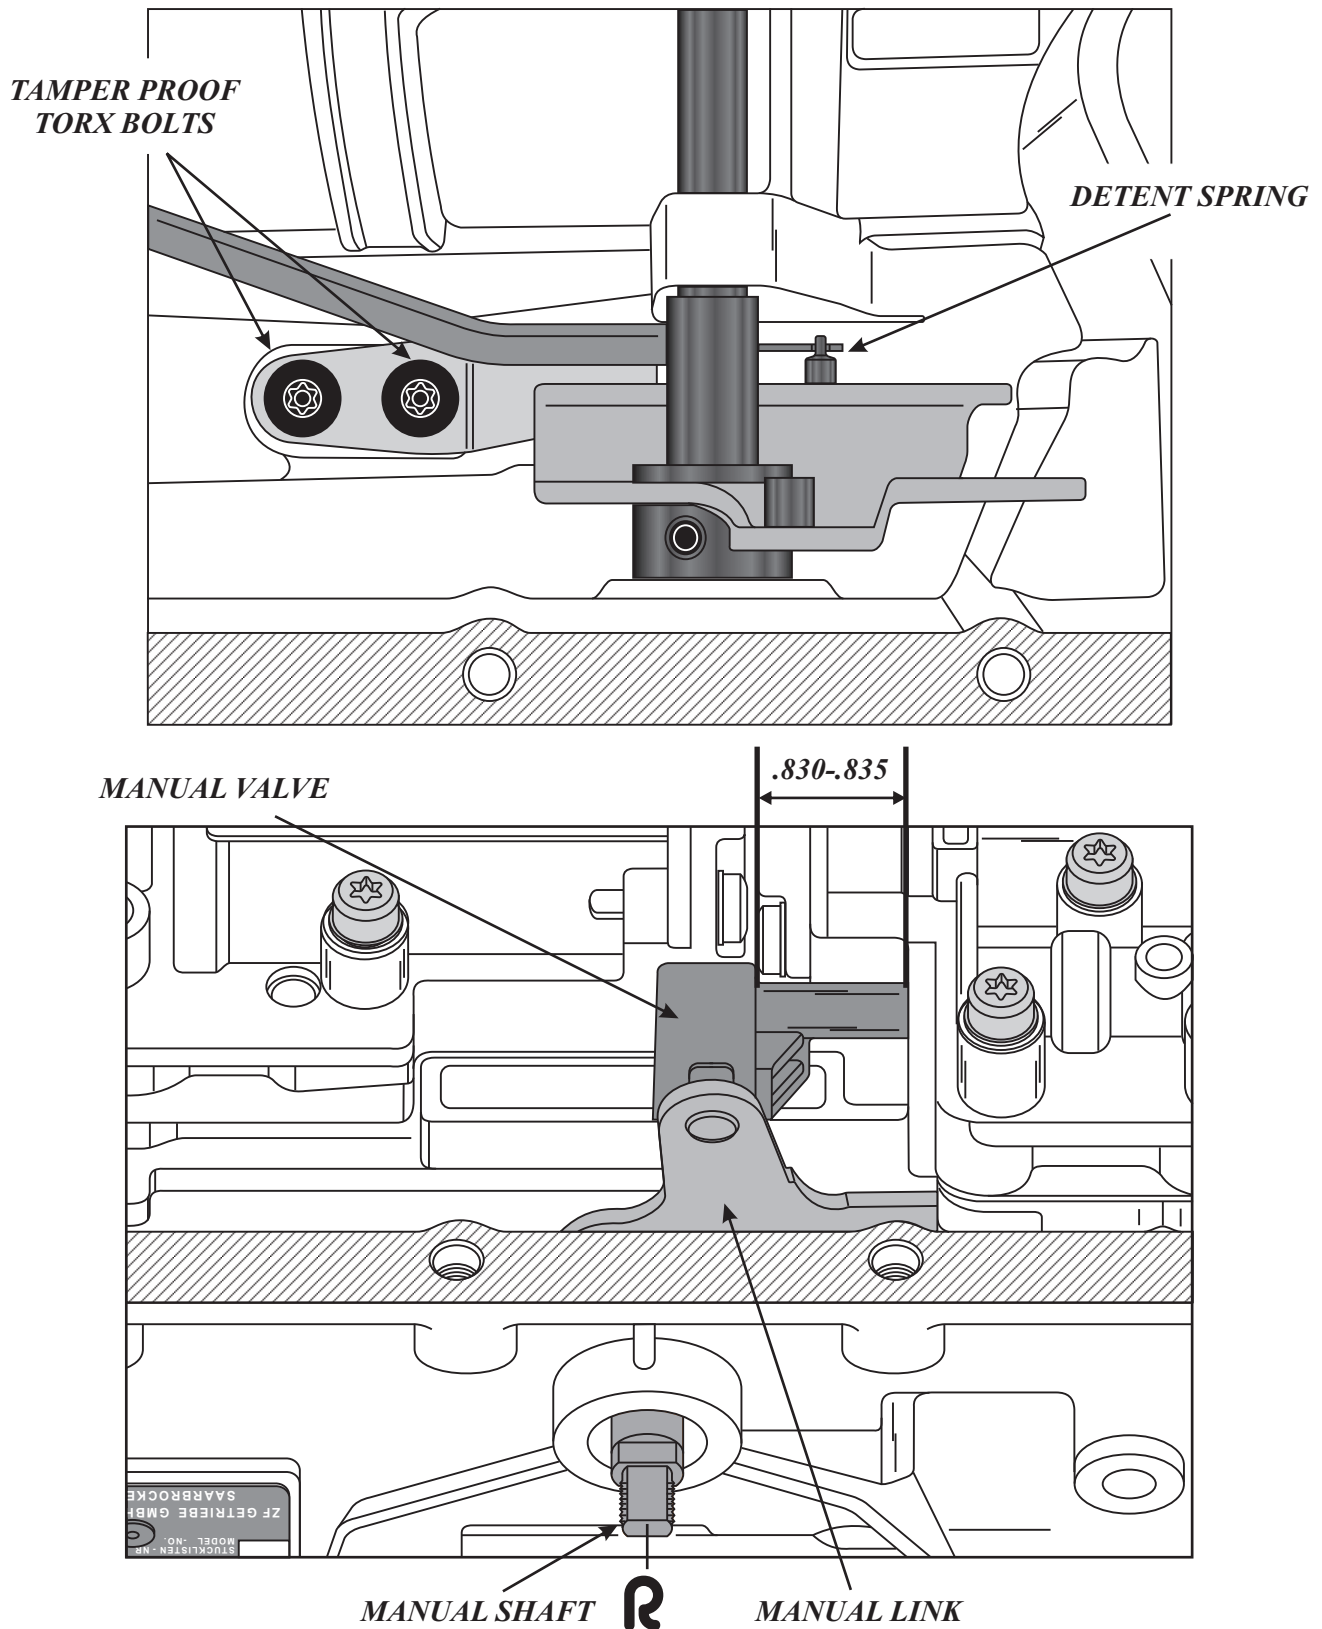
DETENT SPRING AND MANUAL VALVE ALIGNMENT

CORRECTION: To correct this condition, Refer to Figure 2 and place the Manual shaft in Reverse range. Measure from the edge of the valve body casting to the edge of the Manual Valve and verify that the reading is approximately .830"-.835." It may be necessary to remove the valve body and loosen the tamper proof bolts to adjust the detent spring to get the right reading.
