Technical Service Information

FORD MAZDA 4R44/5R55 ENGINE DAMAGE DURING R&R

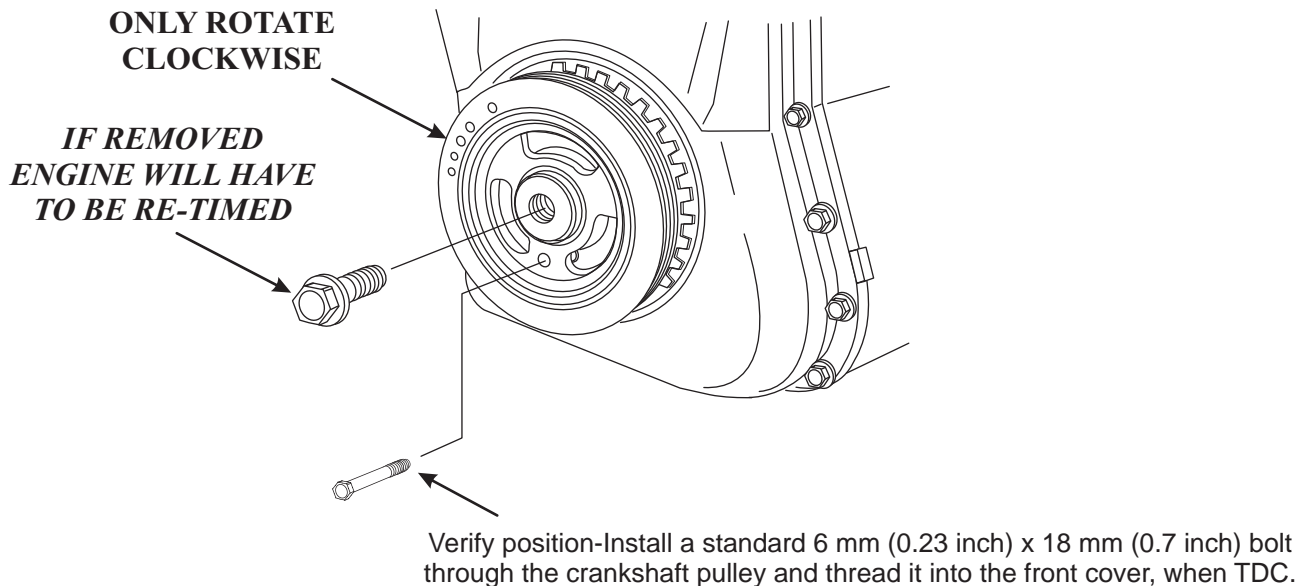
CAUSE: The cause may be, that during removal of the transmission, the crankshaft bolt that retains the front pulley/harmonic balancer was used to rotate the crankshaft as there is little access to the flywheel for removing torque converter nuts. Note: A starter switch can not be used on these models as the starter has to be removed to access the window for removing the torque converter nuts, as shown in Figure 1. The issue with using the crankshaft bolt is only if the bolt is loosened or if the ratchet and socket are mistakenly left on the bolt and the engine is started after the R&R process. The crankshaft on these models is not keyed to the timing gear and front pulley/harmonic balancer and when the bolt comes loose during start up it damages valves and the pistons in the engine as it quickly goes out of time.

CORRECTION: To verify that the balancer has not moved refer to Figure 2 and see the line-up hole in the balancer to the front cover of the engine. When turning the crankshaft, only rotate it in a clock-wise rotation. Remove tools before starting engine!

NOTICE: The crankshaft must remain in the Top Dead Center (TDC) position during installation of the pulley bolt or damage to the engine may occur. Therefore, the crankshaft pulley must be held in place with the Drive Pinion Flange Holding Fixture and the Adapter for 205-126 and the bolt should be installed using hand tools only. Consult O.E. manual for additional tools for holding the balancer and crankshaft during the torquing process and specifications.
