Technical Service Information

FORD 6F35 HARSH SHIFTS OR ENGAGEMENTS

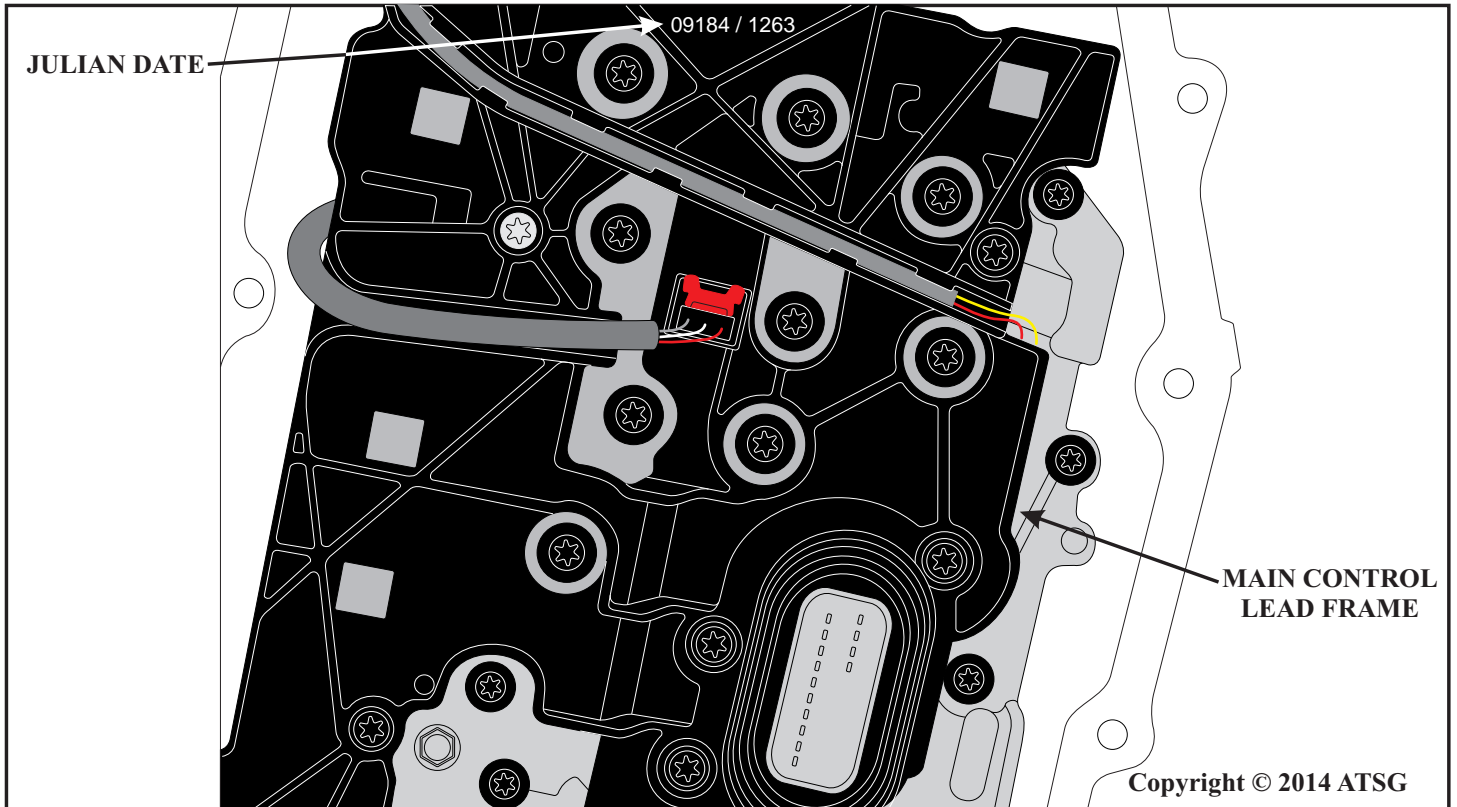
Figure 1

CAUSE (1): There is an open circuit in the Main Control Lead Frame to which the Output Speed Sensor is connected or the Output Speed Sensor is faulty.
There is a defect in the Main Control Lead Frame in these model years which can be identified by the Julian Date located on the lead frame.
The first 2 digits are the year of manufacture and the next 3 digits are the day of the year, for example if the Julian Date on the lead frame is 09184, it was manufactured in the 2009 model year on the 184th day of the year which would be July 3 (July 4 in Leap Year).
Lead Frames with Julian Dates not to be used are: 09184, 09185, 09186, 09229, 09230, 09234, 09235, 09236 and 09237, Figure 1.
