BMW ZF6HP FAMILY PLANETARY NOISE ALSO WHEN STOPPED IN DRIVE

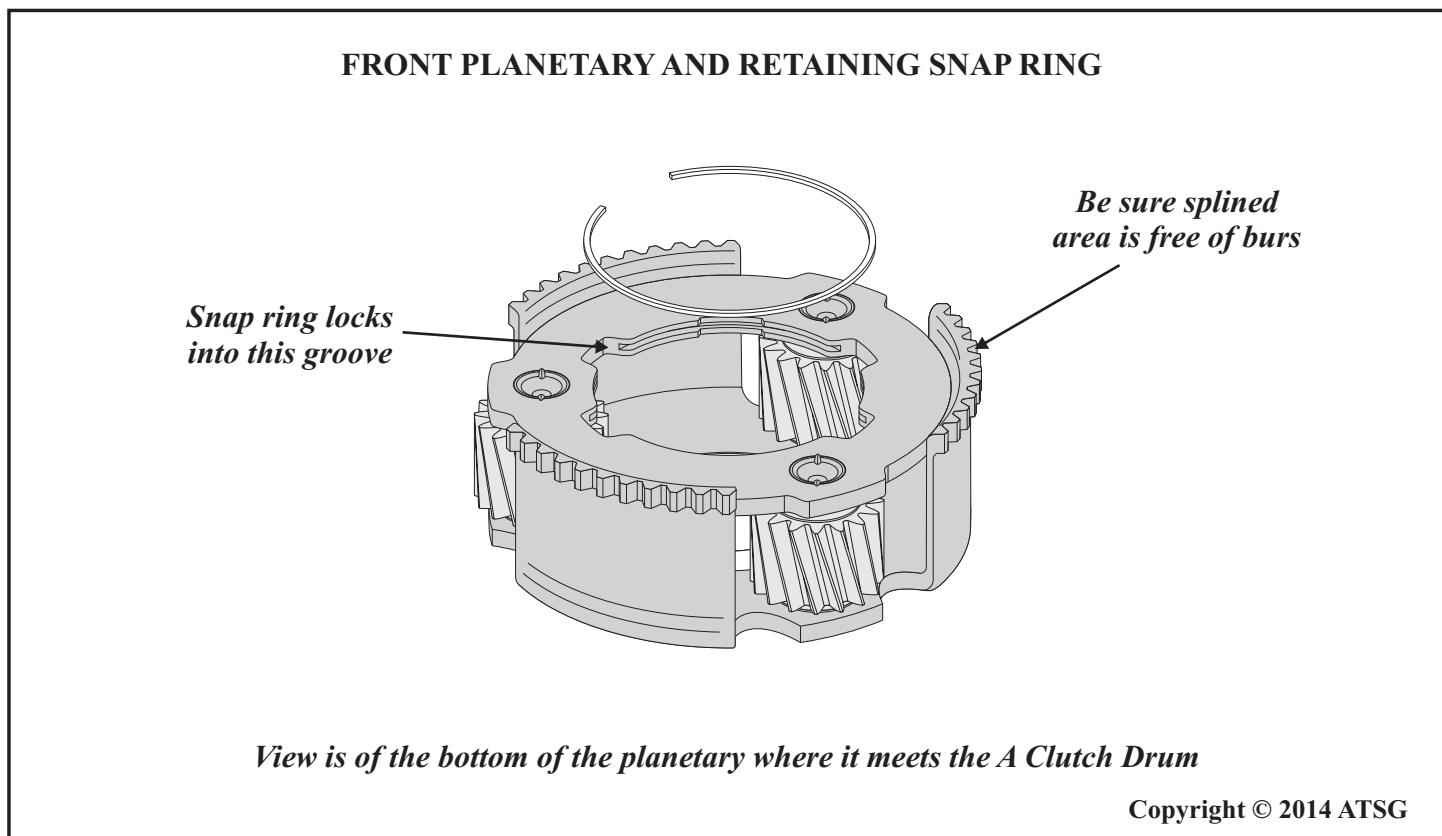
Figure 1

- CAUSE:** The cause may be that during the rebuild process, the snap ring retaining the Planetary into the A Clutch drum was not removed correctly and the splined area on the bottom of the planetary carrier was damaged where it sits against the splined area in the A clutch drum. This causes a problem with the planetary being slightly offset which creates the gear noise. This typically happens when the technician slams the A Clutch drum against the floor repeatedly, to remove the planetary. The reason this noise can also be heard in Drive at a stop is because 2005 and up models are capable of “De-Coupling” which means that the A Clutch is only partially applied at a stop, when the computer strategy requirements are met, the turbine shaft will begin to rotate. See the partial oil circuit diagram in Figure 2.
