Technical Service Information

NISSAN MAXIMA RE0F09B

LOW VEHICLE POWER

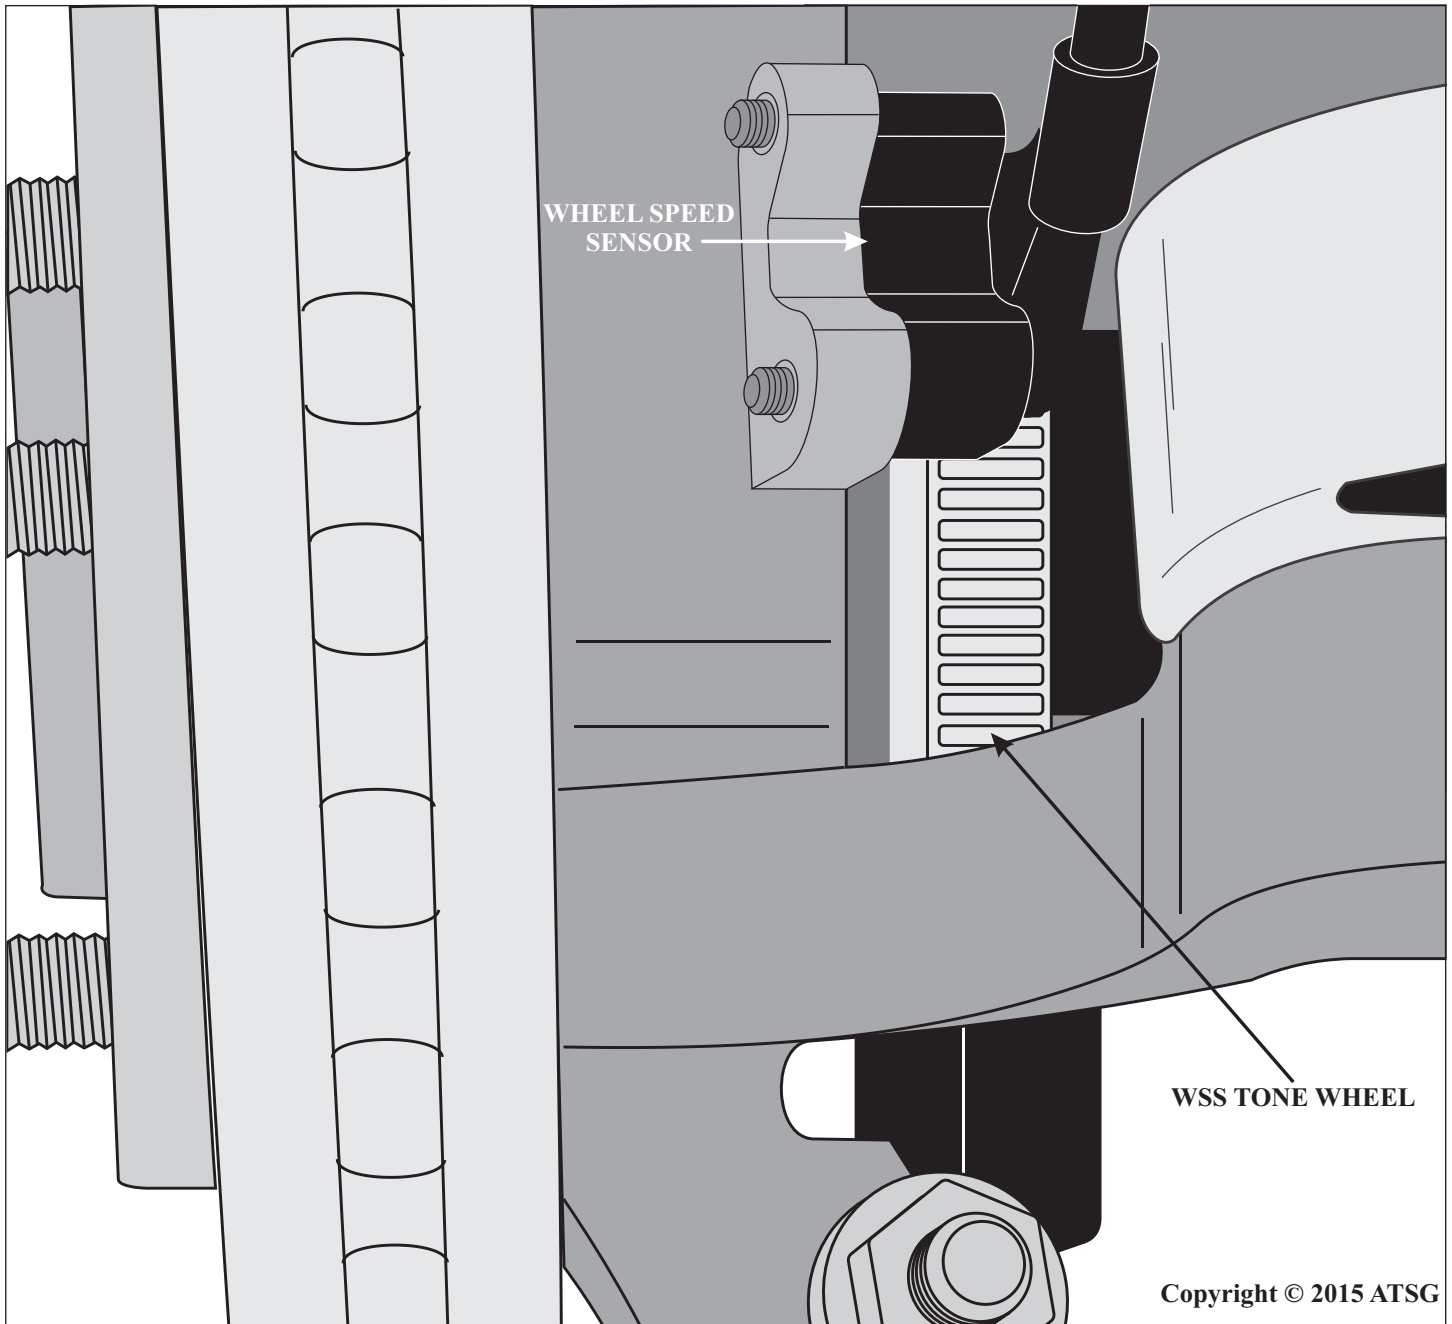
Figure 1

CAUSE: The traction control system is very sensitive to wheel speed input. The cause of this problem can be a faulty Wheel Speed Sensor or a rusted or corrosion coated tone wheel that the WSS gets its signal from, Refer to Figure 1.
A weak or erratic wheel speed sensor signal can cause poor performance or lack of power at low to mid-range speeds.

CORRECTION: A good test for this complaint would be to disconnect the ABS Module and now see if the vehicle accelerates normally. Use a scan tool to view all wheel speed sensor rpm, when driving in a straight line, all should read the same. Each wheel speed sensor signal can also be viewed on a scope. Replace the Wheel Speed Sensor if faulty or replace the axle that has a damaged tone wheel.
