TOYOTA U660E

SHUDDER IN REVERSE BIND UP IN FIRST

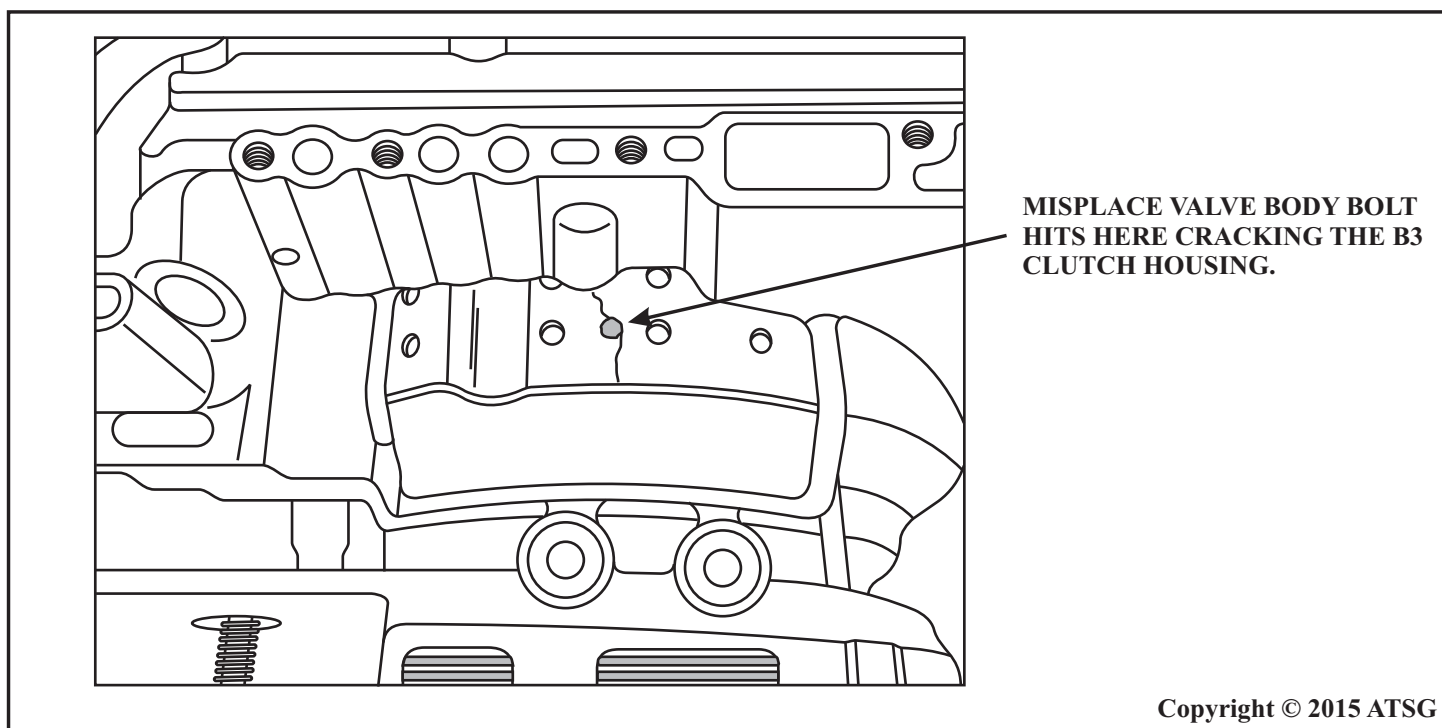
Figure 1

CAUSE: A mis placement of a valve body bolt causes the tip of the bolt to extend further than originally designed. When the valve body is bolted to the case, the tip of the bolt presses into the B3 clutch housing causing it to crack. When reverse is selected, the B3 clutch can not fully apply correctly causing a shudder in reverse. When D is selected, the B3 clutch does not fully release causing a slight bind up moving forward in first gear.

CORRECTION: Correct the placements of the valve body bolts and replace the B3 clutch housing.

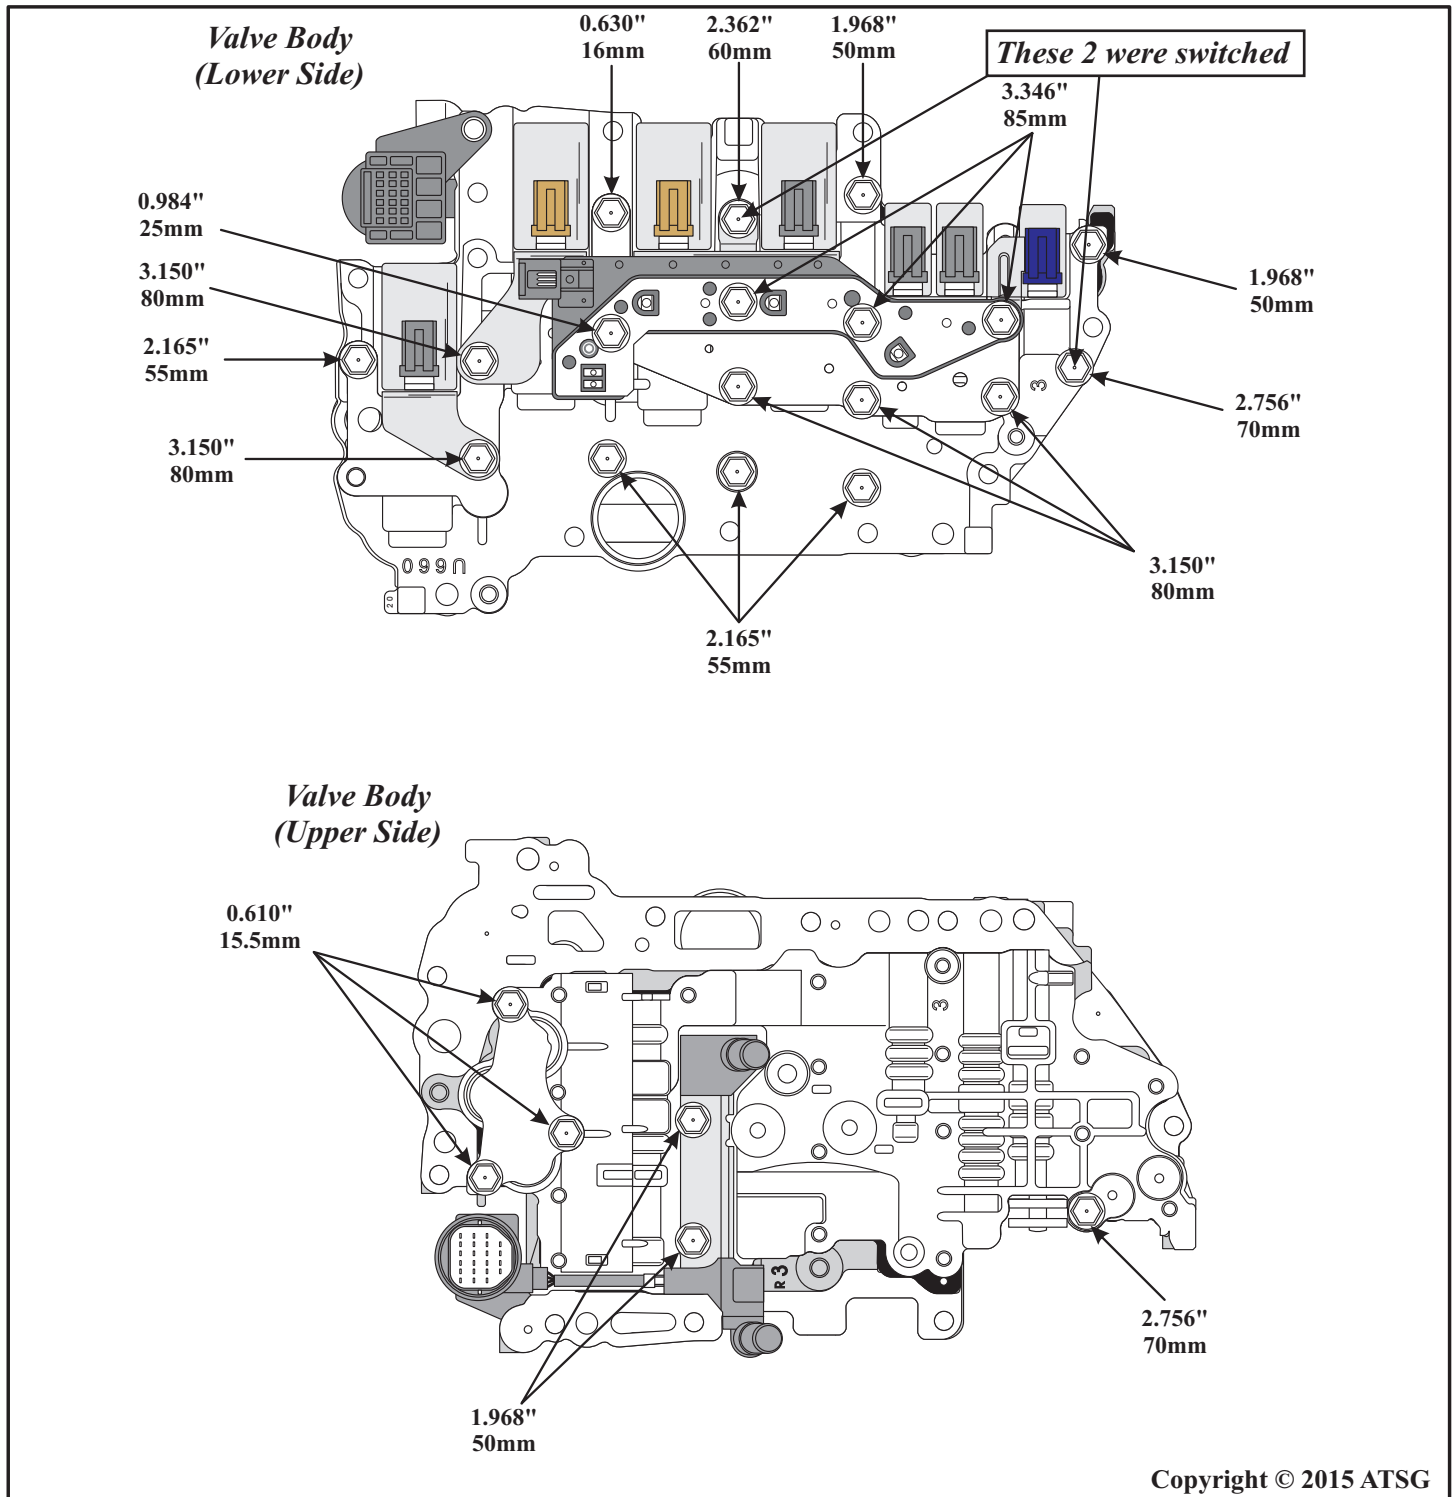
Figure 2

VALVE BODY BOLT IDENTIFICATION AND LOCATION
