Technical Service Information

GM 4L60E SERIES INTERMITTENT HARSH SHIFTS

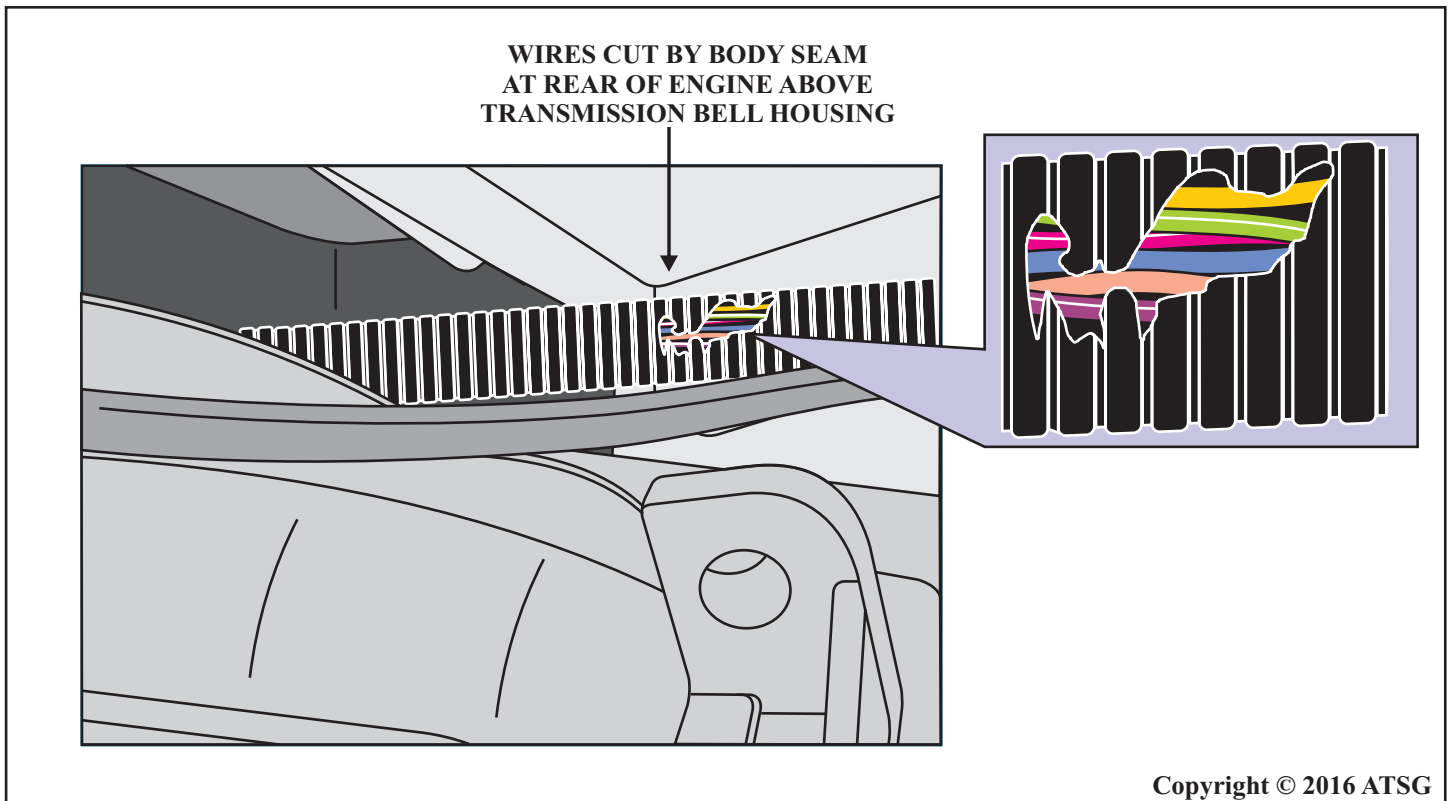
Figure 1

CAUSE: The wiring harness that is routed from the transmission case connector over the top of the transmission towards the rear of the engine on the drivers side has been damaged by contact with a body seam, Refer to Figure 1.
The body seam edge has cut through the harness conduit as well as the pressure control and TCC Solenoid wires resulting in the above complaints.

CORRECTION: Repair the affected wiring and reroute the harness out of harms way.
