Technical Service Information

TOYOTA PRIUS - GEN-1

MISLEADING DTCs

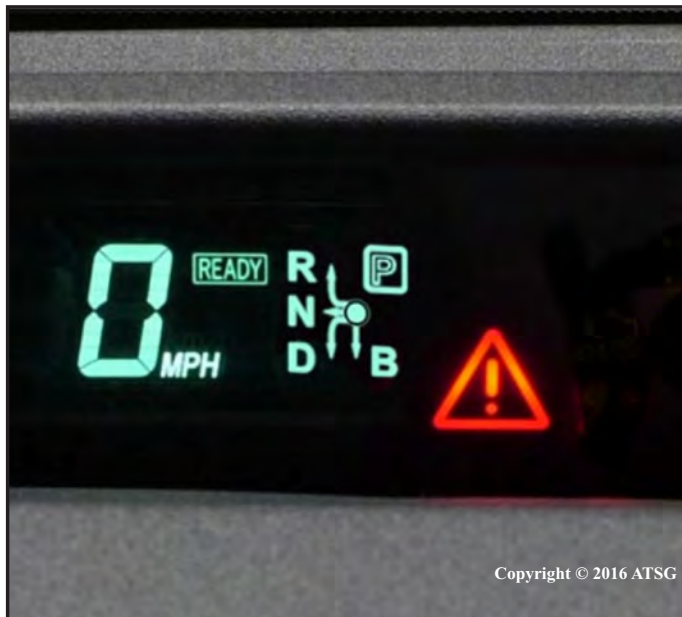
Figure 1

COMPLAINT: A 2001 to 2003 Toyota Prius may have complaints of the Master Warning Lamp illuminated (Figure 1), with the following DTCs stored:
P1636 - HV ECU Malfunction.
P3002 - HV Serial Communication Abnormality.
P3120 - Transaxle Assembly Malfunction with Information Code 253 - Generator Resolver
Inter-Phase short, Refer to Figures 2 and 3.
C1213 - HV System Communication Circuit Malfunction.

The Master Warning Lamp is illuminated yet the “Ready” Lamp is on.

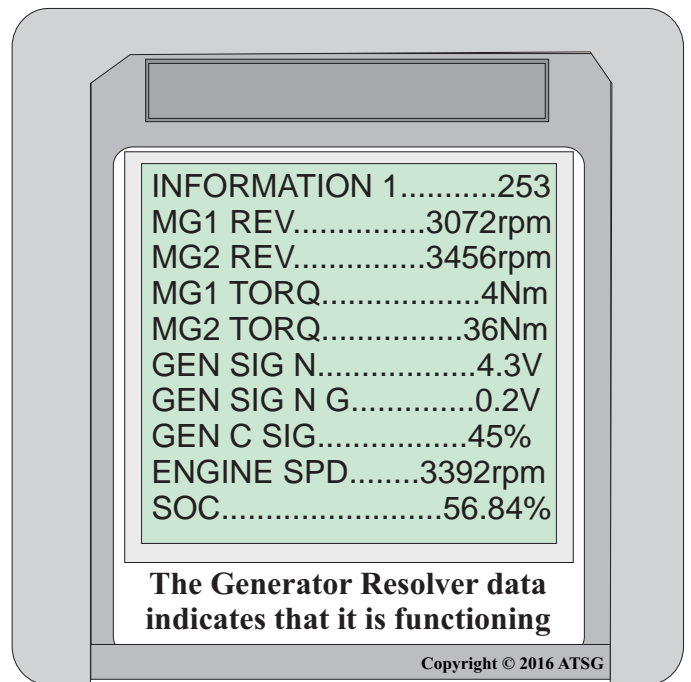
Figure 4

P3120 - Inspect and repair HV ECU to Resolver wiring harness or replace transaxle generator yet the data indicates the Generator Resolver is functional, Refer to Figure 4.

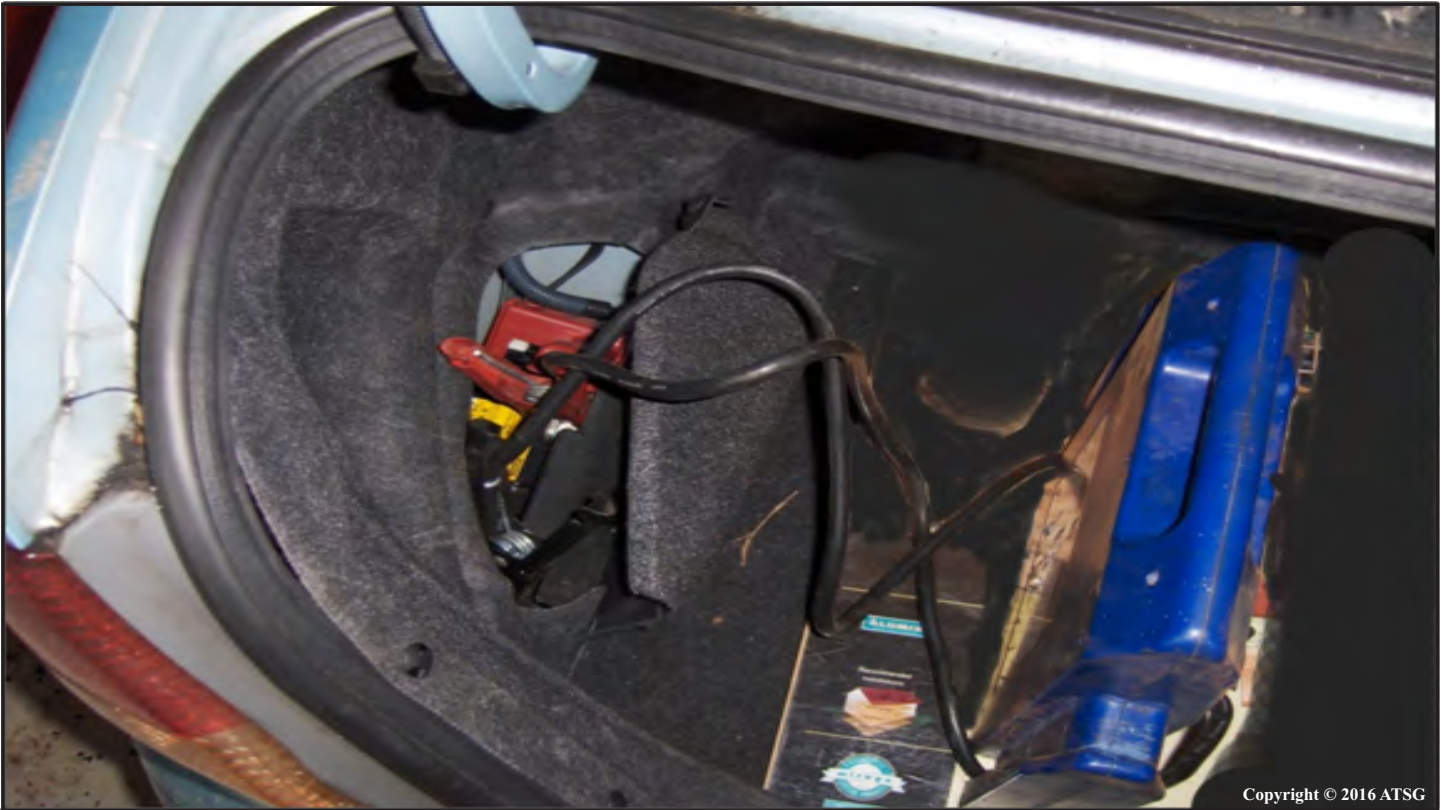
Figure 5

CAUSE: The vehicles 12 Volt Battery is discharged.

A battery booster connected to the 12 volt battery extinguished the Master Warning Lamp & DTCs were cleared. A new 12 volt battery restored the vehicle to proper working condition.

CORRECTION: Replace the 12 Volt Battery (See Figure 5).
