## FORD CFT30 CVT INTERMITTENT HARSH SHIFTS

## Technical Service Information

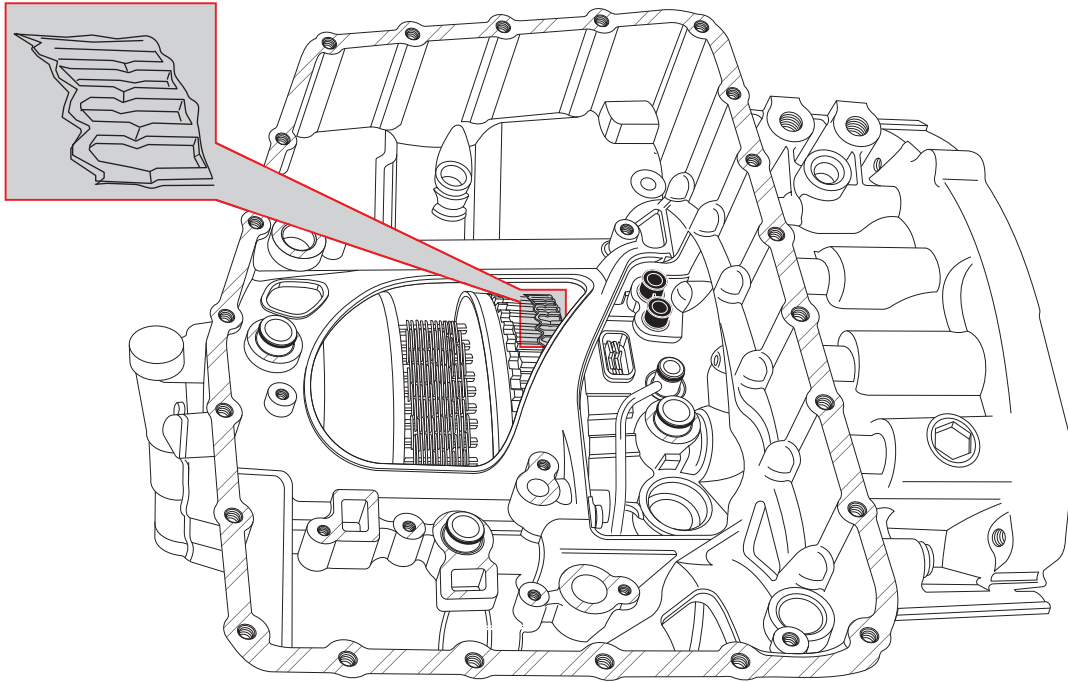
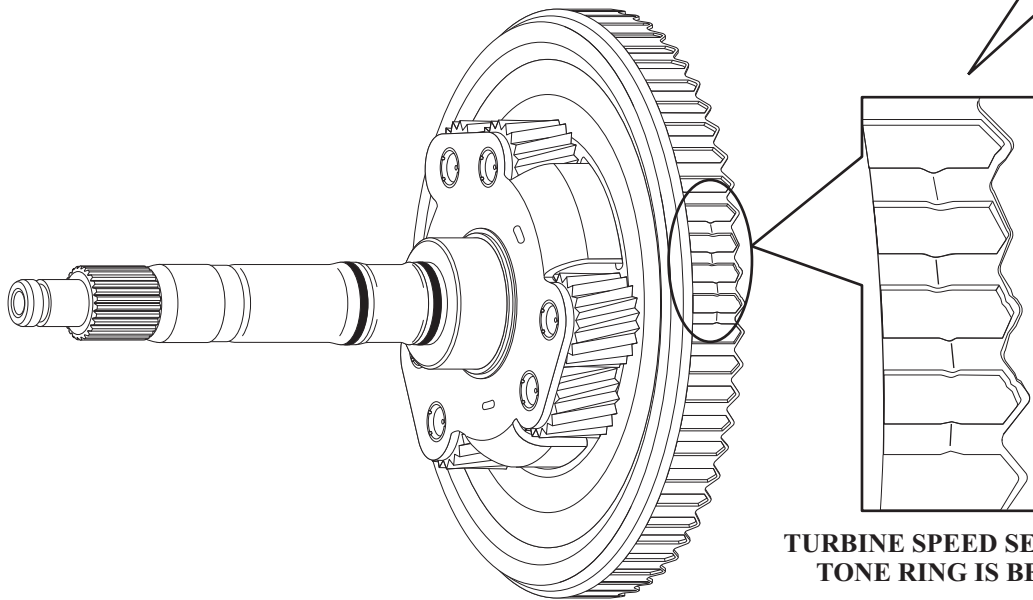
Figure 1

**CAUSE:** A reverse planetary with a bent turbine speed sensor tone ring was installed, Refer to Figure 1. This created a pulley speed ratio error yet no gear ratio codes were ever set.

**TURBINE SPEED SENSOR  
READS REVERSE PLANET  
TONE RING**

**TURBINE SPEED SENSOR  
TONE RING IS BENT**

**CORRECTION:** Replace reverse planetary.

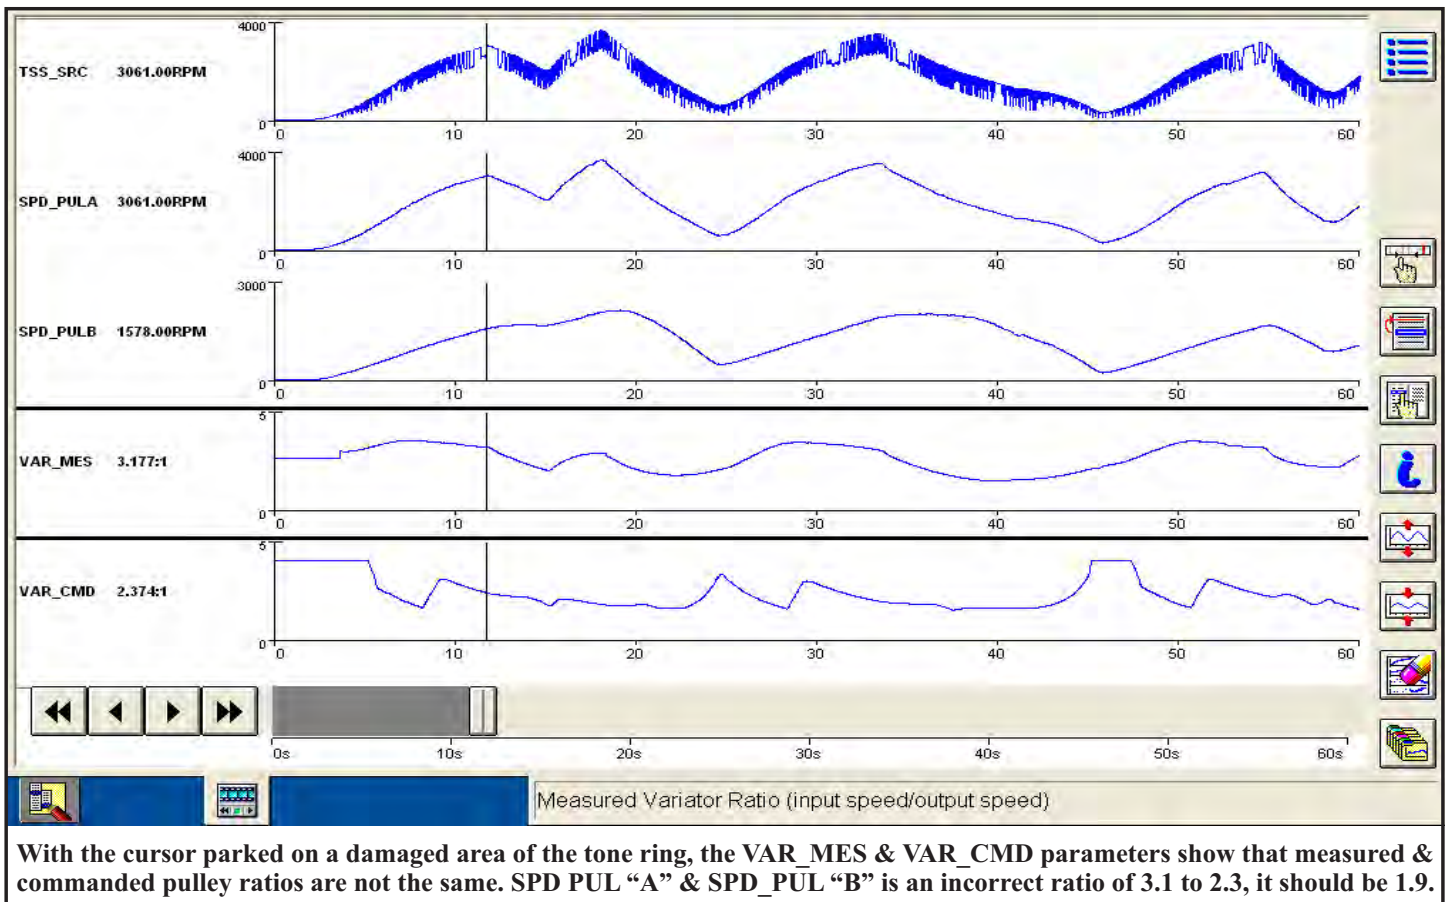
Comparing the two waveforms in Figure 2 and 3, notice where the cursors are parked, in Figure 2 the cursor is parked on a damaged area of the turbine speed sensor tone ring. The waveform also shows that the measured and commanded pulley speed are not the same using the VAR\_CMD and VAR\_MES parameters. These parameters represent commanded ratio and measured ratio which are incorrect. The correct ratio should be 1.9 but is indicating a 3.1 to 2.3 ratio.

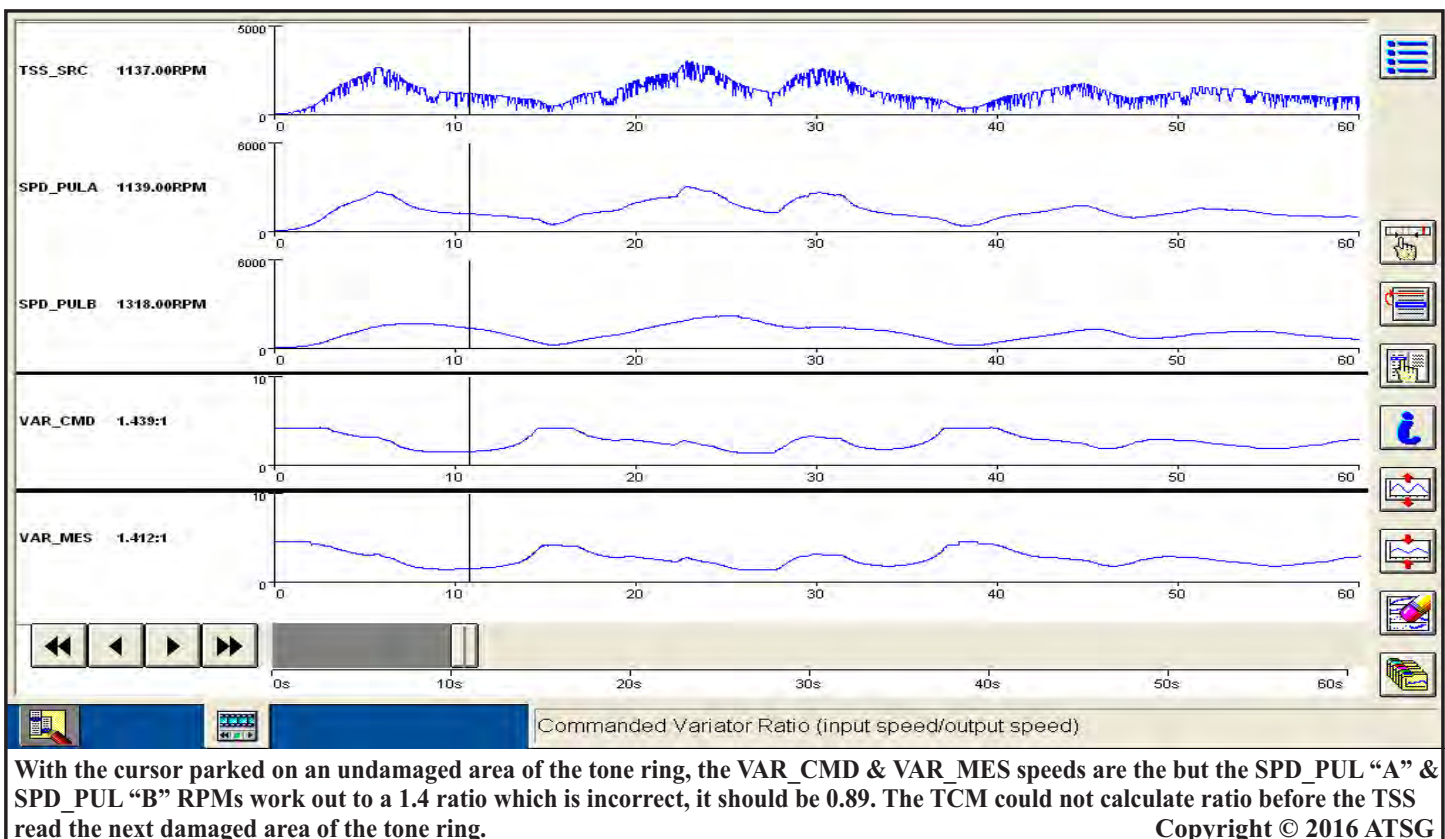
In Figure 3 the cursor is parked over an undamaged area of the turbine speed sensor tone ring. The VAR\_CMD and the VAR\_MES parameters indicated approximately the same gear ratio but using the formula of Speed Pulley "A" divided by Speed Pulley "B", the gear ratio should read 0.86 but is indicating a 1.4 ratio. This means that even though the cursor is on an undamaged area of the tone ring, the TCM has not been able to calculate the correct gear ratio before the turbine speed sensor reads the damaged area of the turbine speed sensor tone ring again.
