## 48RE

### NO TCC AND TRANS TEMP OVERHEAT

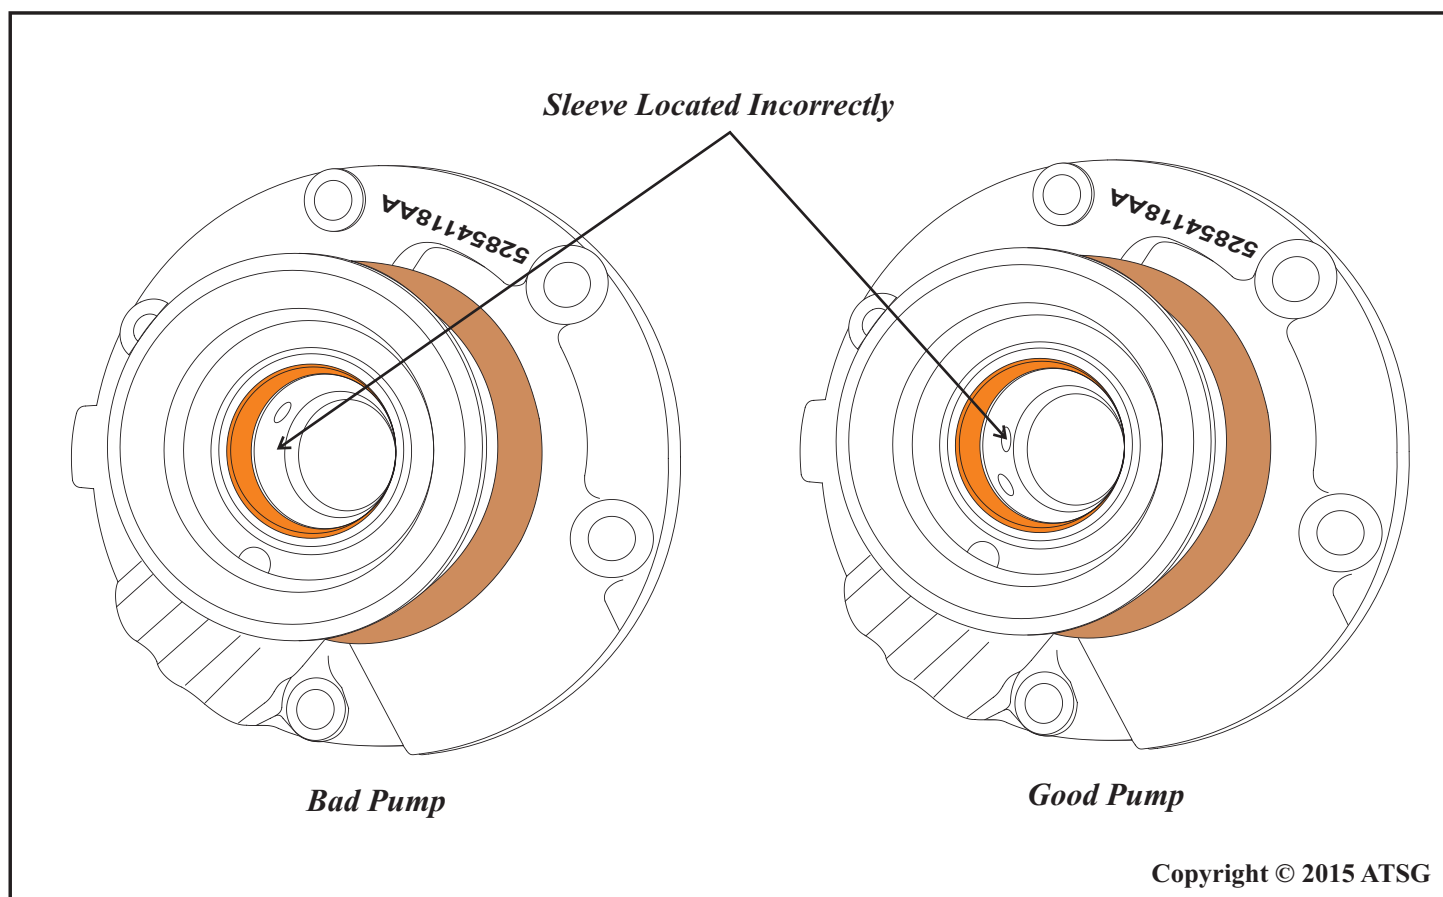
Figure 1

**COMPLAINT:** During a road test after a rebuild, it is noticed that there was no converter clutch apply. A scan tool revealed that the computer was commanding the converter clutch to apply. It was also noticed that transmission fluid temperature was up to 270 F. The vehicle was put on a hoist where cooler flow was carefully checked in Drive and there was none.

**CAUSE:** A reconditioned pump was used that had its inner sleeve out of position (Figure 1) compromising the converter clutch and cooler circuits (Figure 2).

**CORRECTION:** Replace the pump assembly.
