# Technical Service Information

## GM 6L80/6L90

### WRONG GEAR START & DELAY IN REVERSE

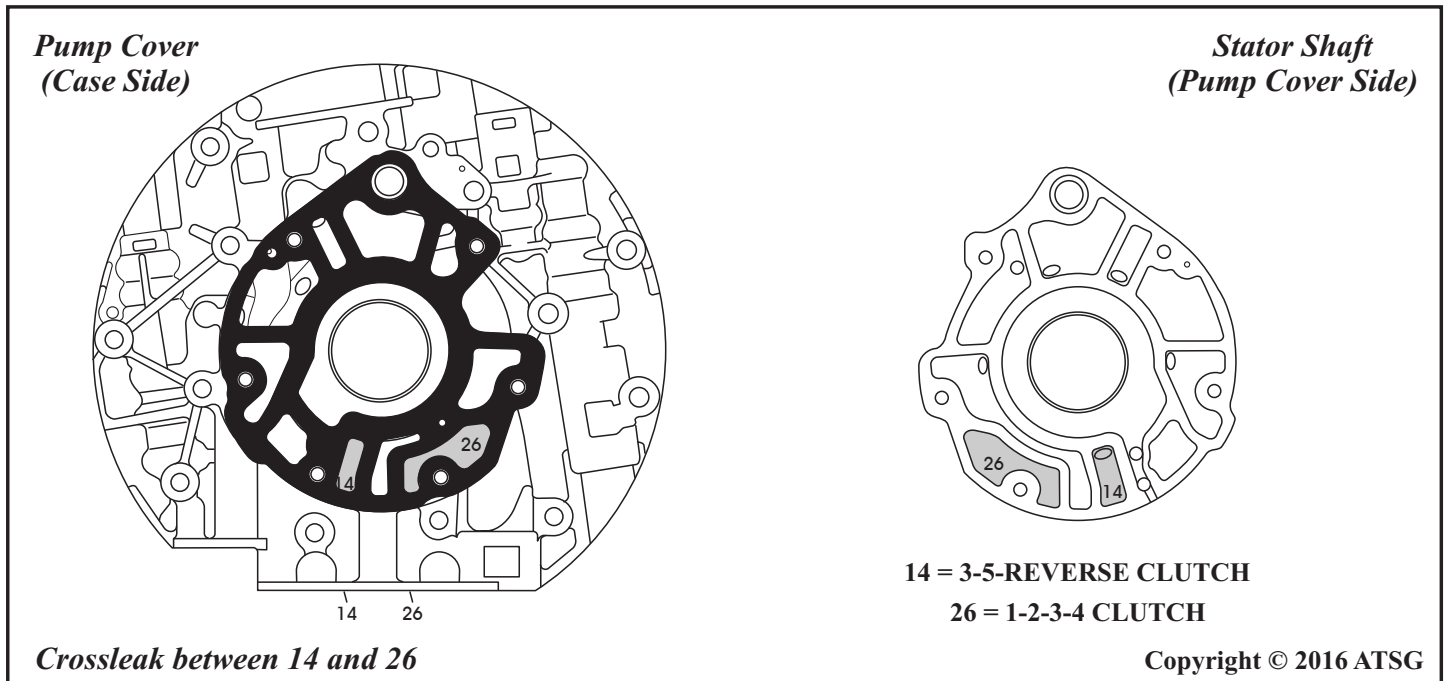
Figure 1

**CAUSE:** A severe cross leak has developed between the stator support shaft and the pump cover at hydraulic circuits 14 for the 3-5-Reverse Clutch and 26 for the 1-2-3-4 Clutch (See Figure 1). When air checking the 3-5-Reverse Clutch feed hole in the pump cover, a large volume of air would exit the 1-2-3-4 Clutch feed hole in the pump cover, See Figure 2.

**CORRECTION:** It is difficult to flat sand the pump cover due to high casting areas surrounding the mating surface. The stator support shaft would have to have the alignment pin removed. Although the stator support shaft and pump cover come with a gasket, the cross leak may still develop. If the problem is not rectified with a new gasket which comes in most rebuild kits, a thin layer of anaerobic sealer may be required to save the pump assembly. Follow the pump to bell housing tightening sequence shown in Figure 3. **Notice** in Figure 4 that the pump assembly tightening torque specifications have been revised from 97 in. lbs. to 110 in. lbs.
