Technical Service Information

4L60-E

TCC STUCK ON SENSATION

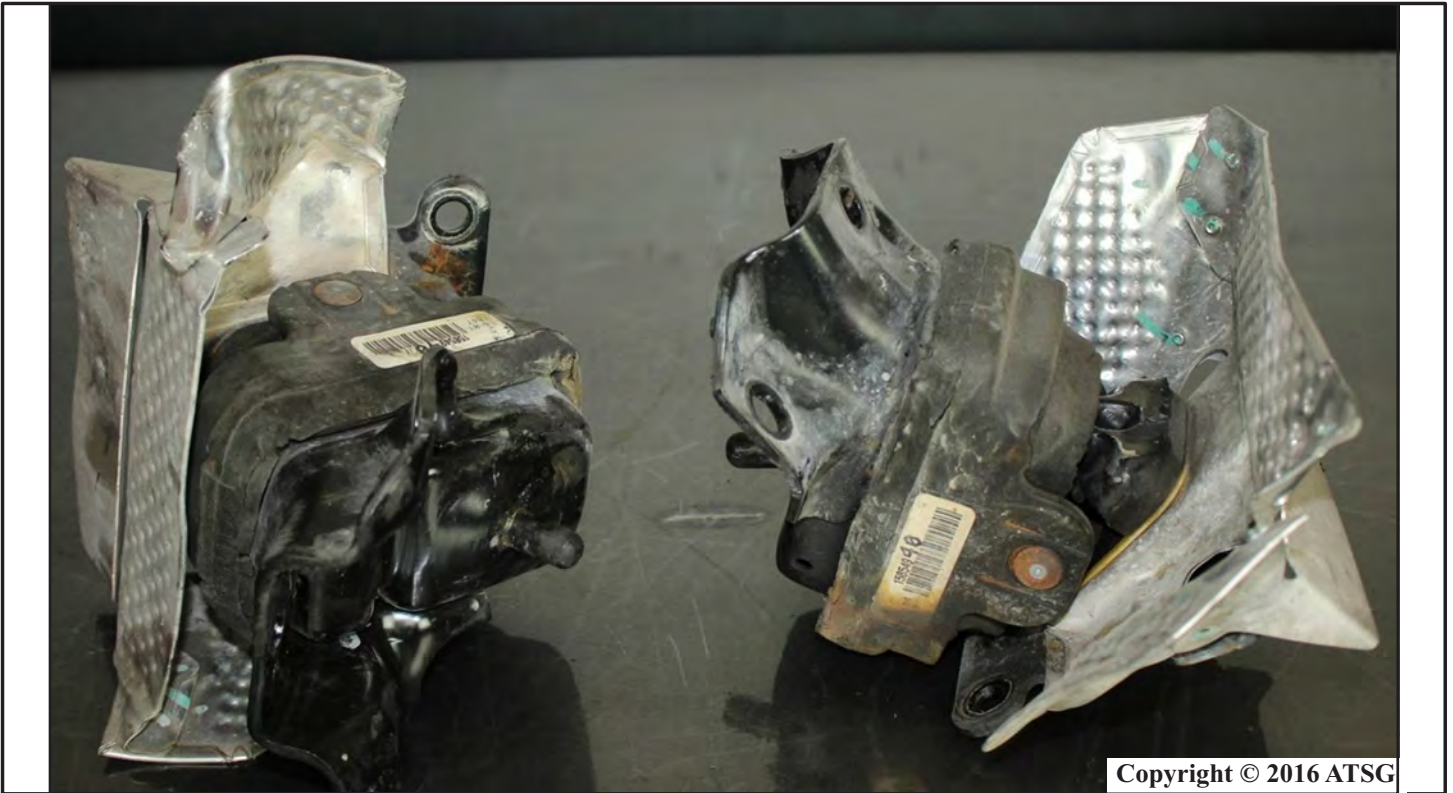
Figure 1

CAUSE: It was determined that the clunk noise which was both felt and heard was due to a completely broken left motor mount (Figures 1 and 2 - *the right one was not broken but needed to be replaced also*). The hesitation during aggressive throttle openings from a low coast as well as the sensation of the converter clutch being applied was blamed on TPS code P0123.

CORRECTION: Before the P0123 was addressed, new motor mounts were installed. Surprisingly, the sensation of the converter clutch being applied was no longer present. The hesitation during aggressive throttle openings from a low coast remained and was not resolved even after replacing the APP sensor which eliminated the P0123 code.
