Technical Service Information

FORD 5R110W

PUMP DAMAGE SOON AFTER OVERHAUL

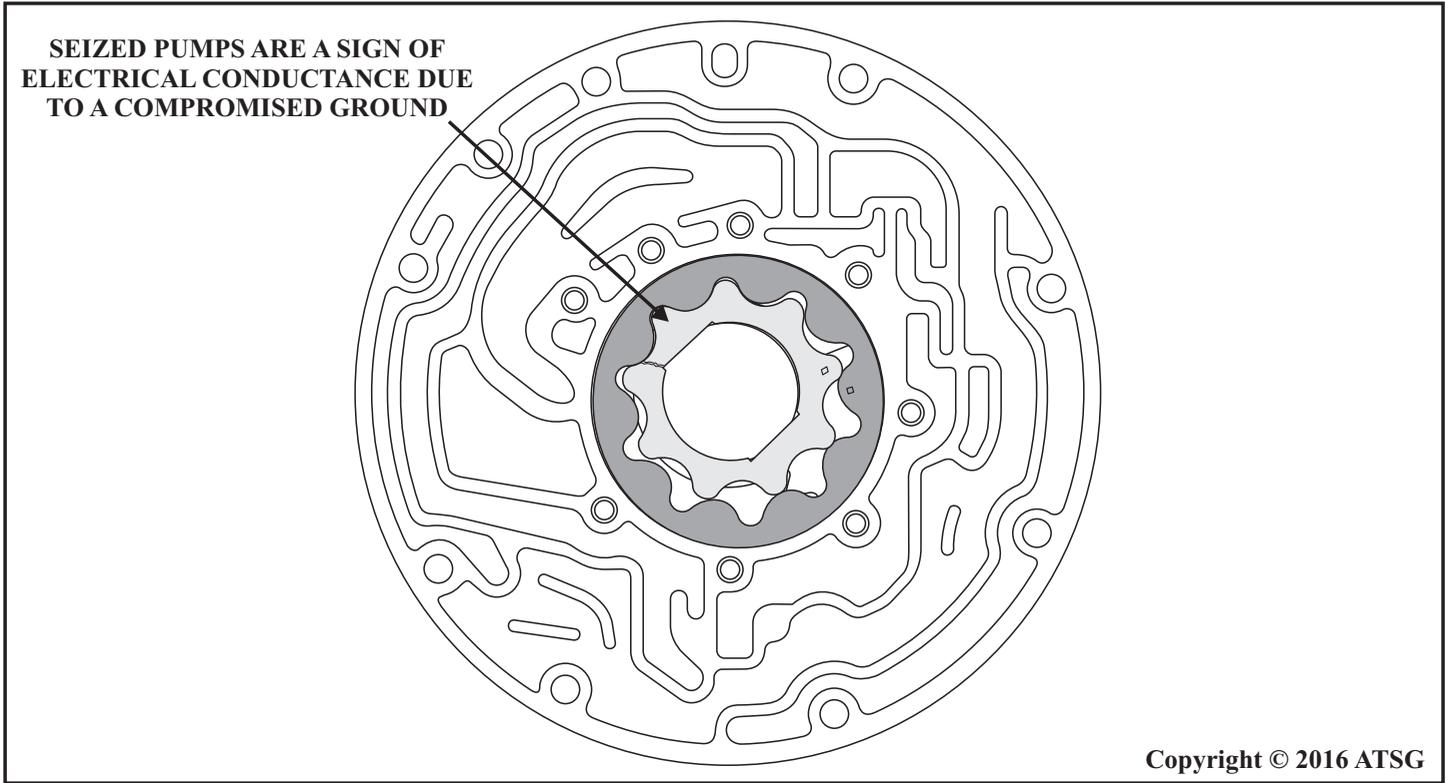
Figure 1

COMPLAINT: A Ford truck equipped with a 5R110W transmission is delivered to the owner after transmission repairs have been completed. The truck returns with a “No Move” condition usually within 100 miles of driving. Upon disassembly, the pump gear are welded to the pump plate and may even be broken, Refer to Figure 1. The torque converter neck is discolored and also damaged. Close inspection of the pump spacer plate shows electrical tracking, Refer to Figure 2.

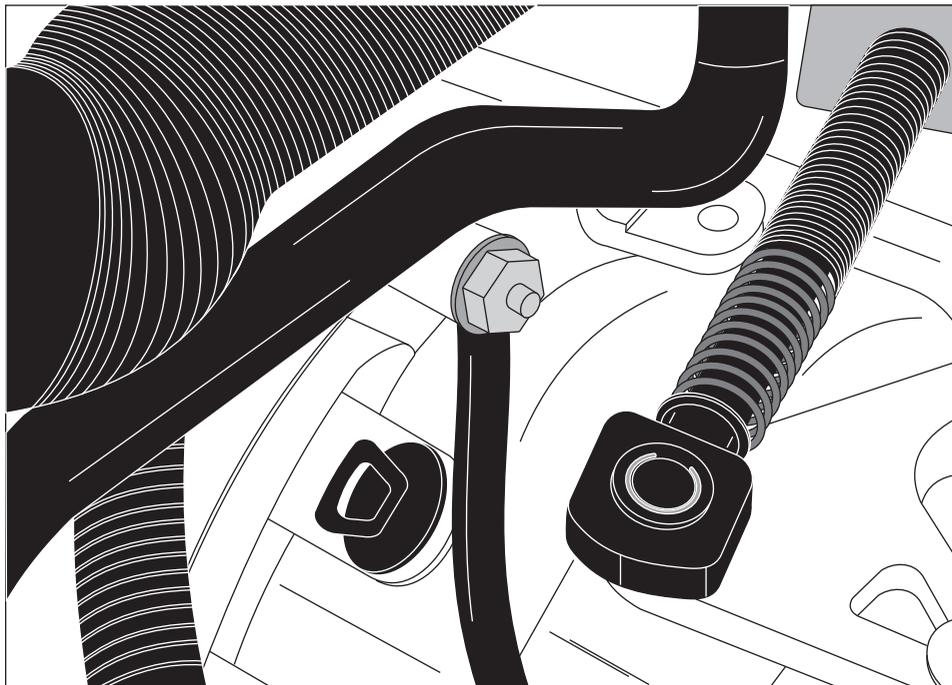
Figure 3

CAUSE: A compromised main ground from the negative side of the battery(s) or the ground is attached to an inappropriate location such as a bell housing bolt, Refer to Figure 3.

Attaching The Negative Battery Ground Cable To A Transmission Bell Housing Bolt Is Not Recommended
