# Technical Service Information

## GM 4L60/70/75E PREMATURE/REPEATED 3-4 CLUTCH FAILURE

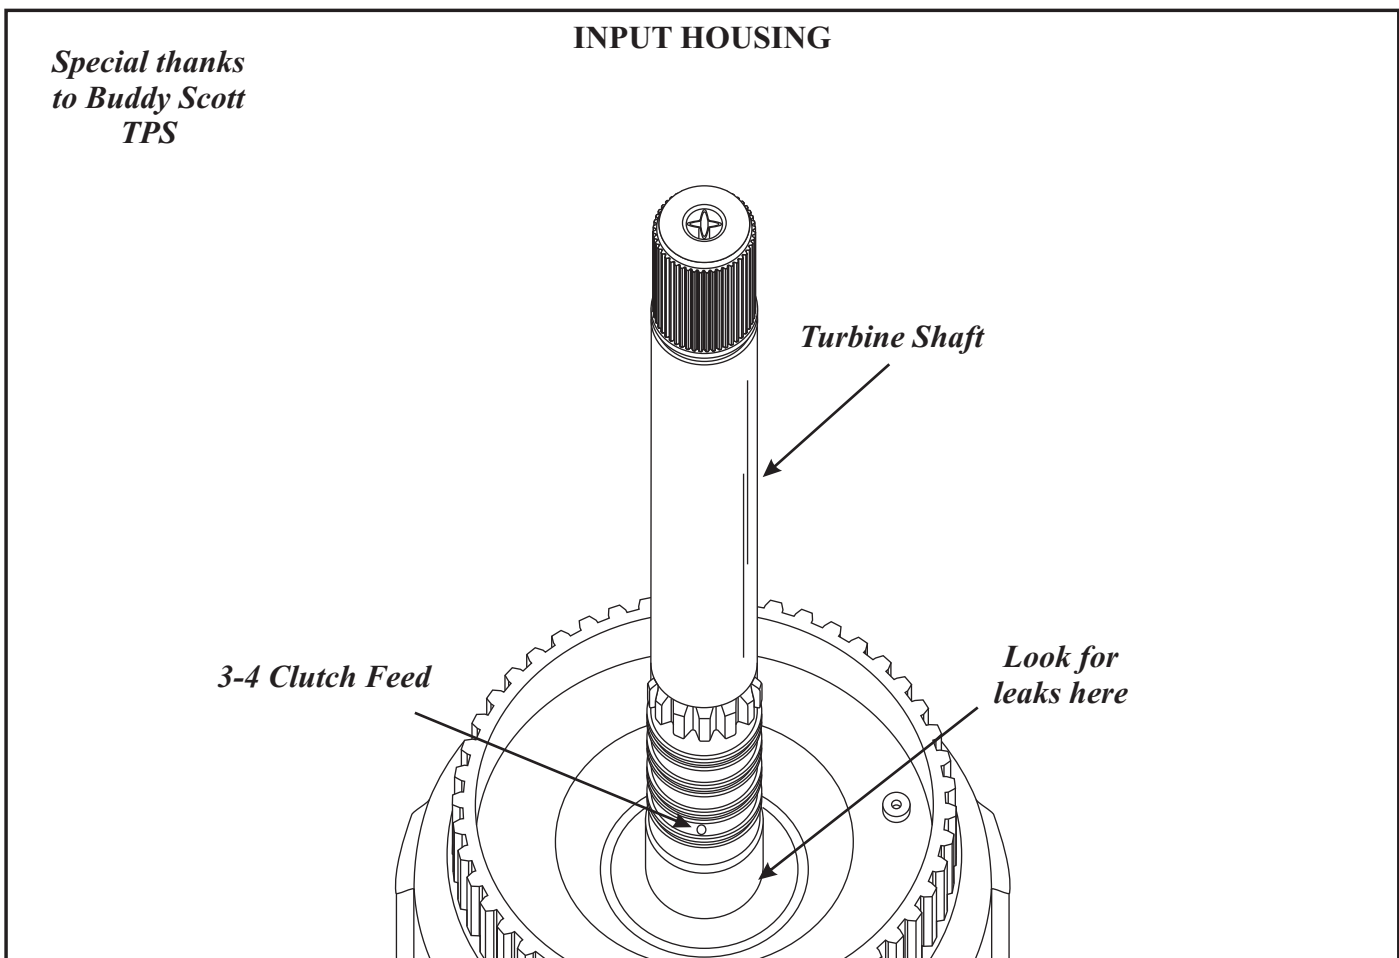
**COMPLAINT:** Vehicles equipped with the 4L60/70/75E transmission may exhibit a complaint of premature or repeated 3-4 Clutch failure.

**CAUSE:** The cause may be a leak where the turbine shaft is pressed into the input housing as shown in Figure 1. **Note:** This problem may only show up when hot, take the input drum fully assembled and place it in a plastic bag and put in the parts washer then re test.

**CORRECTION:** To correct this condition, press the turbine shaft out of the input drum , from the opposite side shown, and apply Loc-tite around the shaft and press it back in. Let the drum set for a while and re- air test to make sure the leak is fixed. If the leak can not be fixed, replace the drum.

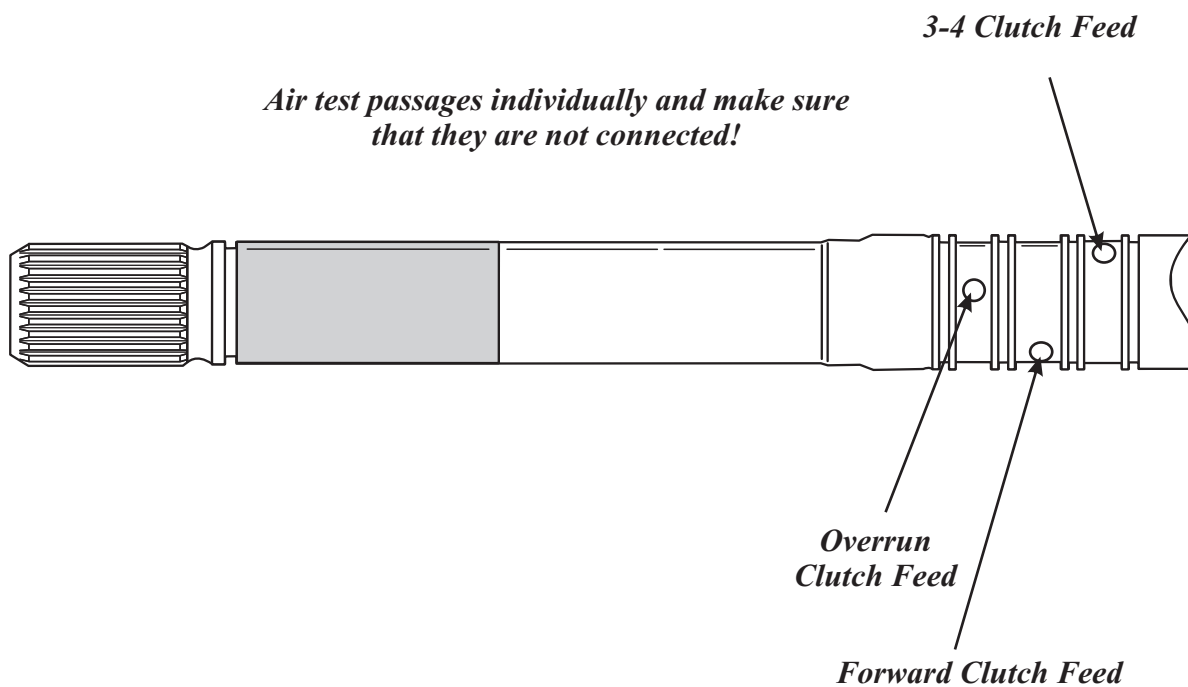
Figure 2

**Special note:** GM part number 17803687 has been known to have an issue with passages connected from incorrect drilling of the turbine shaft. Verify that the passages are not connected , as shown in Figure 2, before installing the drum back together.

*Note: GM part number 17803687 does not have the reluctor for TSS*
