# Technical Service Information

## TF81SC

### SLIPS IN REVERSE & TCC CHATTER

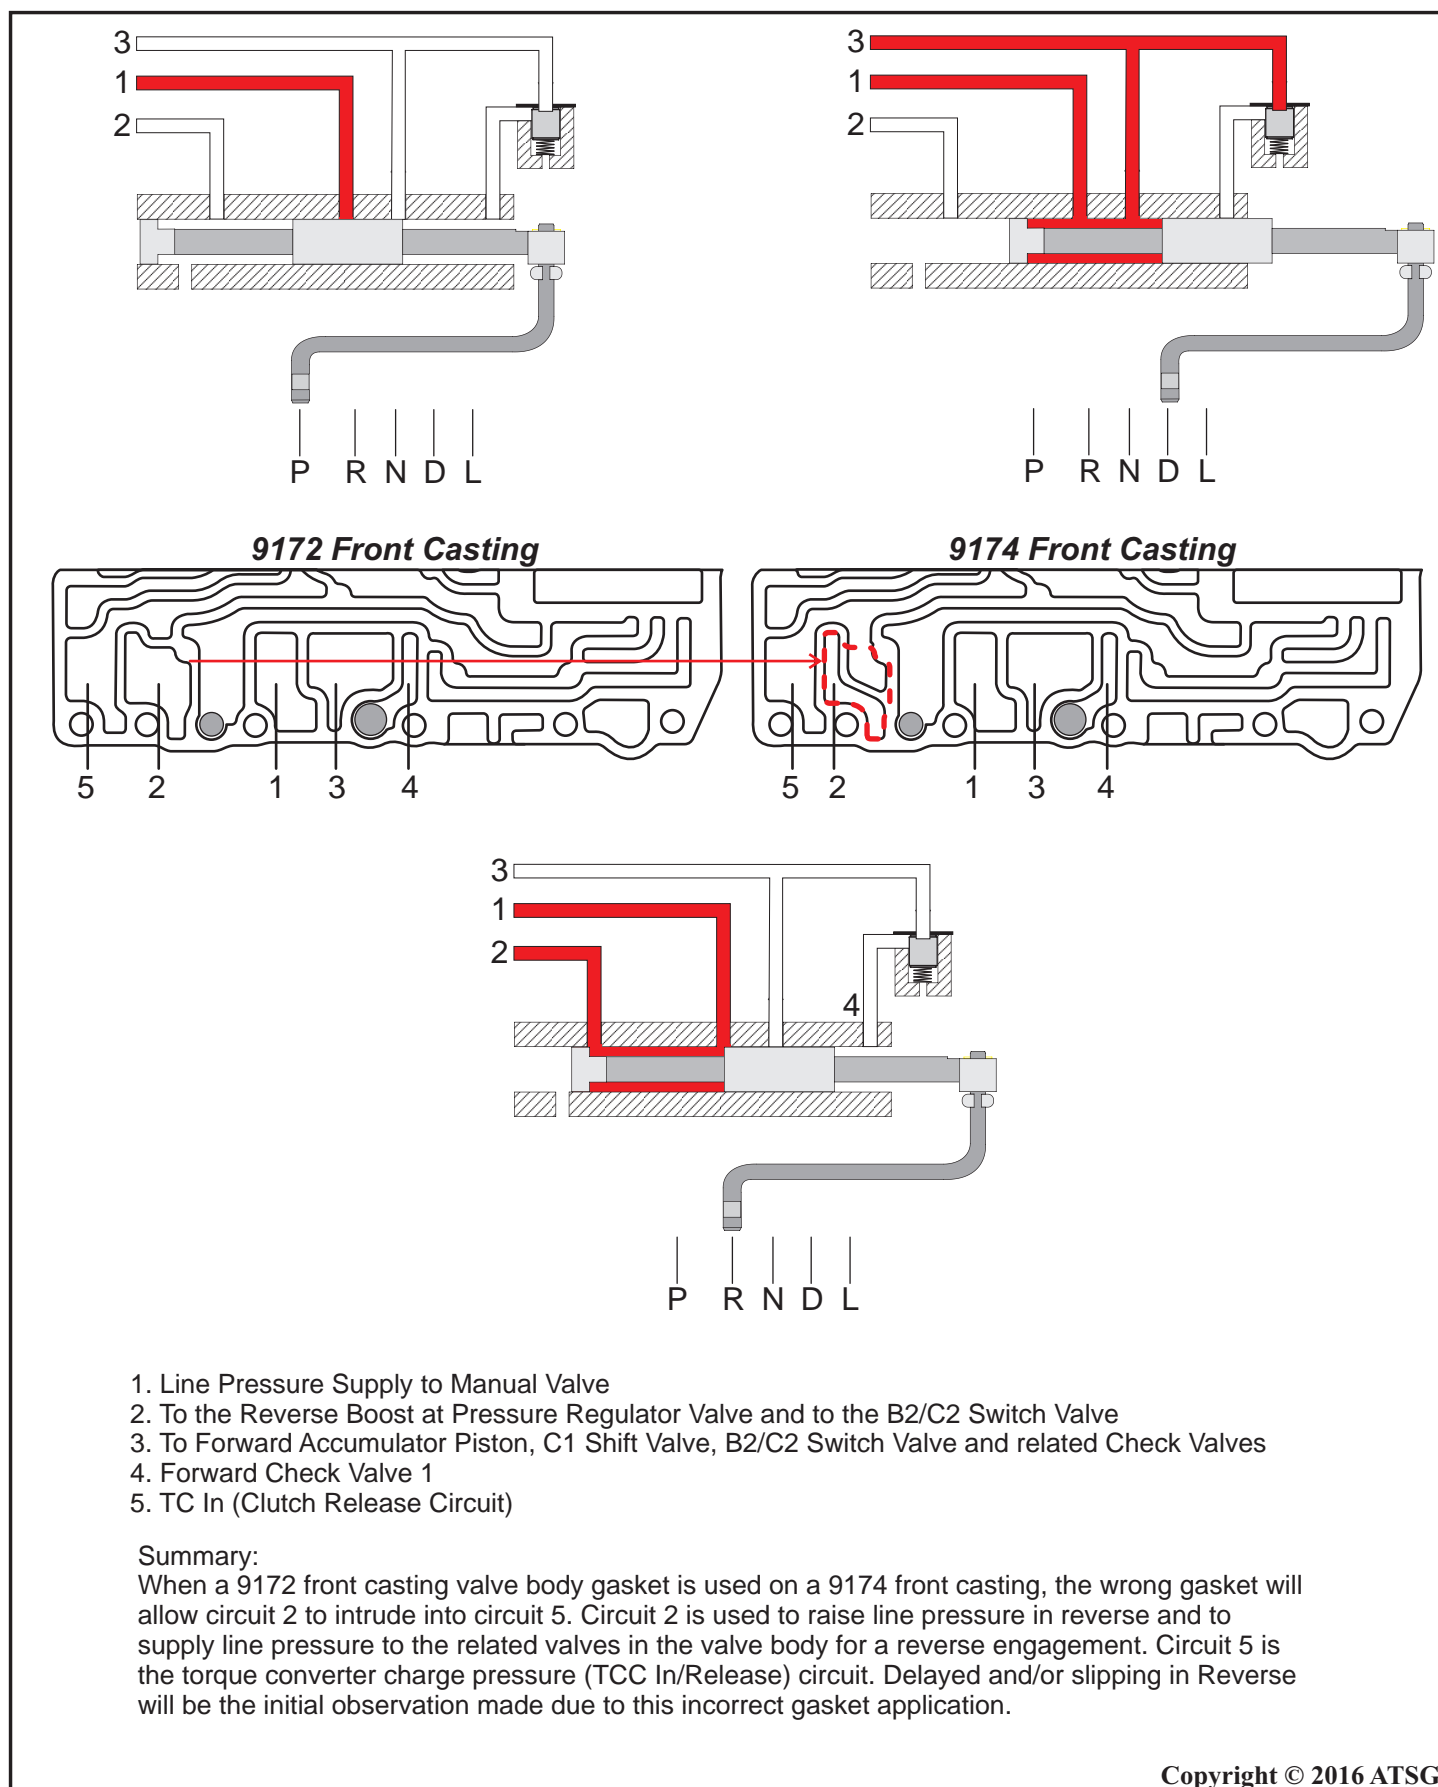
**COMPLAINT:** A vehicle equipped with the TF81SC transmission may have a complaint after overhaul of a delayed or slip in reverse. A secondary complaint may be a converter clutch chatter or engine rpm drop. Other complaints may also be harsh shifts and a bind-up sensation.

- CAUSE:**
- (1) Installing the 9172 gasket on the 9174 valve body:
    - In Reverse - Reverse chatter or slip due to loss of boost pressure.  
Stall the engine or loss of engine rpm to converter clutch apply, Refer to Figure 1.
    - In Drive - High line pressure due to crossleak into reverse boost circuit, Refer to Figure 1.  
Harsh and/or bump shifts with a bind-up sensation.
  - (2) Installing the 9174 gasket on the 9172 valve body:
    - No Functional problems, However if the original bonded gaskets are removed and replaced with after market gaskets and because a part of that gasket is not supported, a piece can break off and become lodged in the Reverse Boost Valve which could cause engagement problems, Refer to Figure 2.

**CORRECTION:** Install the correct gasket onto the correct valve body casting as seen in Figure 3 or reuse the bonded plate and gaskets if they are in good condition.
