ZF6HP TRANSMISSIONS

BUMPS AND CLUNKS

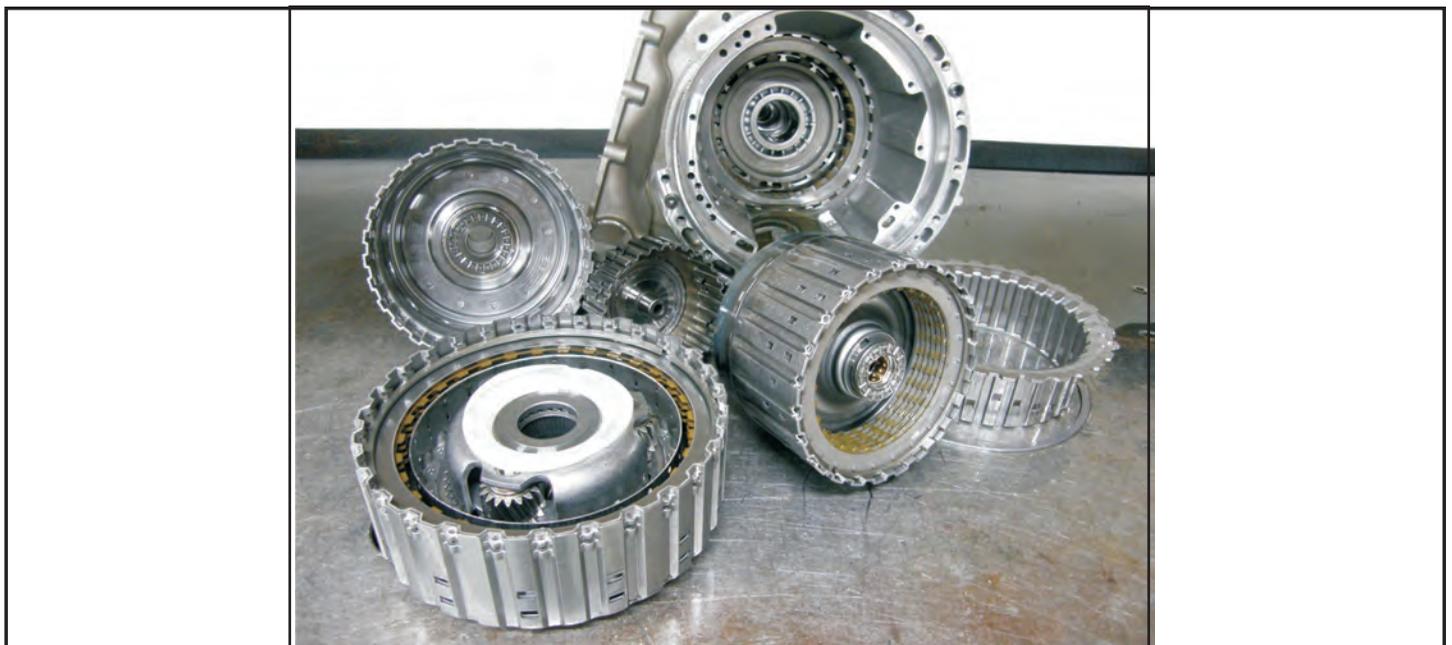
Figure 1

COMPLAINT: A ZF6HP26 transmission comes into the shop to be rebuilt. After rebuilding it, downshift clunks and bumps are noticed during the road test. Resetting the adapts doesn't resolve the problem nor does the PCM adapt from driving the vehicle for lengthy periods of time. A new or different valve body is installed with different solenoids and still the downshift bumps and clunks continue. It is then decided to bring it to the dealer for software updates and adaptation reset. Afterwards, the shifts feel a little better, especially the 2-1, but the shifts are still not clean enough to deliver the car. By this time the fluid being used becomes a consideration. With Shell M1375.4/Life Guard 6 fluid selling around 25 bucks a liter with a trans that takes 9.5 liters on a dry fill, a high end synthetic fluid at 5 dollars a quart is used. Out of desperation, the unit is pulled and all the fluid is drained. The transmission goes back in along with \$237.50 dollars worth of O.E. fluid. The bumps and clunks remain.

CAUSE: During the rebuilding process, modifications for tighter clutch clearances were performed to improve shift quality. This type of modification has been a successful for the most part but no so with the ZF6HP transmission (Figure 1). The adaptive process is based on friction surface area per friction plate which requires looser clearances for proper shift overlap to take place. When clearances are brought to the tighter end, it interferes with the computer's calculating process to make that shift. It will not be able to properly adjust for the overlap resulting in bumpy shifts.

CORRECTION: Adjust clutch clearances as follows:

Clutch A:	.062" - .080"
Clutch B:	.055" - .073"
Clutch C:	.054" - .072"
Clutch D:	.082" - .106"
Clutch E:	.072" - .093"
