Technical Service Information

FORD 6R60/80 EXTREMELY HARSH UP & DOWN SHIFTS

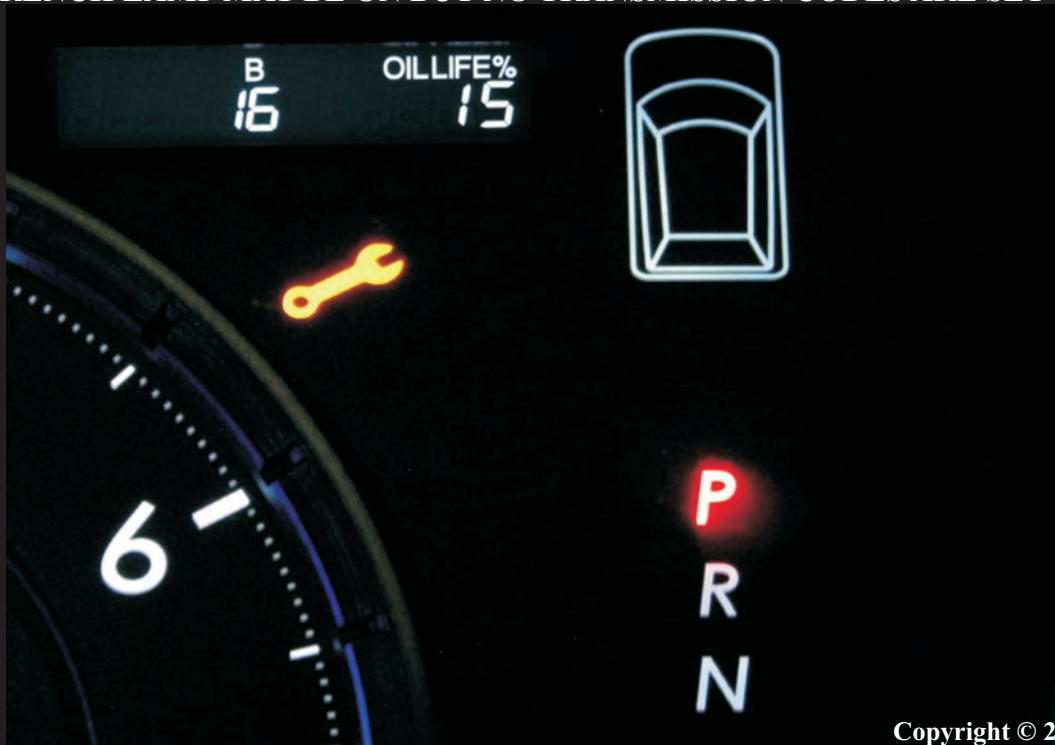
Figure 1

The “Wrench” Lamp is on but no transmission codes are set, See Figure 1.

THE WRENCH LAMP MAY BE ON BUT NO TRANSMISSION CODES ARE SET

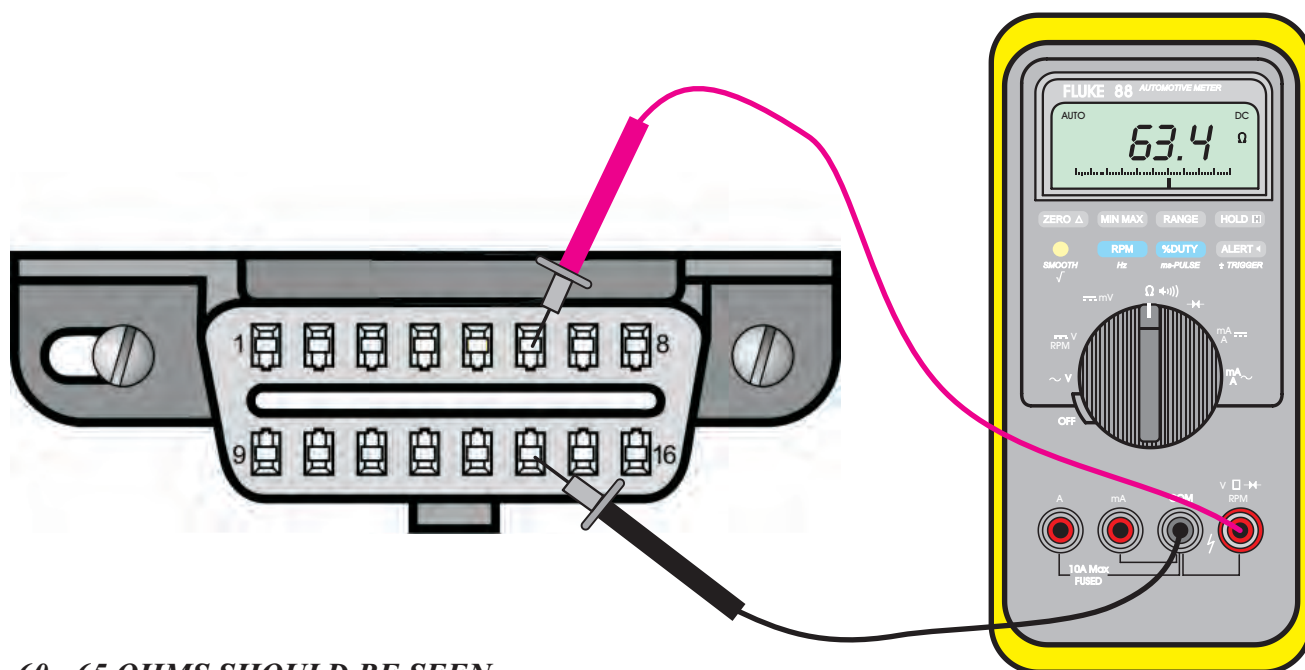
Figure 2

To begin the diagnosis, connect a multimeter set to ohms to Data Link Connector terminals 6 and 14. The resistance should be between 60 and 65 ohms, if it is, the CAN BUS wires are not shorted or open, Refer to Figure 2.

CONNECT METER TO DLC PINS 6 AND 14

60 - 65 OHMS SHOULD BE SEEN
IF CIRCUITS ARE GOOD

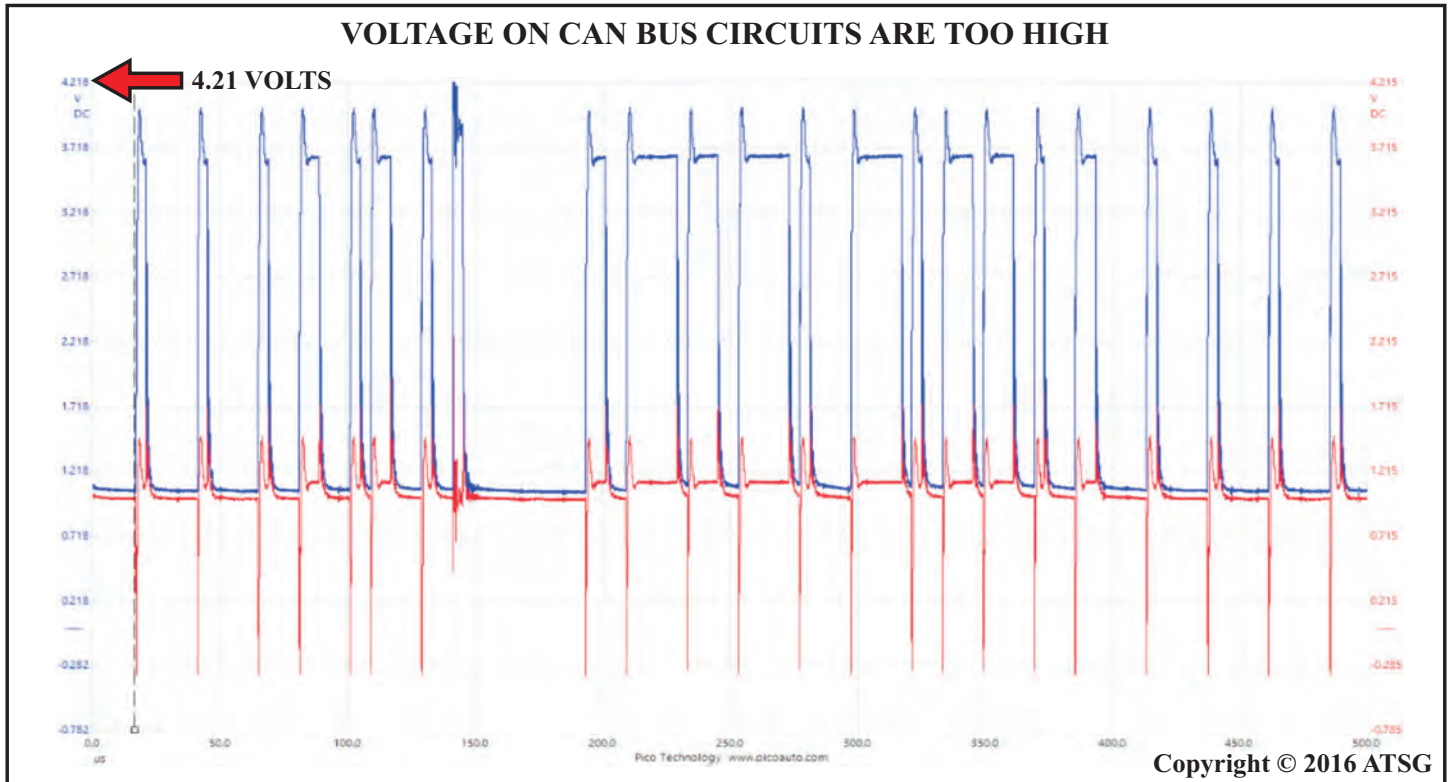
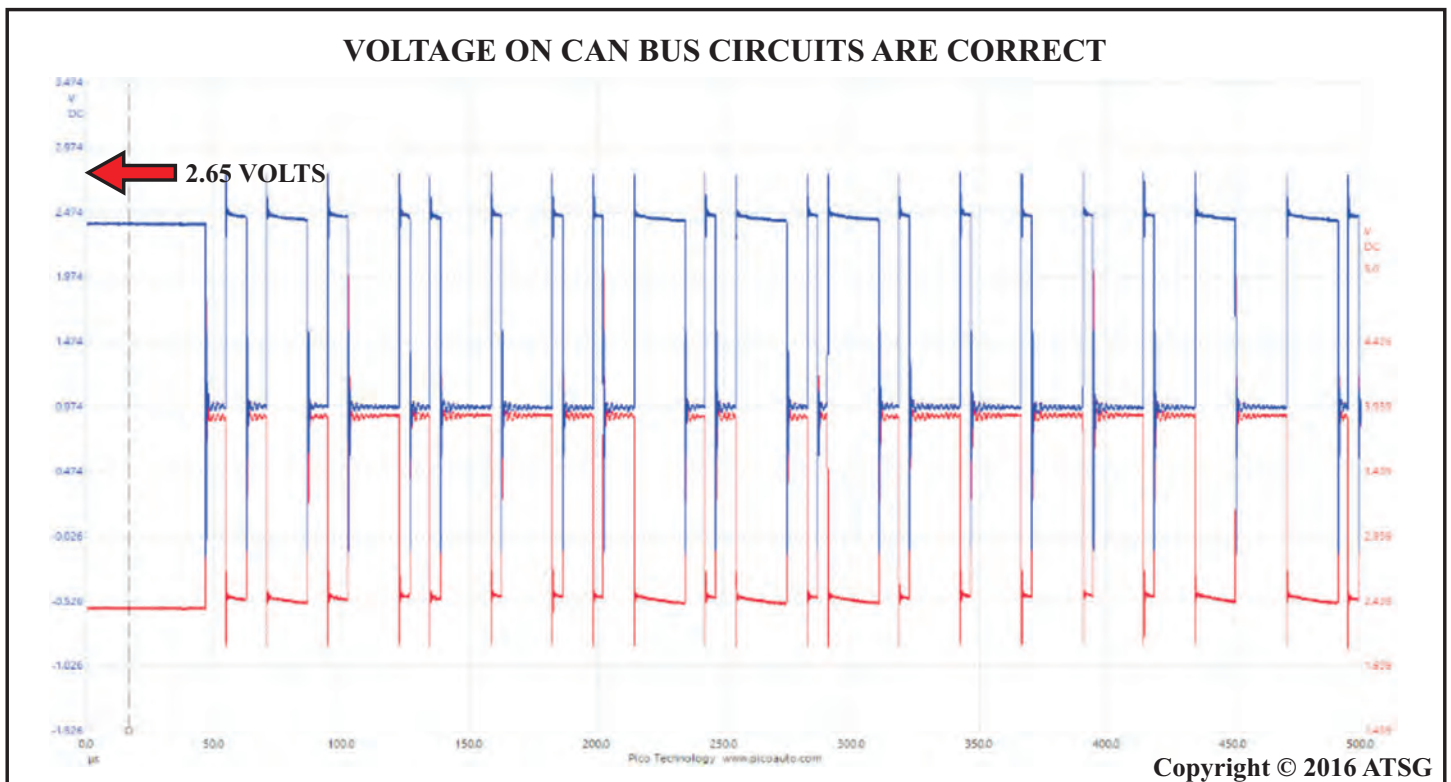
Next connect a scope to DLC terminals 6 and 14 in order to check the voltage on the CAN Hi and CAN LO circuits. CAN HI should be 2.5 to 3.5 Volts, Refer to Figures 3 and 4. CAN LO should be 1.5 to 2.5 Volts. Higher voltage than that indicates an EMI problem. Even though the CAN BUS wires are twisted they are not shielded and can therefore be affected by electrical noise.

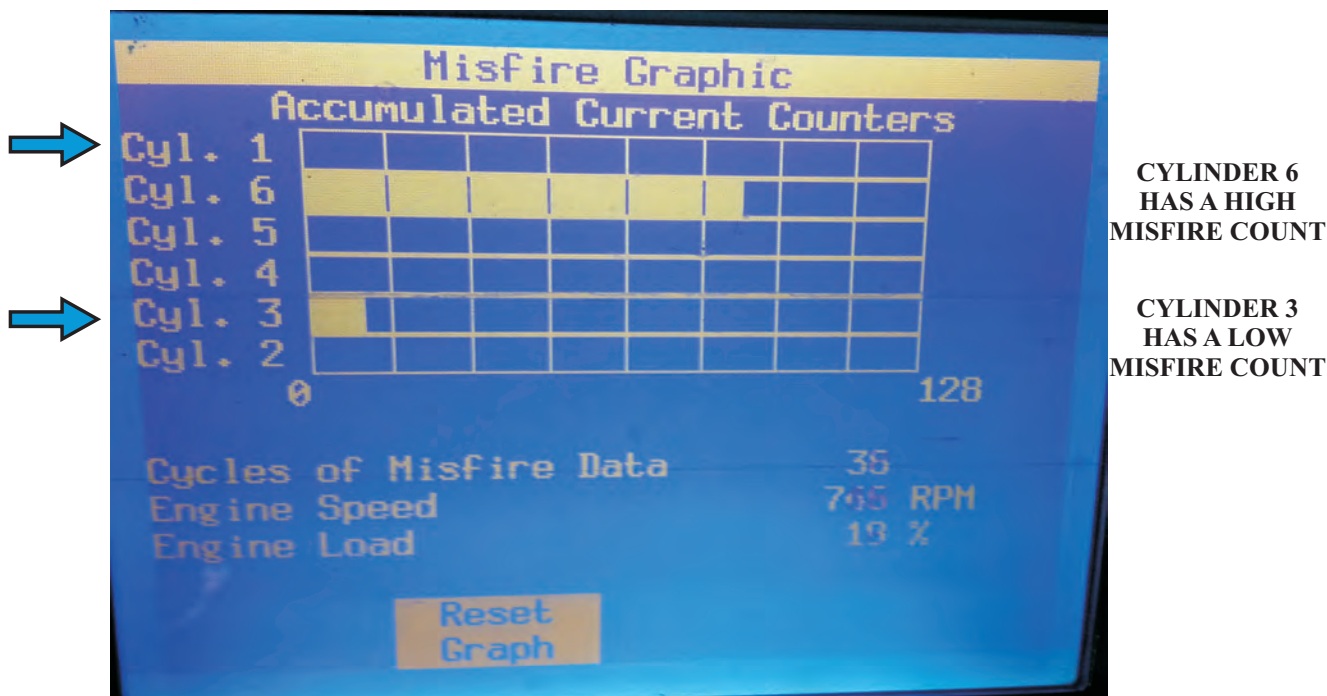
Figure 5

Next, connect a scan tool to the DLC and proceed to the “Global OBD-II” area. Navigate to the “Misfire Counter”. Check to see if misfires are present even though you do not have any misfire codes, Refer to Figure 5.

GLOBAL OBD-II MISFIRE COUNTER

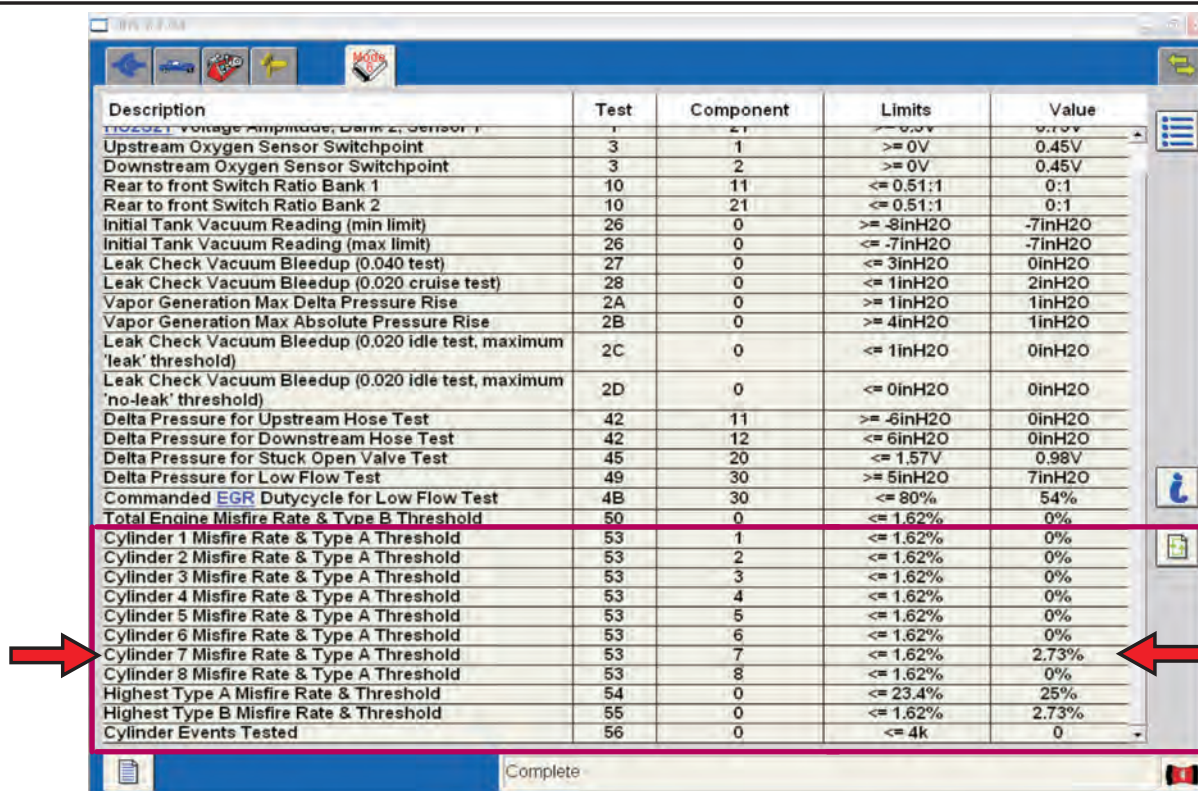
Figure 6

With Ford OBD-II Mode \$06, Misfire CIDs range from 53 to 56. CID 53 is cylinder misfire events. CID 54 is the highest rate and threshold of a Type "A" misfire. CID 55 is the highest rate and threshold of a Type "B" misfire. CID 56 is the number of cylinder events that were tested, Refer to Figure 6.

TIDs run from 1 through 10, these numbers represent which cylinder has been tested, Refer to Figure 6. If the test value exceeds the test limit then the respective cylinder components must be inspected.

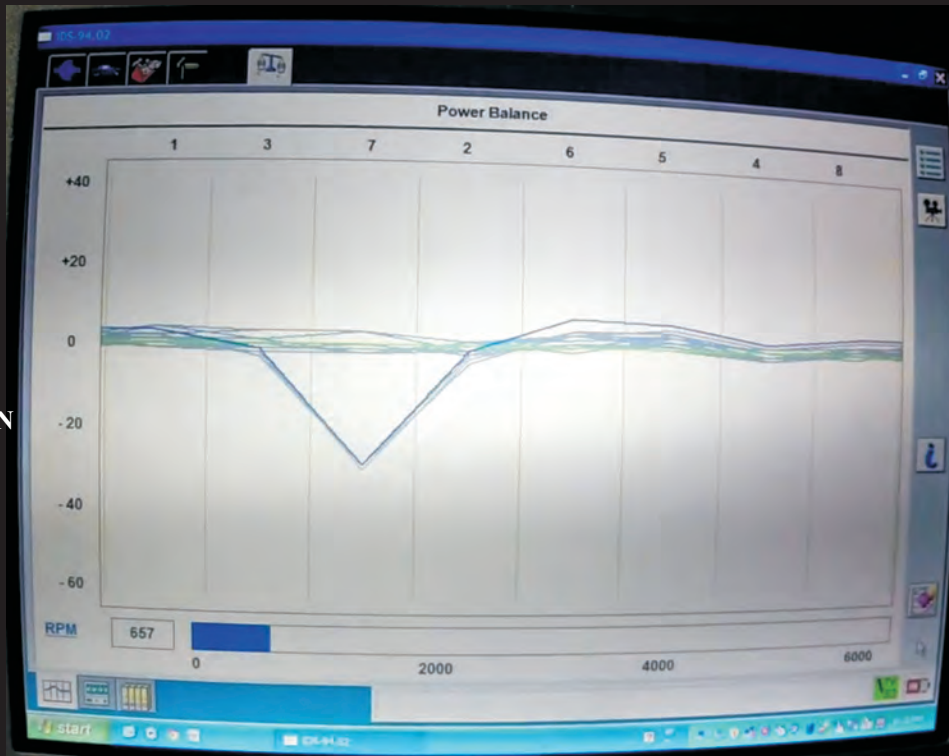
Figure 7

Another test that can be performed to confirm which cylinder(s) is having the misfire event, is a Cylinder Power Balance Test as seen in Figure 7. With positive test results the malfunctioning cylinder(s) should have their spark plug(s) and coil pack(s) replaced, it is recommended that ALL coil packs and spark plugs be replaced at this time with O.E.M. components. All previous testing has been done to diagnose the electrical ignition system components.

CYLINDER POWER BALANCE TEST

**CYLINDER #7
HAS A 30% DROP
IN CONTRIBUTION**

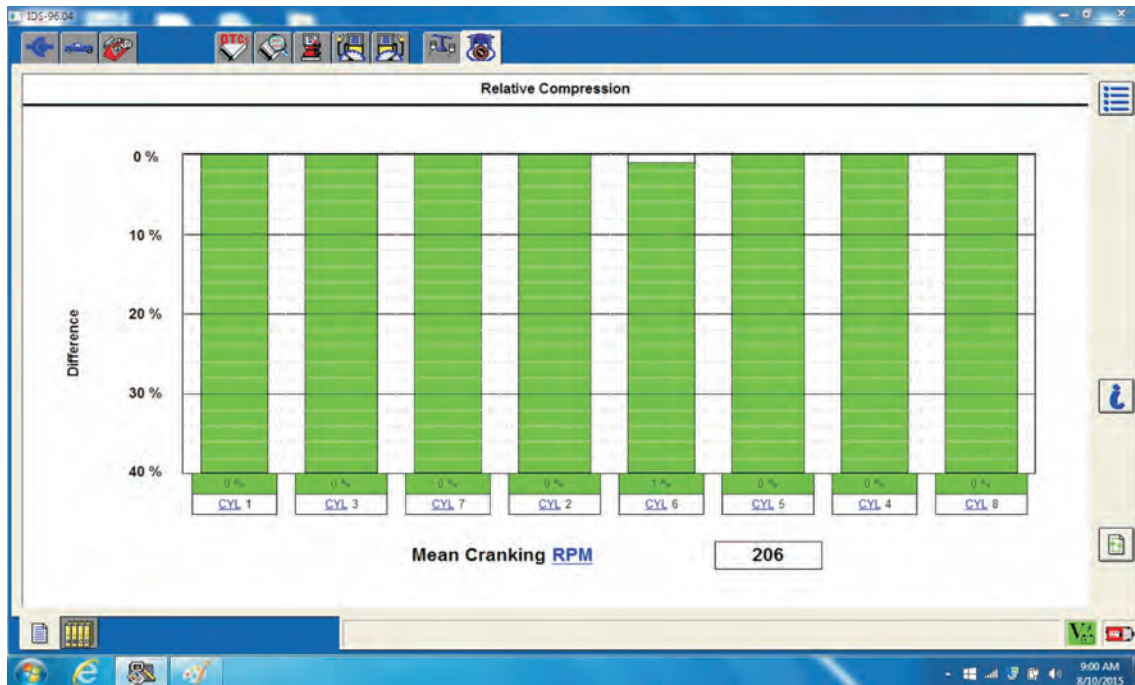
Figure 8

The mechanical cylinder contribution can be accomplished by performing a "Relative Compression" test, Refer to Figure 8, in the event that the engine has a serious mechanical problem.

RELATIVE COMPRESSION TEST

Engine Is In Good Mechanical Health

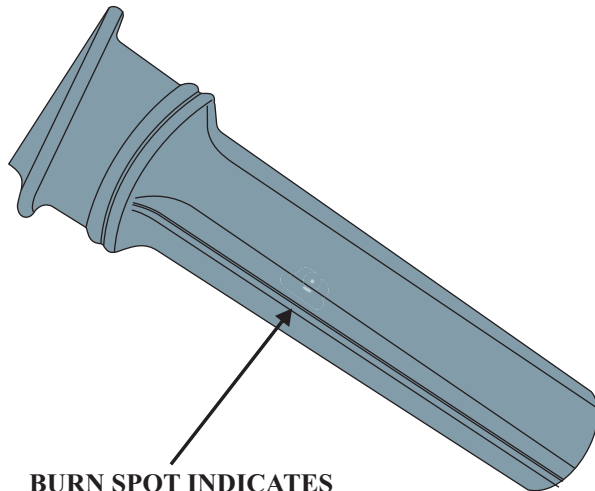
Faulty coil packs may have deteriorated boots which allow leakage which cause electrical interference. They may also have a burn spot on the boot which indicates electrical arcing, Refer to Figure 9.

EXAMPLES OF DAMAGED COIL ON PLUG

BURN SPOT INDICATES
ELECTRICAL ARCING

When replacing the coil packs, make certain the spring contact that is inside the spark plug boot is all the way against the coil. Also check coil pack connectors and wiring for any problems that may prevent the coil pack from maximum efficiency.

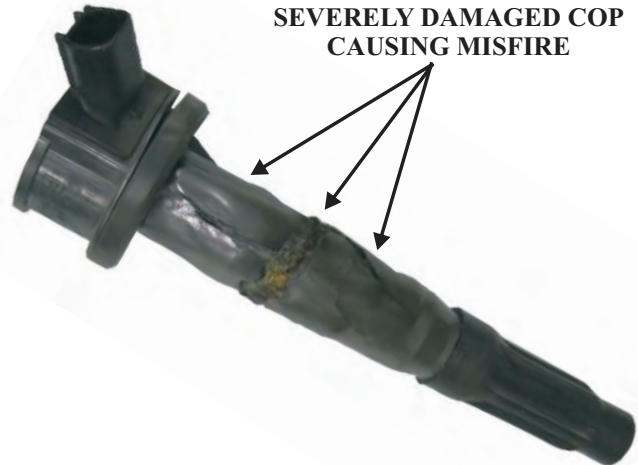
SEVERELY DAMAGED COP
CAUSING MISFIRE

CORRECTION: Replace all spark plugs and coil packs preferably with O.E.M. parts.

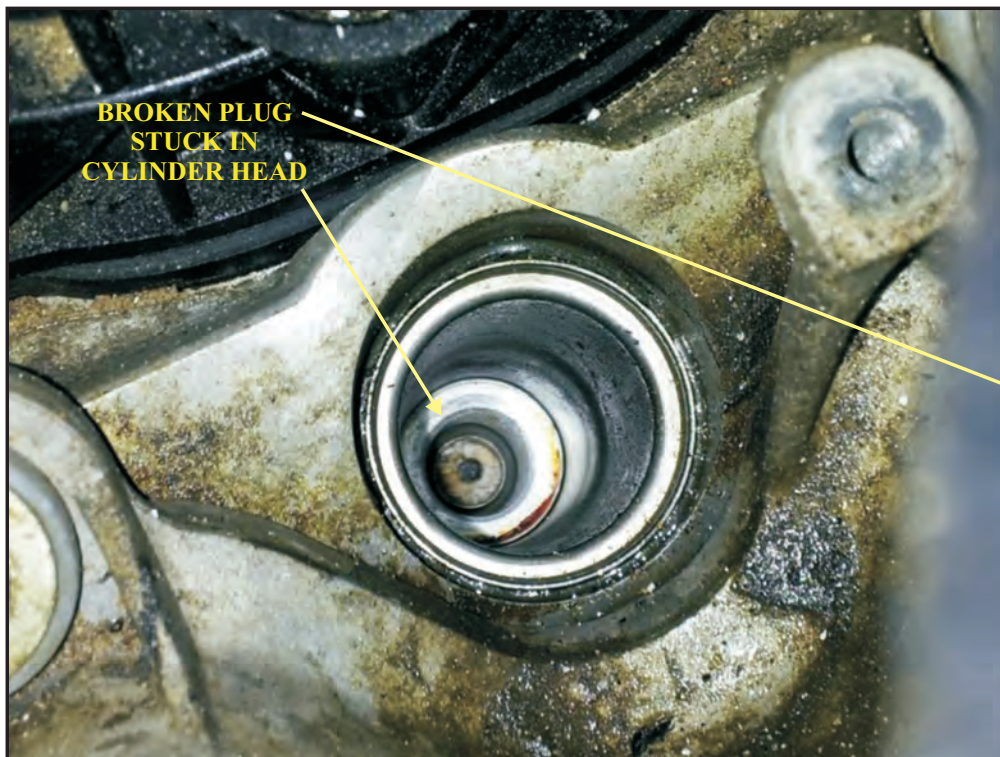
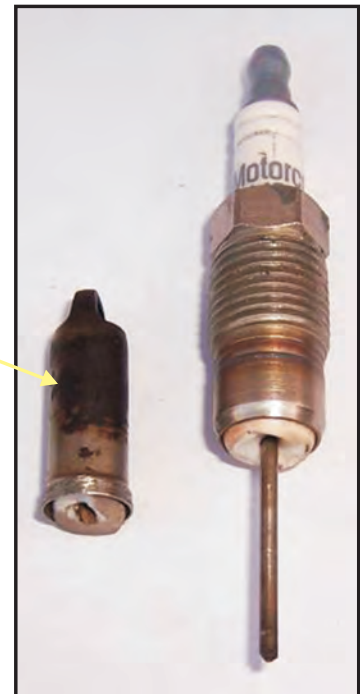
Figure 10

The spark plugs that Ford uses in their 4.6L, 5.4L and 6.8L three valve modular engines is a long reach two piece design. Because of this, when spark plug removal is attempted by the inexperienced, the plugs break off in the cylinder head. This could turn into a very unpleasant situation unless some precautions are taken, Refer to Figure 10.

BROKEN PLUG
STUCK IN
CYLINDER HEAD

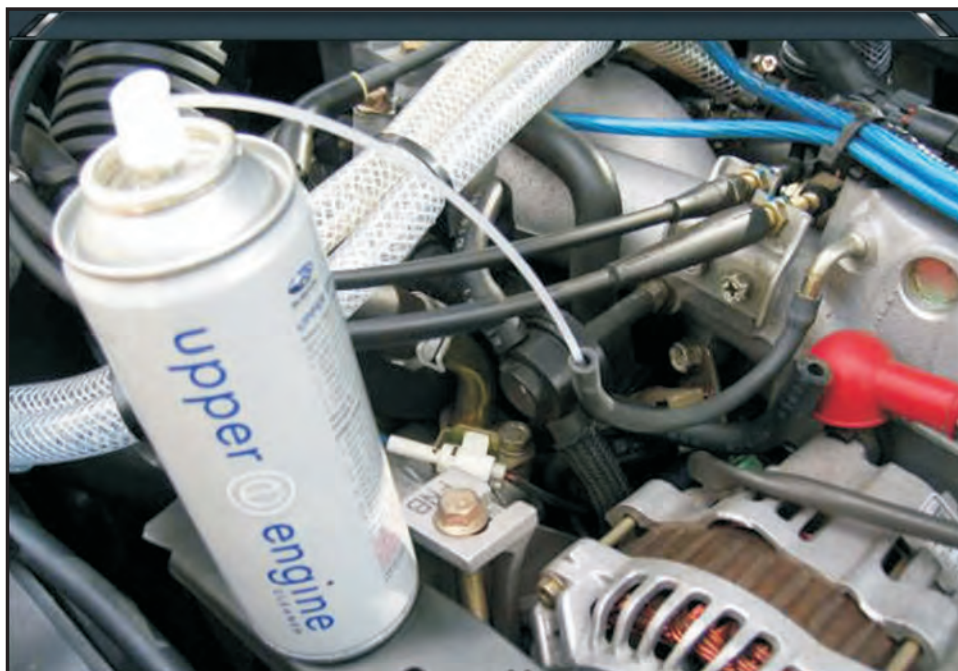
Figure 11

UPPER ENGINE DECARBONIZING PROCEDURE

This Procedure Should Loosen The Spark Plug Electrode Shield

Before spark plug removal is attempted, bring the engine up to normal operating temperature. Perform a top engine decarbonizing procedure, See Figure 11, using one of the many products available in order to remove the carbon from the lower electrode shield of the spark plug which gets it stuck in the cylinder head.

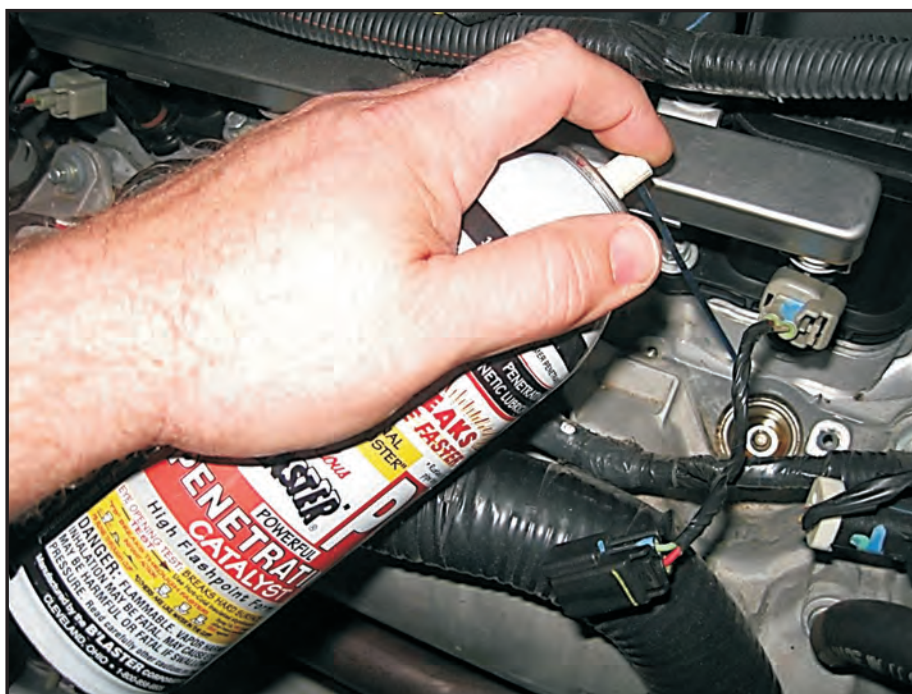
Figure 12

Rust Inhibitor Will Help To Loosen The Spark Plug Threaded Area

Then with the coil on plug removed spray a rust inhibiting product into the spark plug hole, Refer to Figure 12. At this time, the spark plugs should unscrew in one piece. In the event the spark plug does break, repeat the rust inhibitor treatment and acquire one of the spark plug removal tool kits such as the Lisle LIS65600 shown in Figure 13 to remove the broken piece of the spark plug.

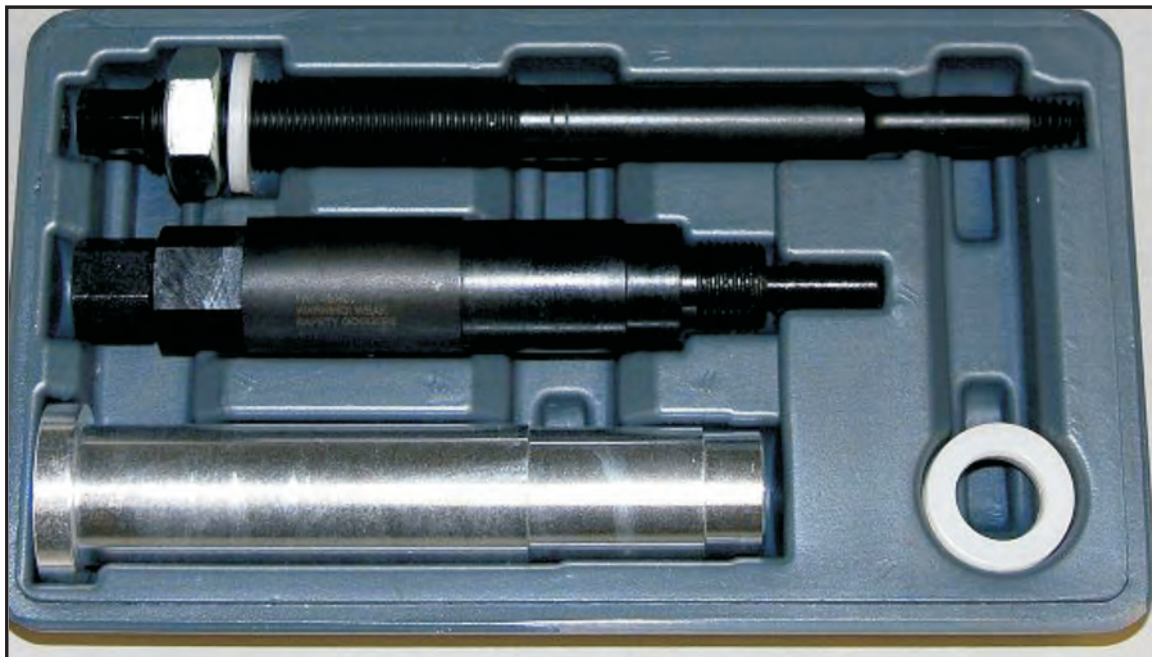
Figure 13

LISLE BROKEN SPARK PLUG REMOVAL TOOL KIT #LIS65600
