Technical Service Information

4L60-E TRANSMISSION LATE 2-3 SHIFT

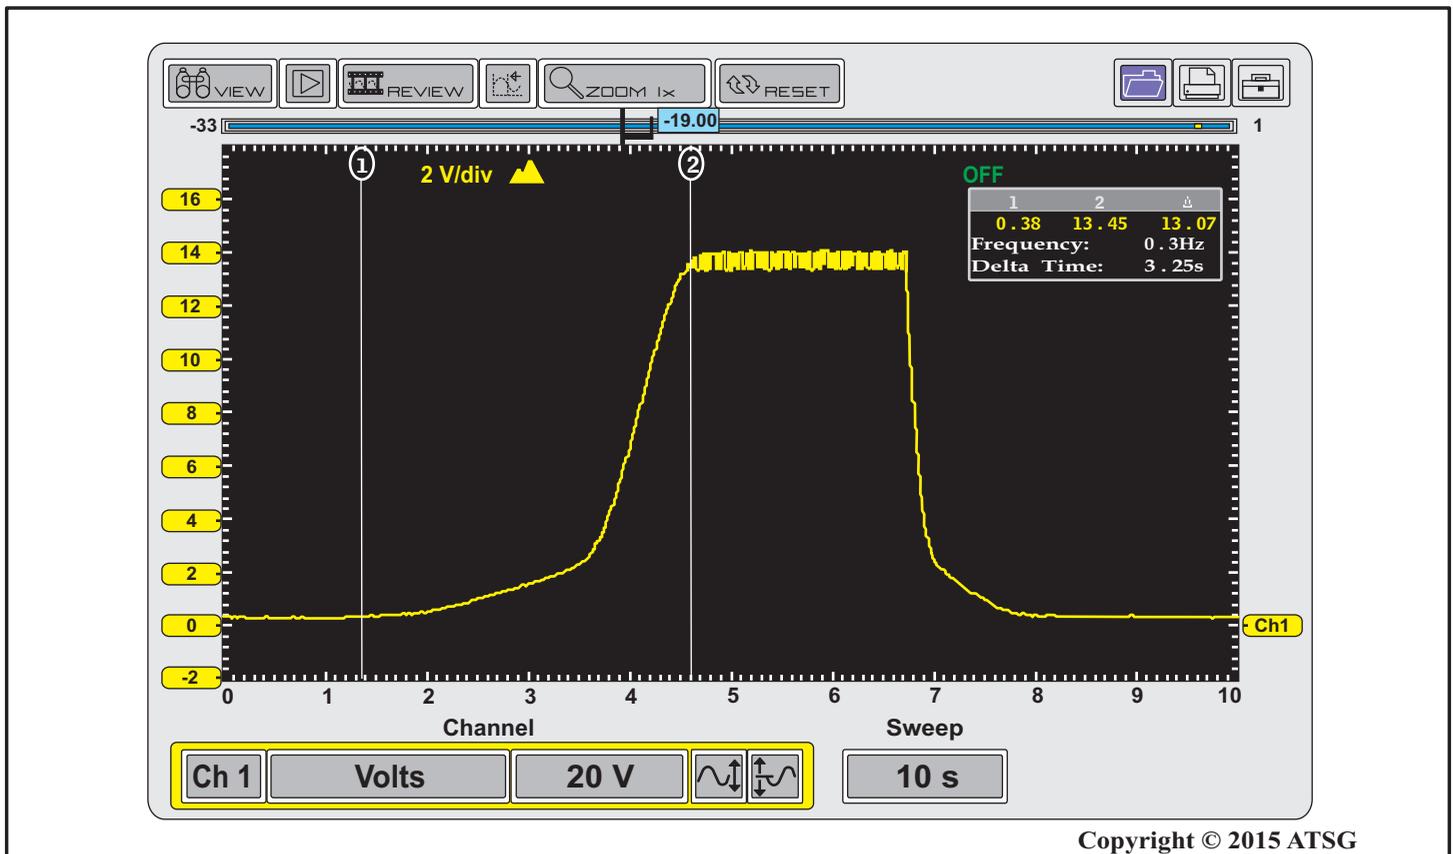
Figure 1

CAUSE: The 2-3 shift solenoid is energized for 1st and 2nd gear and turns off for 3rd and 4th. When the solenoid command signal from the VCM was monitored on a scope, at the time the 2-3 shift was to occur, it took the VCM near 3 seconds to fully release the ground (Figure 1). Once the ground was fully released the transmission made the 2-3 shift causing the late 2-3 shift complaint. By the time the 2-3 shift was made, the 3-4 shift came soon after giving it a perceived slip feel.

CORRECTION: If driven long enough, code P0758 would return indicating a circuit error for the solenoid. Since the circuit was checked during cold and operating temperatures with no circuit issues discovered, it was decided to replace the VCM. Once replaced, all shifts were restored to normal operations during light, medium and heavy throttle conditions.
