Technical Service Information

BMW ZF6HP26/19 “E” SHIFT DTC 507B STAYS IN PARK

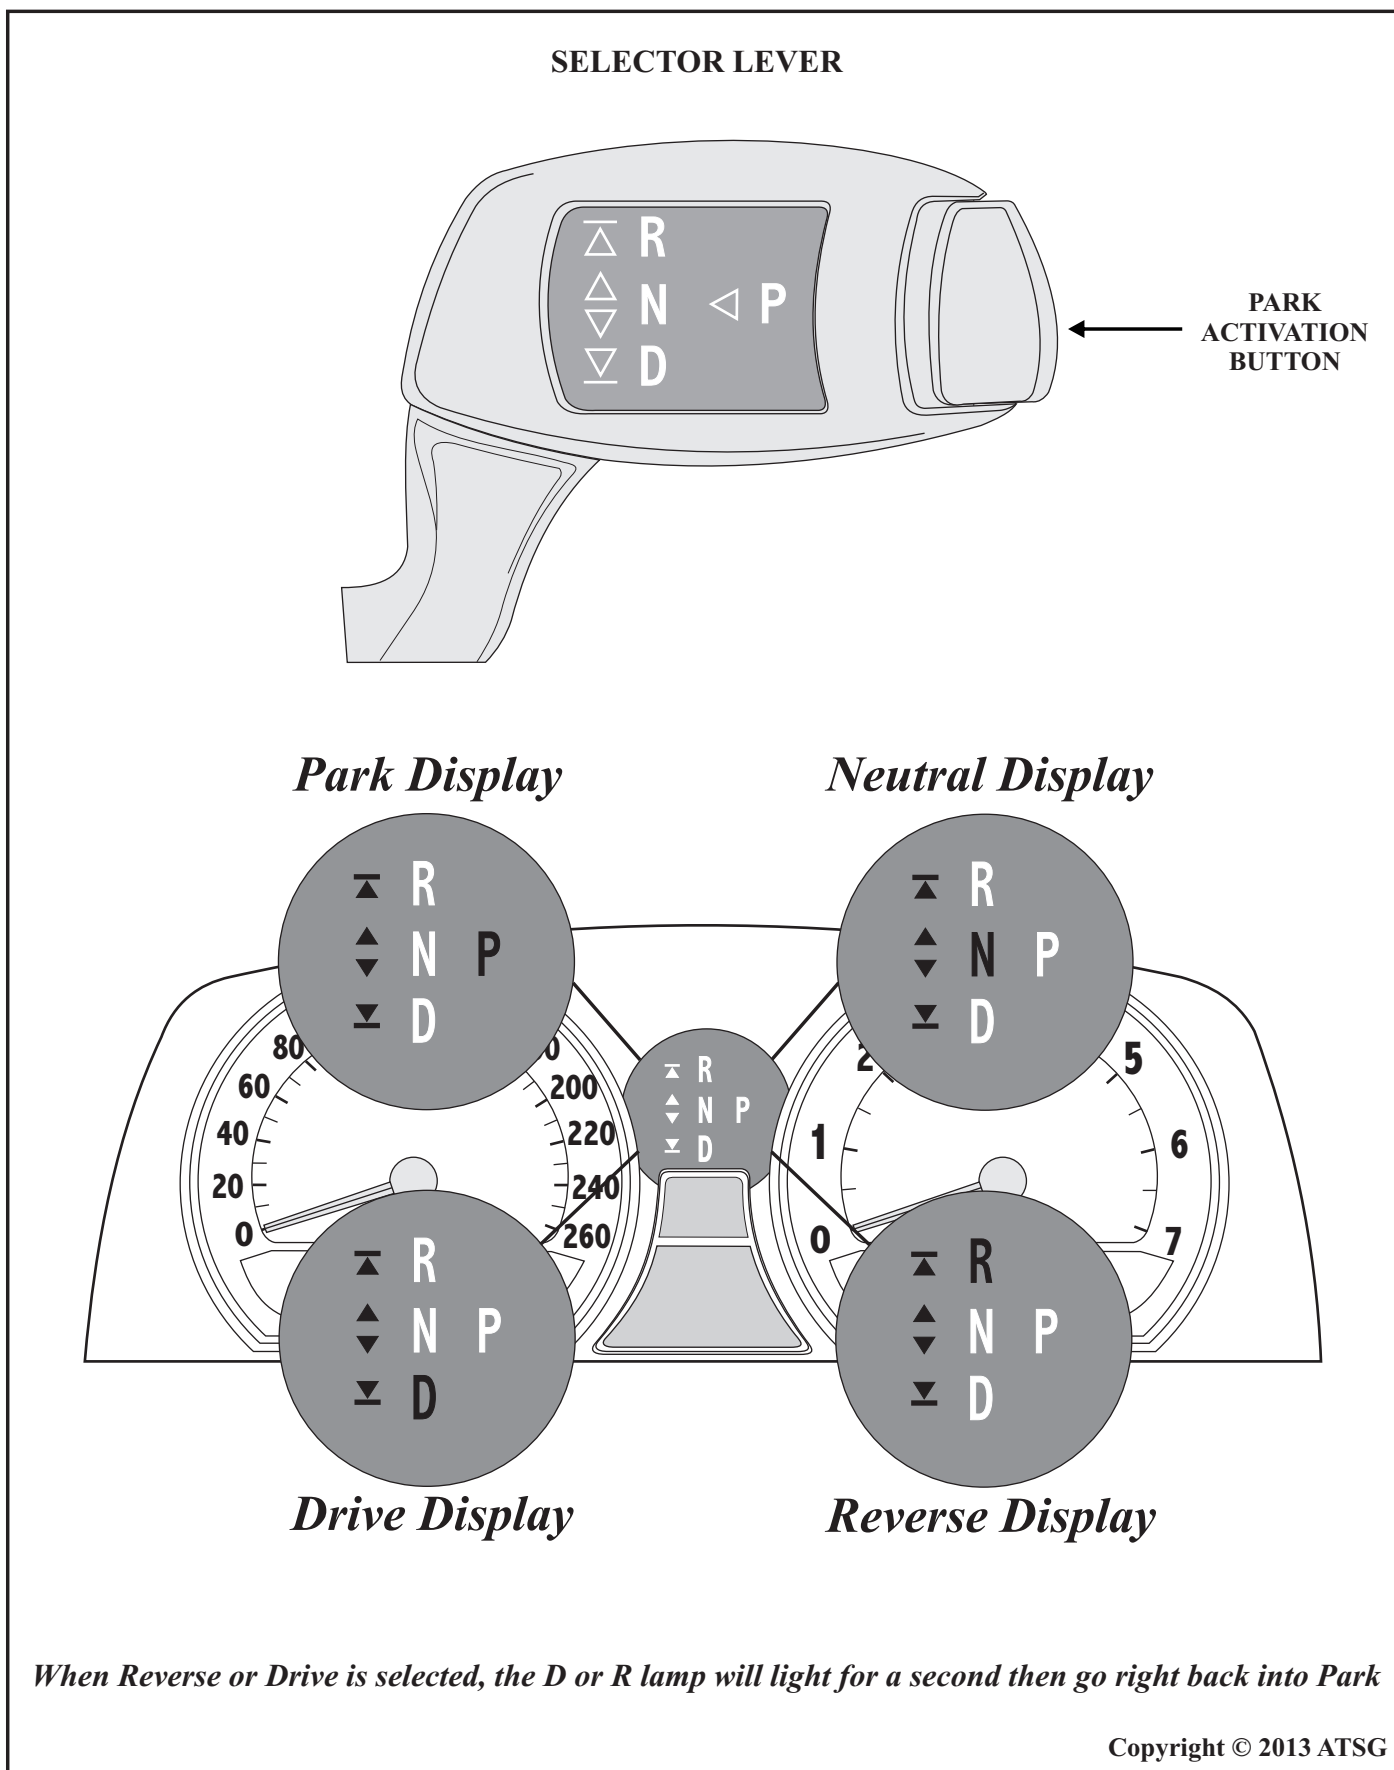
Figure 1

COMPLAINT: 2002 and up BMW vehicles equipped with the ZF6HP26 and or the ZF6HP19, equipped with the “E” Shift, may have a complaint of a Diagnostic Trouble Code of 507B Parking gear sensor implausible, typically after overhaul. The technician observed the gear shift position indicator lamps go from park to neutral to drive and then it immediately returned to park as shown in Figure 1.

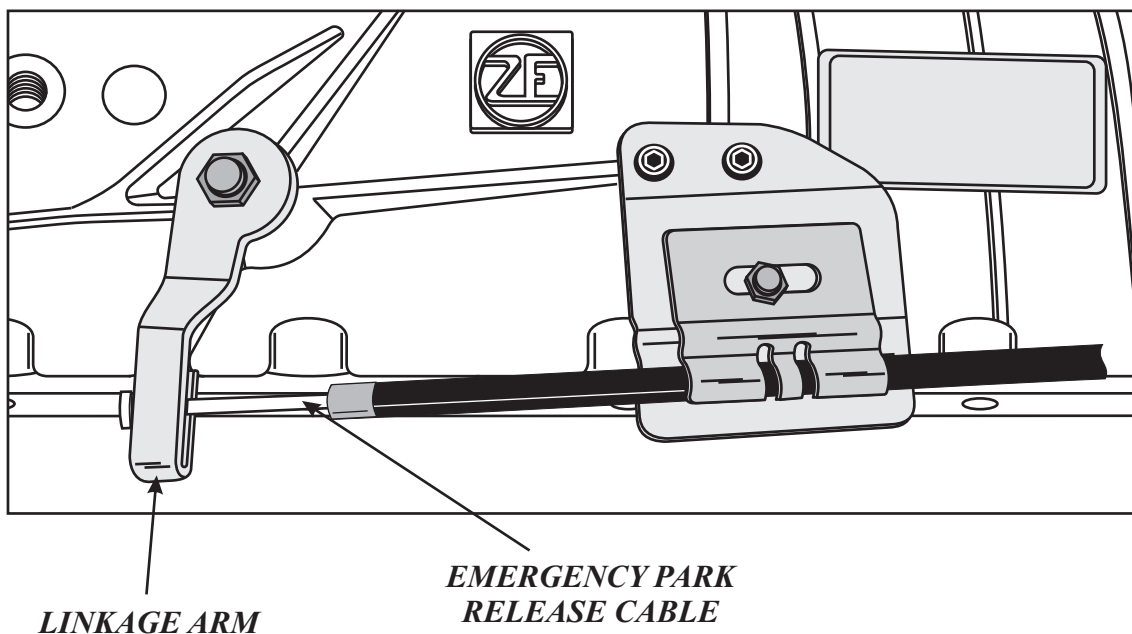
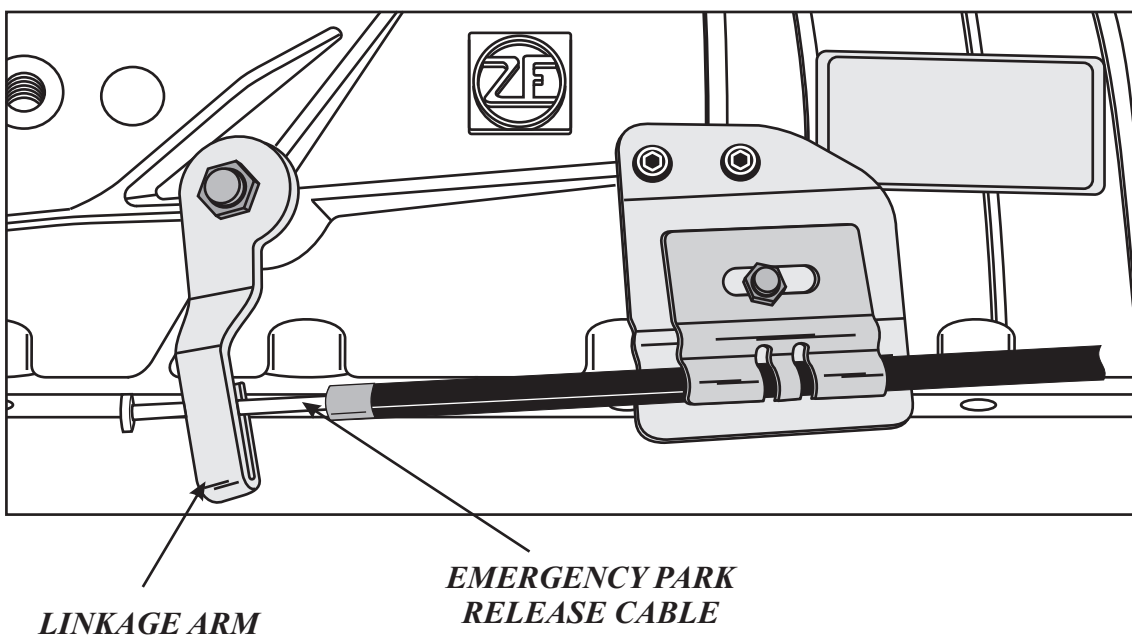
Figure 4

CAUSE: The cause may be that the linkage arm that houses the emergency park release cable is bent not allowing the linkage to fully move towards the rear of the case to release the park rod, which causes the DTC 507B and the shifter to go directly back into Park.

The Linkage arm must move freely over the stationary Emergency Park Release Cable or it will cause it to set the DTC 507B

CORRECTION: To correct this condition, remove the protective cover that houses the emergency park release cable and on a suitable lift, select Drive or Reverse, watching to ensure the free movement of the linkage arm. **Note:** the cable should not impede the movement of the linkage arm, if it does, repair or replace the linkage arm so that it travels freely over the stationary cable, as shown in Figure 4.
