Technical Service Information

FORD 5R110W FLUID OUT THE VENT

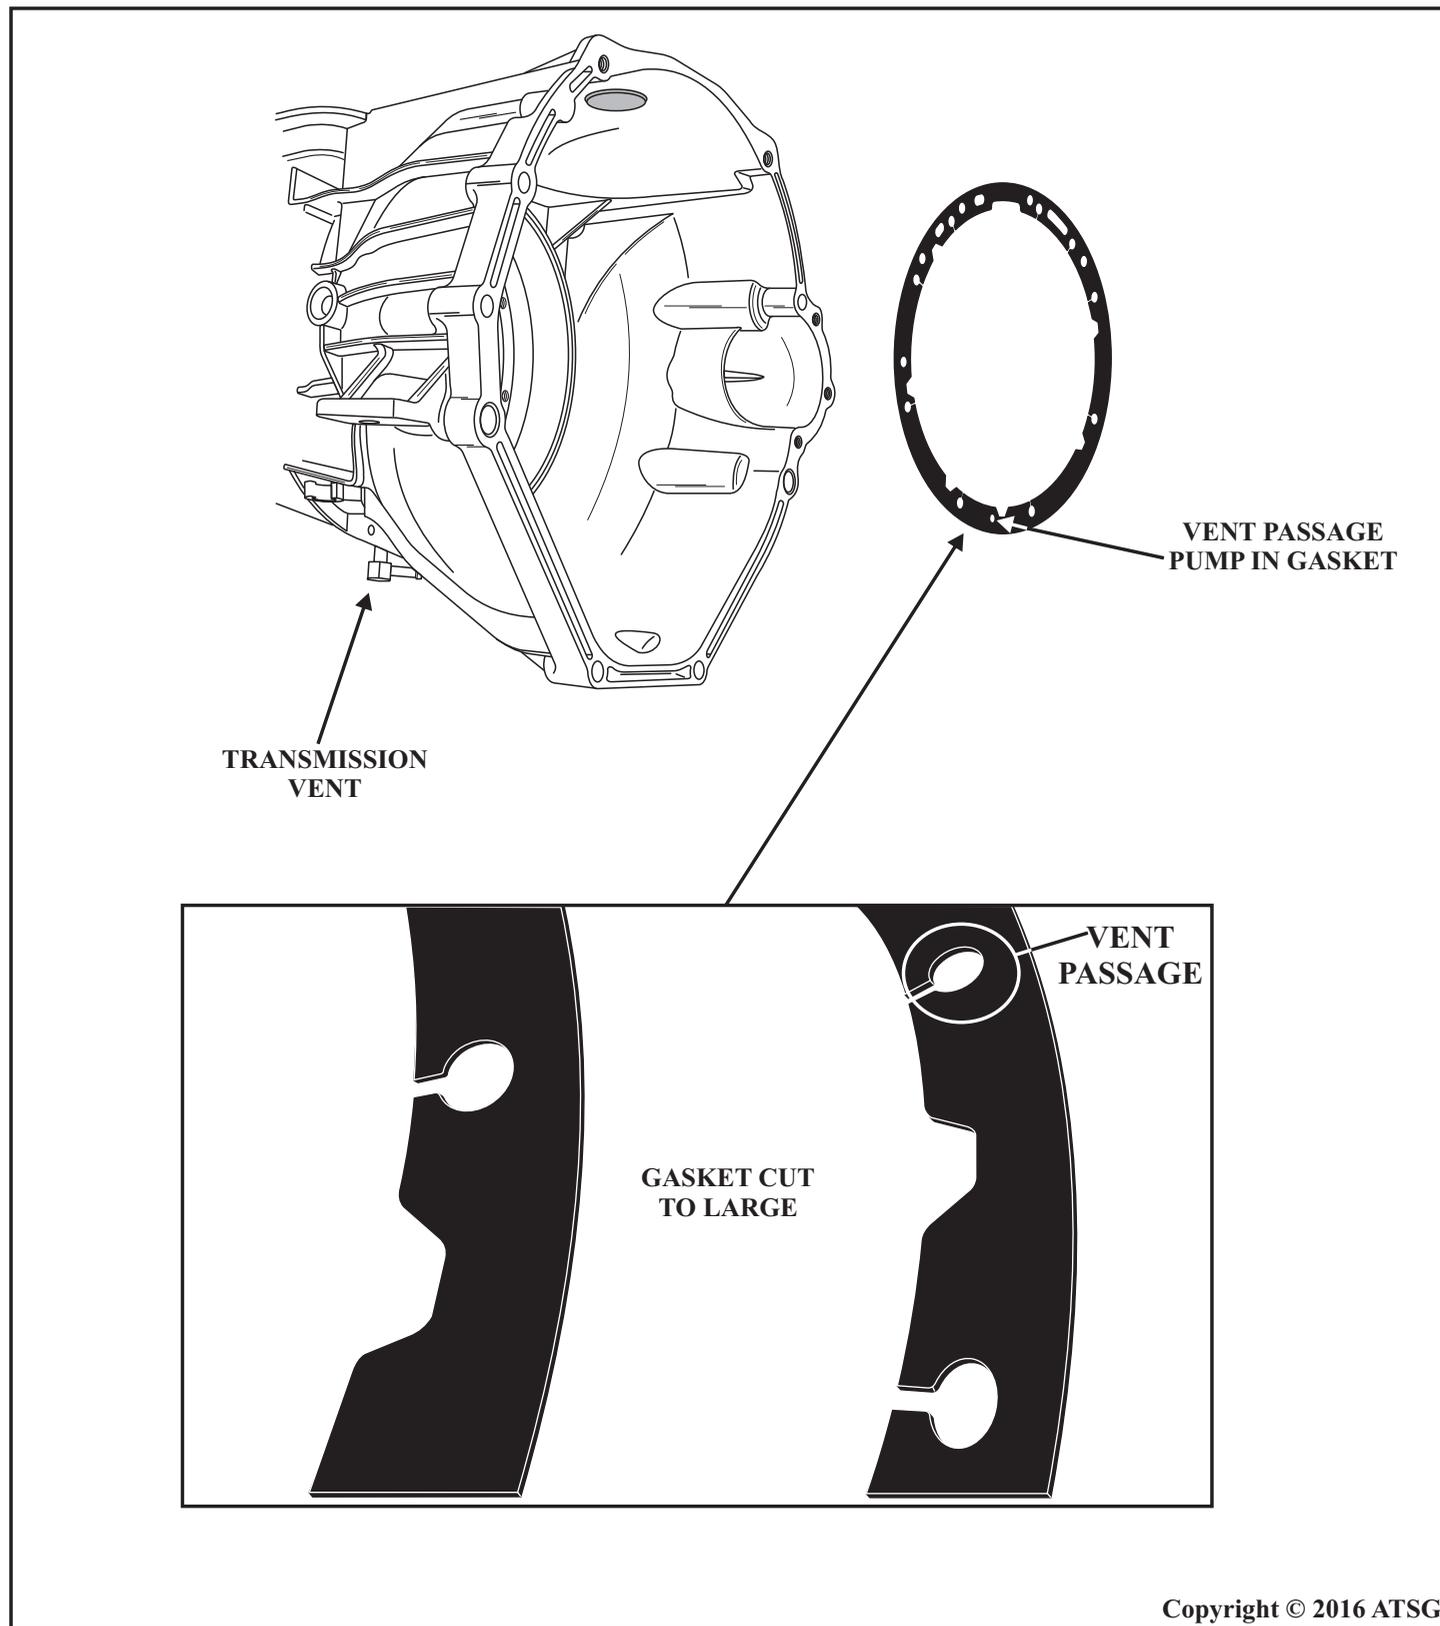
Figure 1

CAUSE: Some transmission overhaul kits may contain pump assembly to case gaskets that have been incorrectly cut, Refer to Figure 1. The pump passage identification shown in Figure 2 illustrates how the improperly fitting pump gaskets cause fluid to leak out of the transmission vent.

CORRECTION: Be sure to place the pump gasket on the pump and case surface to insure the gasket aligns properly.
