ALLISON 1000/2000 SERIES TRANSMISSIONS INTERMITTENT HARSH SHIFTS

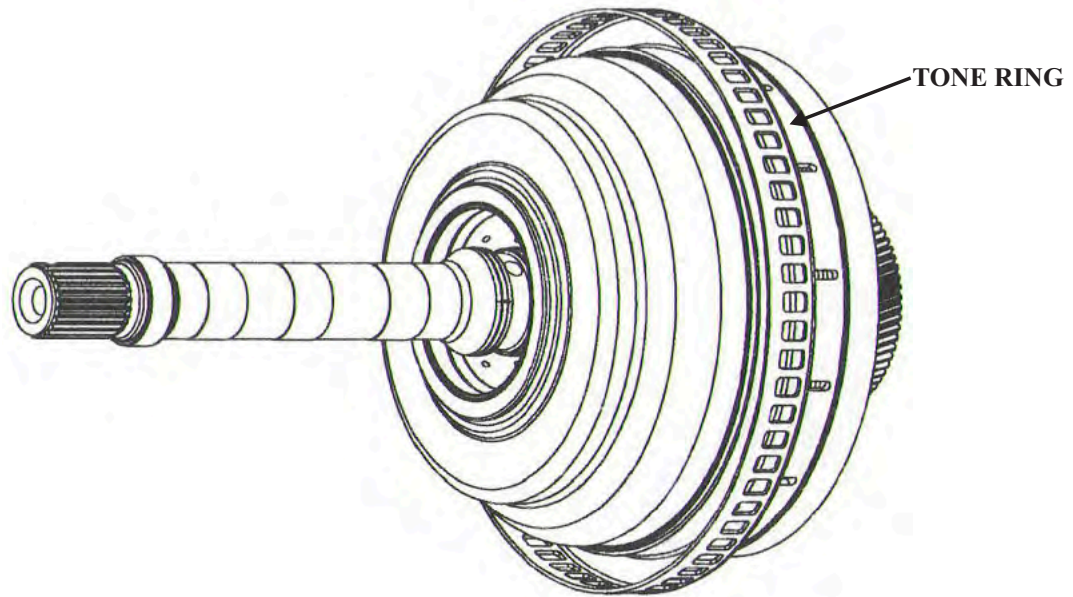
Figure 1

(1): The rotating clutch module is a heavy assembly, if it is mis-handled it is very easy for the turbine speed sensor tone ring which is pressed onto the clutch drum to get damaged (See Figure 1). If one or more of the teeth are bent, this will compromise the Turbine Speed Sensor signal and cause one or more of the above mentioned complaints.

(2): Although the Turbine Speed Sensor sets no trouble code, it can cause the above mentioned complaints when it is malfunctioning.

ROTATING CLUTCH MODULE WITHOUT PTO

(1): It is possible to remove a PTO cover and straighten the bent teeth on the tone ring. If it is badly damaged the transmission will have to be dis-assembled at which time either the drum can be replaced or a new tone ring can be purchased and installed onto the drum.

(2): Once the tone ring has been verified good, replace the Turbine Speed Sensor.

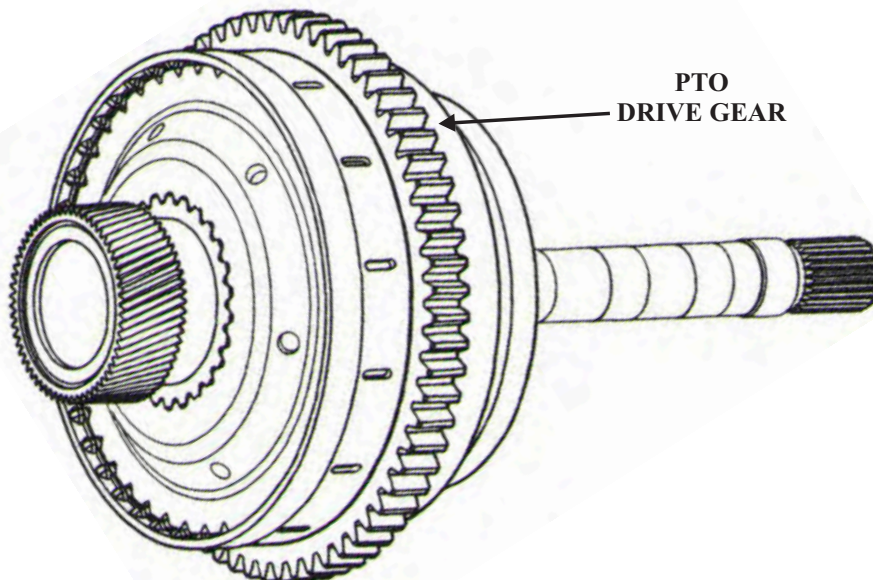
Figure 2

NOTE: Vehicles equipped with a PTO will have a PTO drive gear pressed onto the rotating clutch module instead of a tone wheel (See Figure 2).

Although it would take some abuse to damage the drive gear, a more likely scenario is that the drive wheel can loosen its grip on the drum and can turn independently of the drum.

ROTATING CLUTCH MODULE WITH PTO

If the PTO gear is loose, either the drive gear will require replacement or the drum will have to be replaced.

NOTE: In some instances the PTO drive gear will loosen when it gets hot. Be sure to heat the drum when checking the PTO drive gear for tightness.

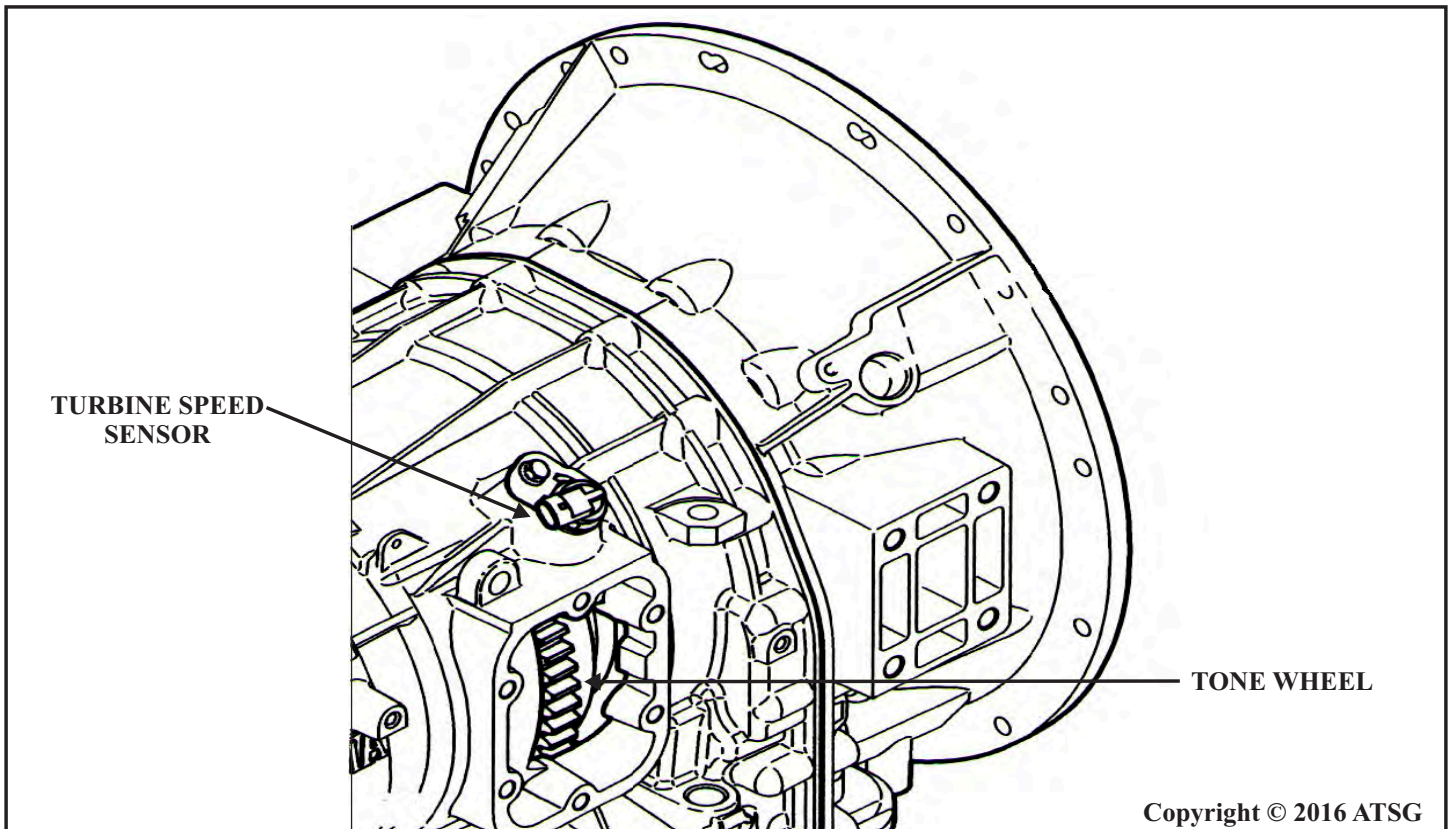
Figure 3

This will compromise the TSS signal because in a PTO application the TSS is looking at the PTO drive gear (See Figure 3).

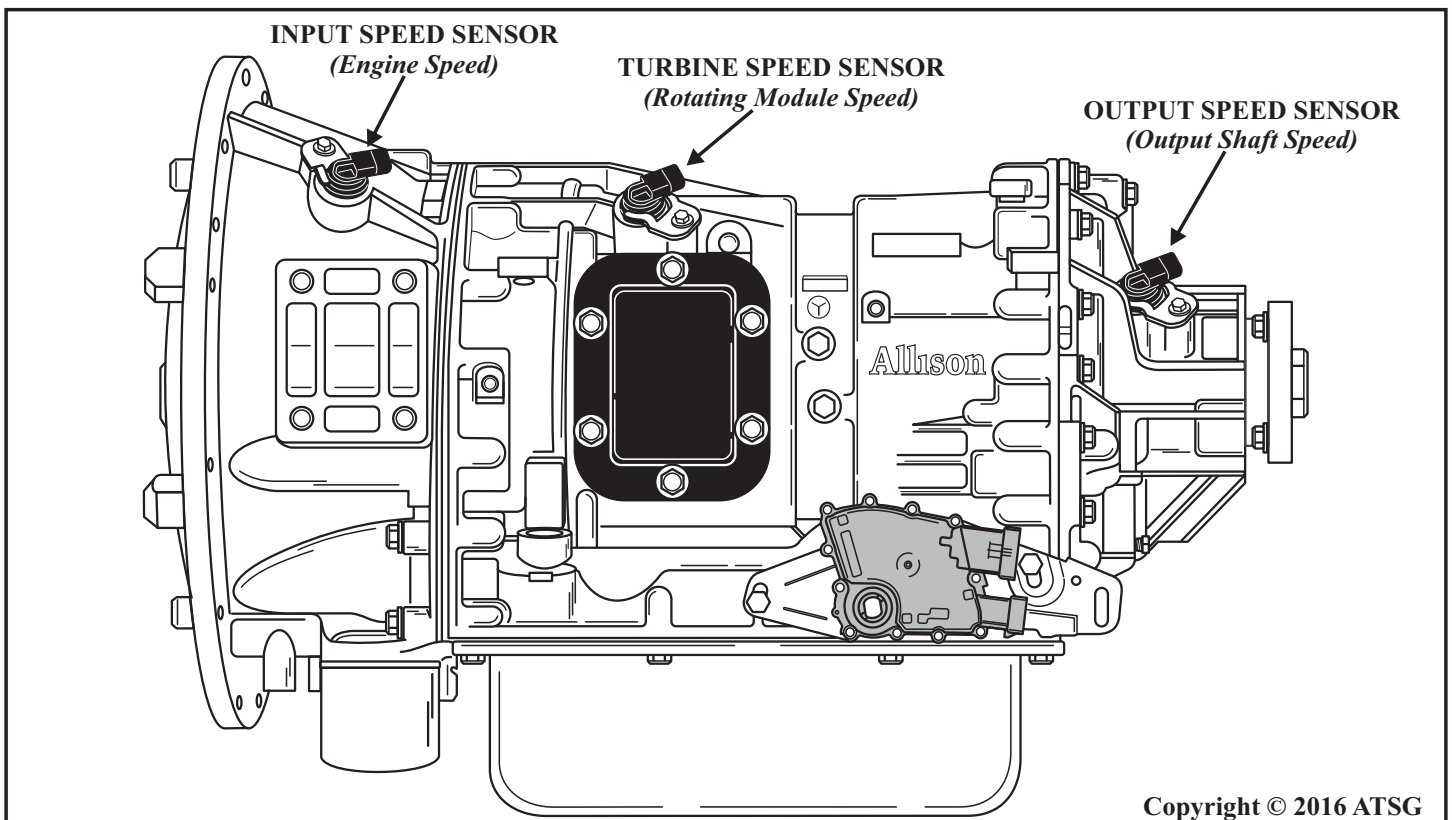
Figure 4

Transmission speed sensor identification can be seen in Figure 4. There is confusion at times as the names of the speed sensors can be misleading.

NOTE: The Input Speed Sensor is actually the engine rpm sensor while the Turbine Speed Sensor is indicating input speed.

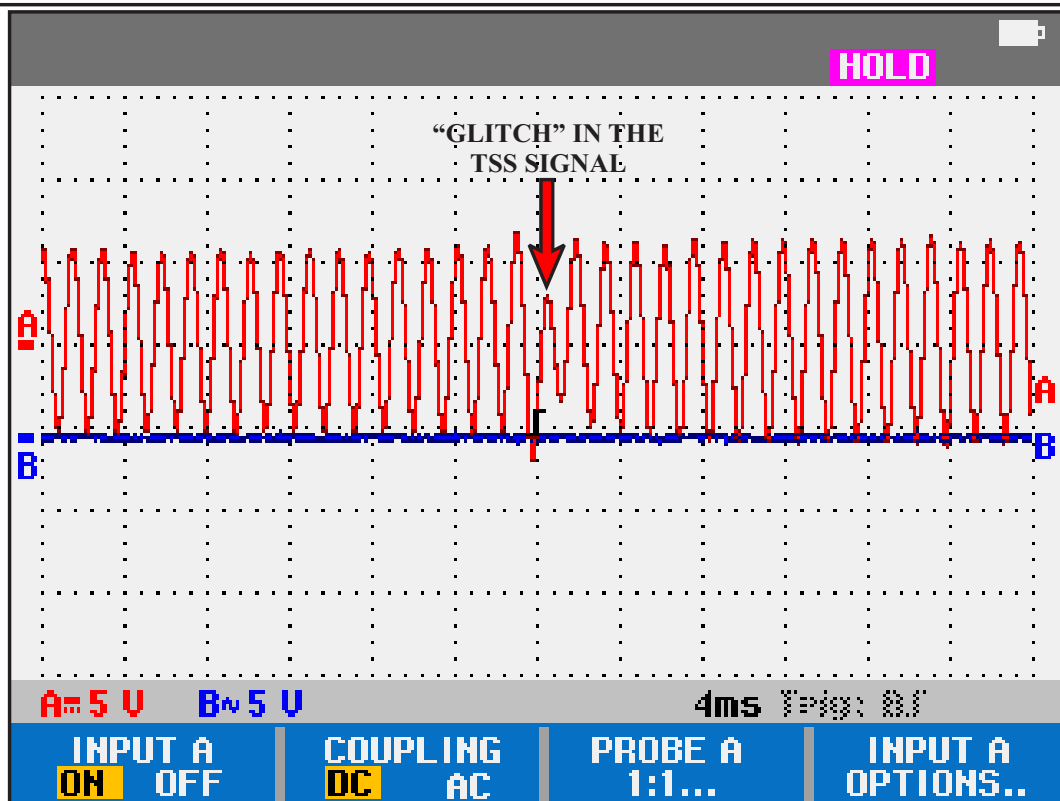
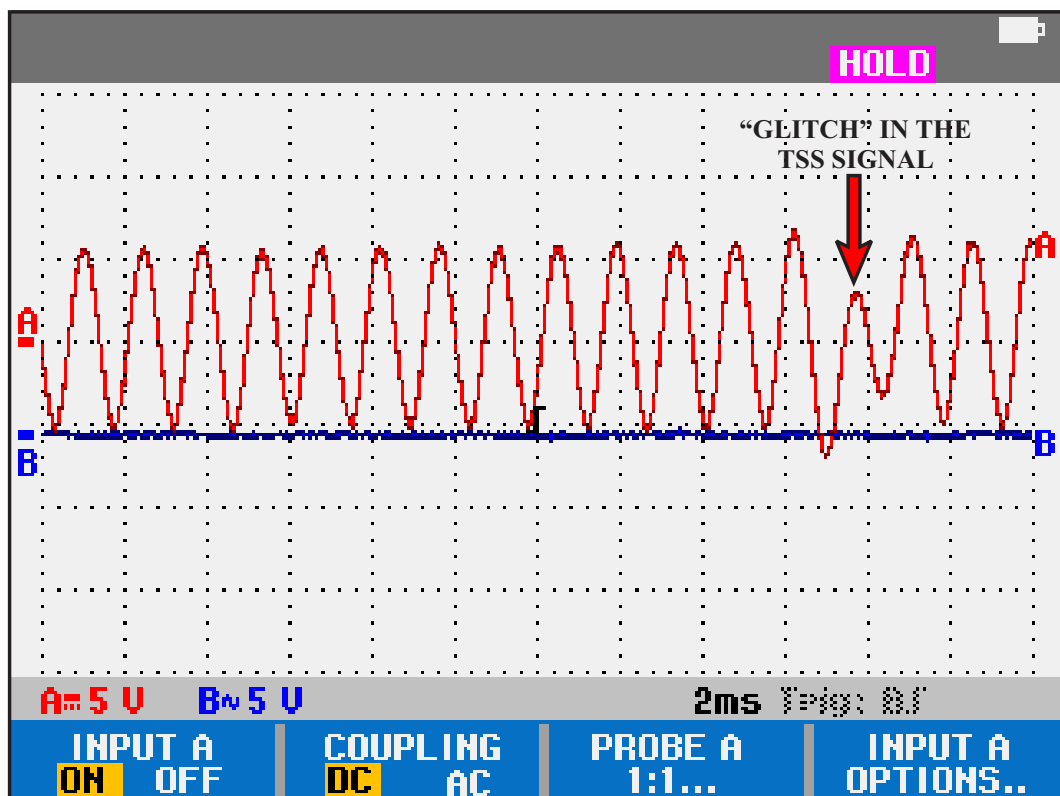
Figure 5

The use of an automotive oscilloscope can show a “glitch” in the TSS signal as seen in Figure 5.

ENGINE RUNNING IN PARK
