Technical Service Information

GM 4T65E

FRONT SEAL “WALK OUT”

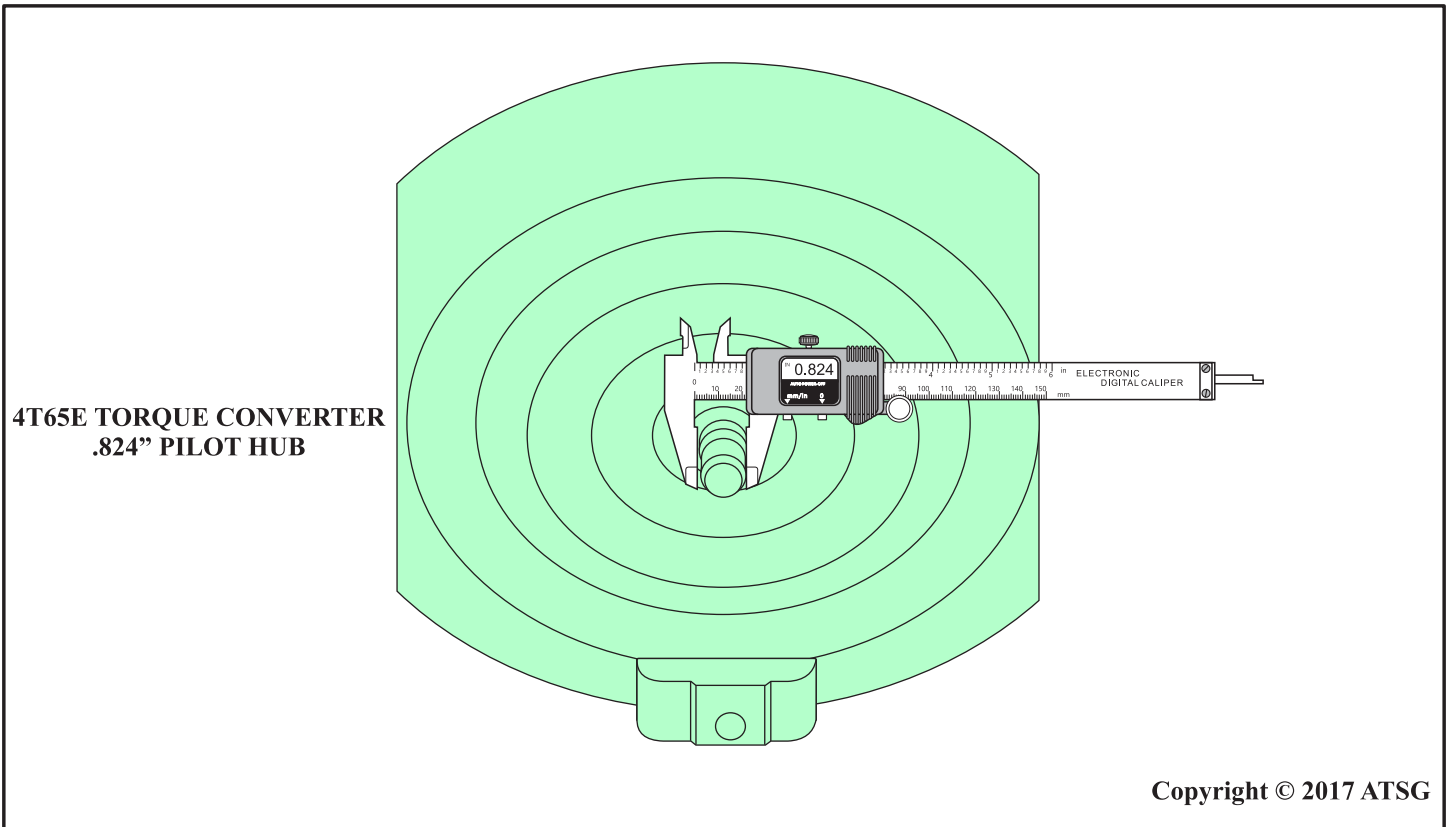
Figure 1

CAUSE: The Impala with a transversely mounted 5.3 Liter engine and a 4T65E transmission is equipped with a torque converter with a pilot hub that measures .824” in diameter, Refer to Figure 1, This converter requires a pilot bushing, Refer to Figure 2 and 3 to keep the converter spinning in a centerline rotation. Without the pilot bushing the converter would spin off center and “walk” the front seal out of the seal pocket in the case.

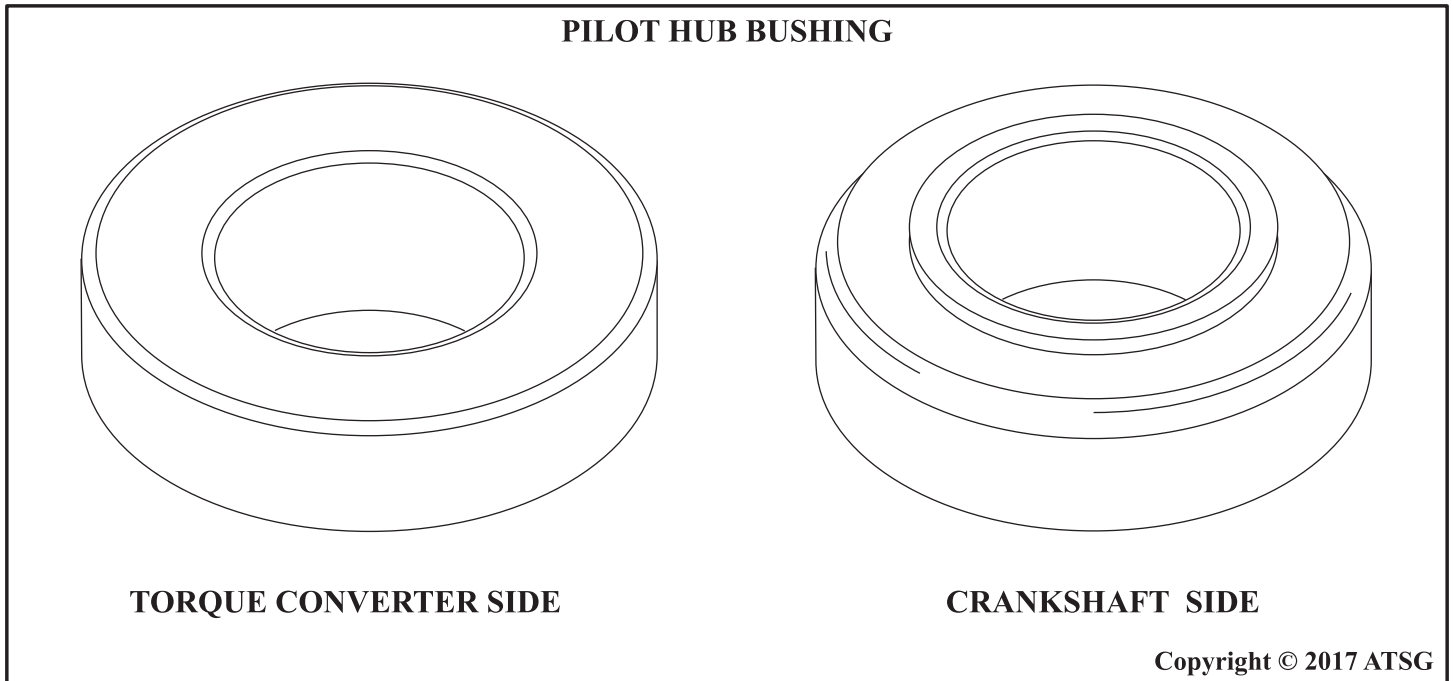
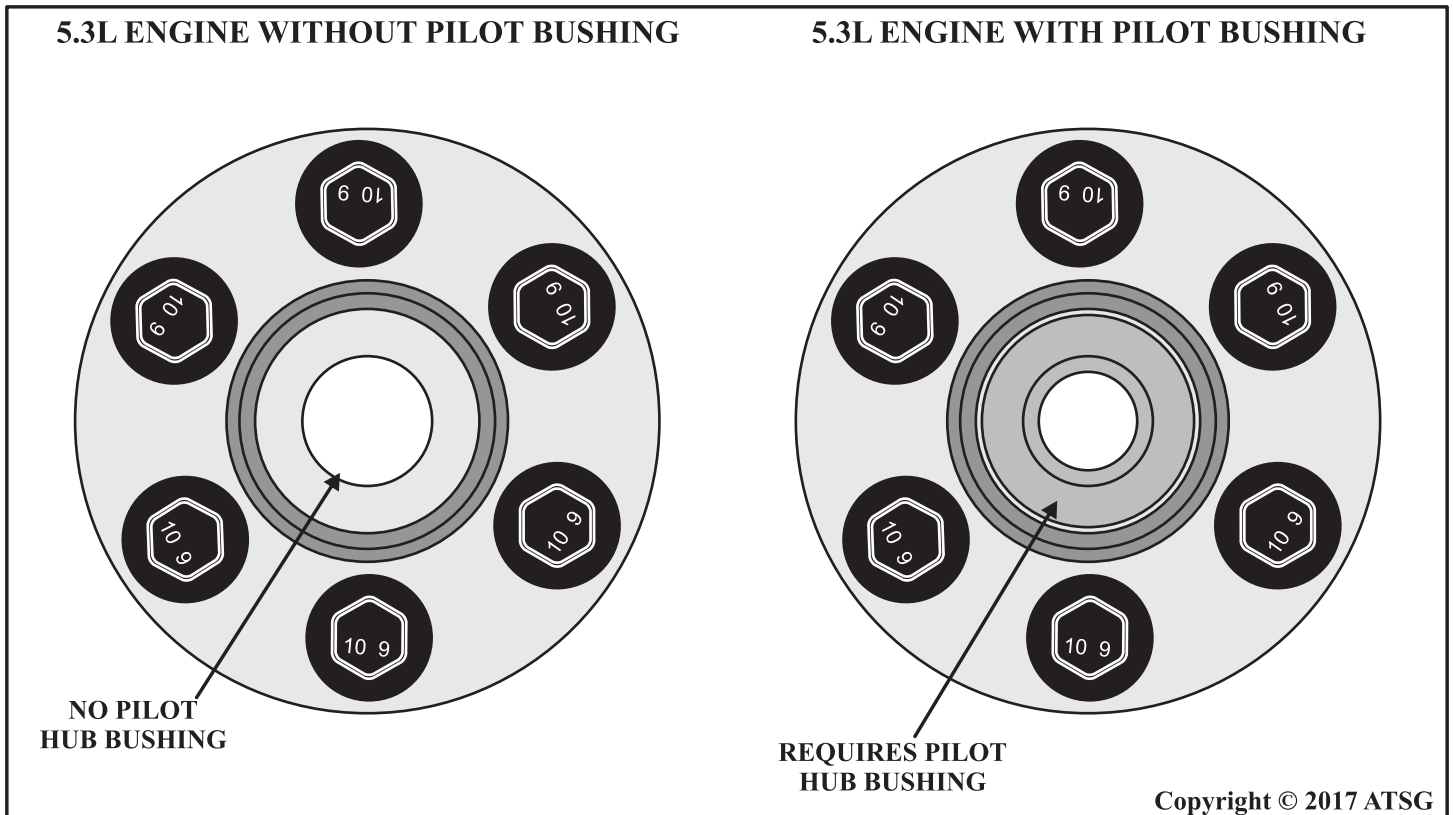
A general repair shop had changed the engine in this vehicle, soon after the front seal leak developed. This 5.3 Liter engine came out of a vehicle that did not have the pilot bushing in it, it may have been stuck to the converter.

CORRECTION: Install a pilot bushing into the crankshaft pilot hole.

Crankshaft Pilot Bushing.....12571220
