VW TOUAREG

SHIFT INTERLOCK & STOP LAMPS INOPERATIVE

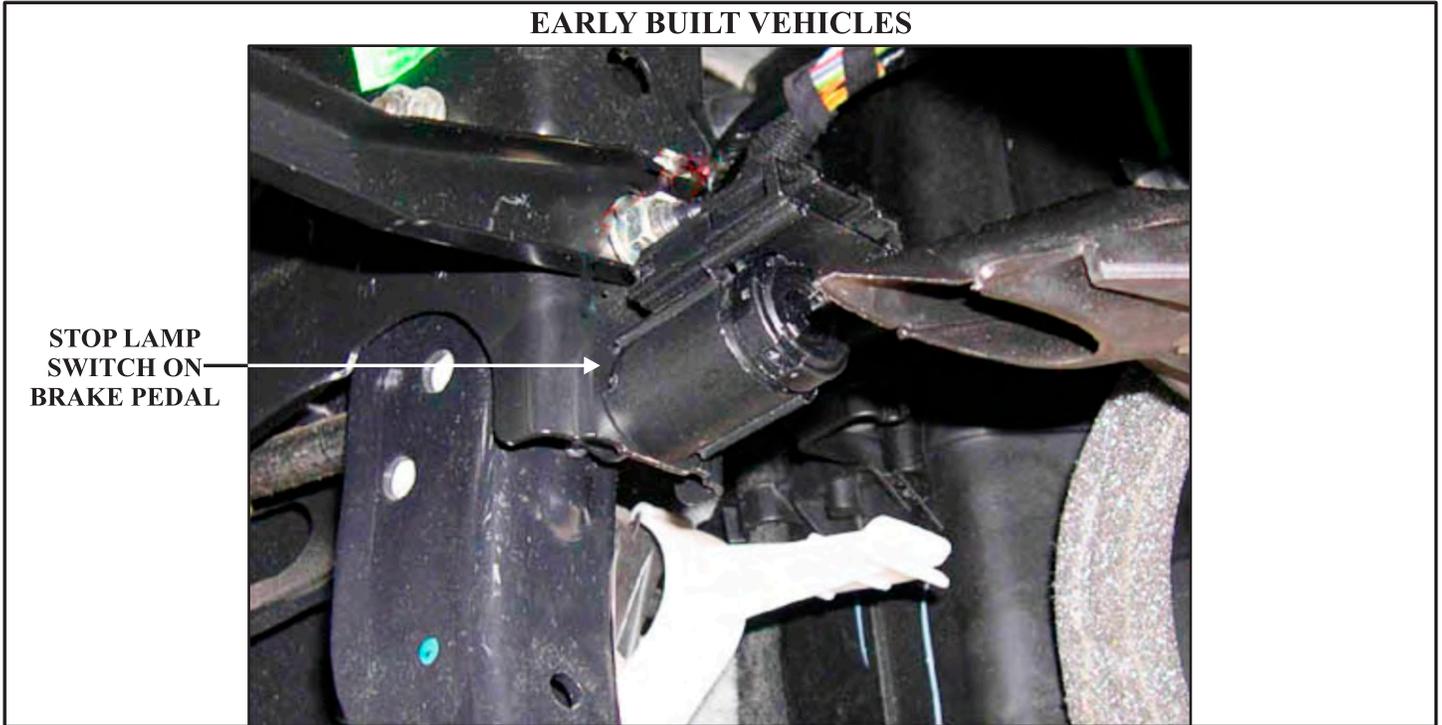
Figure 1

EARLY BUILT VEHICLES

- (1) Replace the Brake Light Switch. The problem is finding it!
Depending on when the vehicle was built, will dictate where to look for the switch.
 - 1 - Early built vehicles will have the switch in the usual place on the brake pedal (figure 1).
 - 2 - Later built vehicles will have a pressure switch that screws into the brake master cylinder (figure 2).
 - 3 - Late built vehicles have a pressure sensor built into the ABS Pump Assembly and will communicate the stop lamp ON signal over the CAN BUS Network (figure 3).

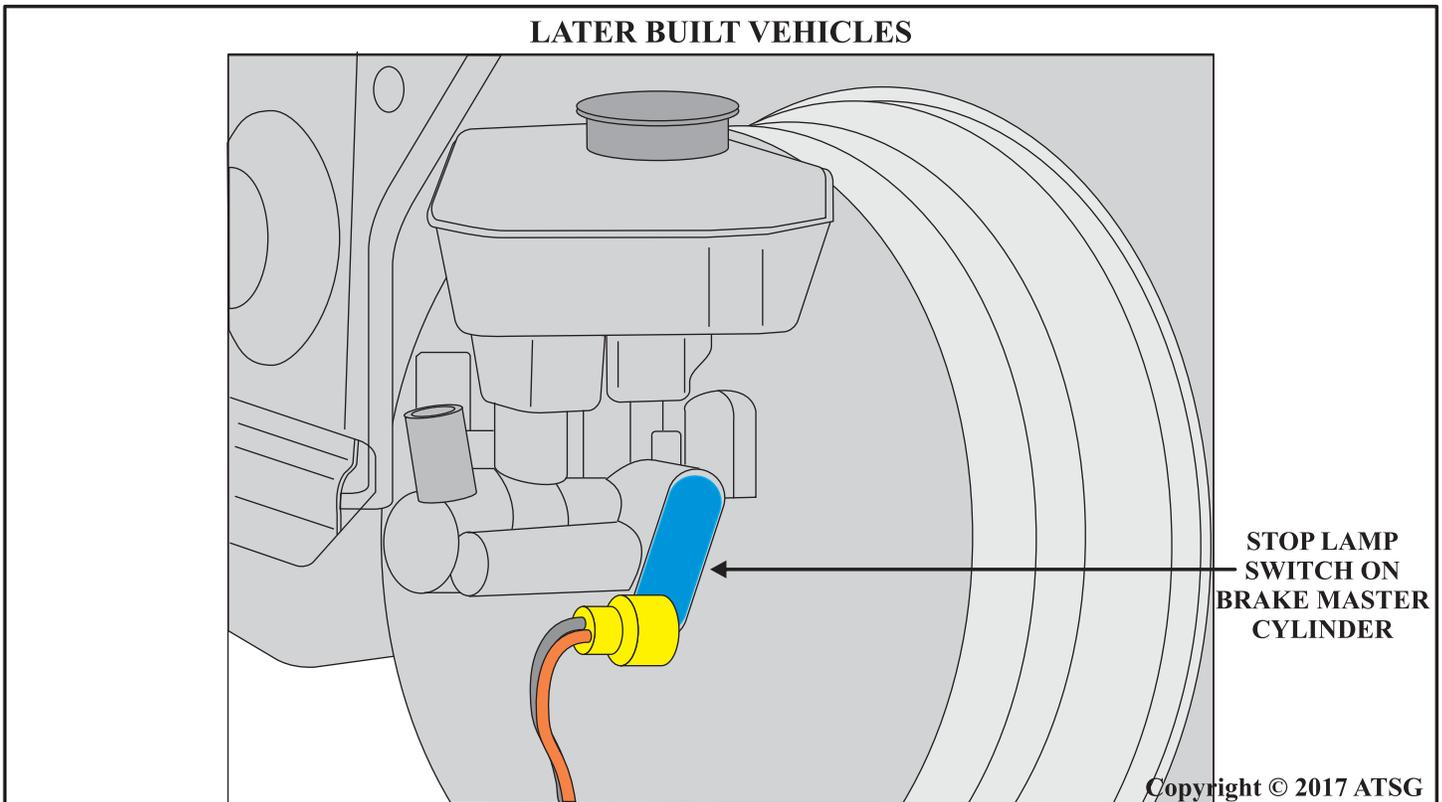
Figure 2

LATER BUILT VEHICLES

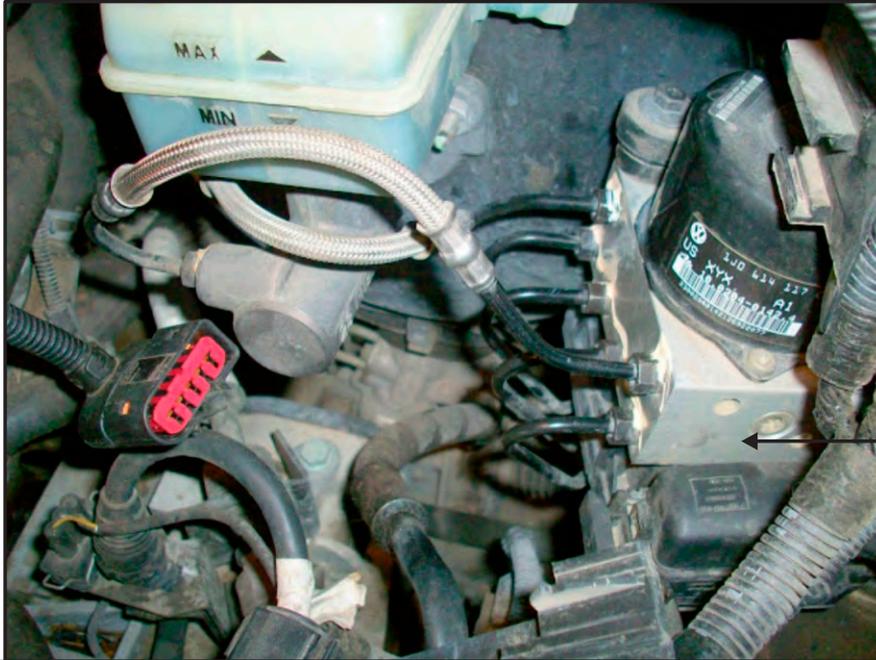
Figure 3

**STOP LAMP
SWITCH IS A
PRESSURE SWITCH
BUILT INTO THE
ABS MODULATOR
ASSEMBLY**

On Later built vehicles the ABS pump and modulator assembly will have to be replaced.

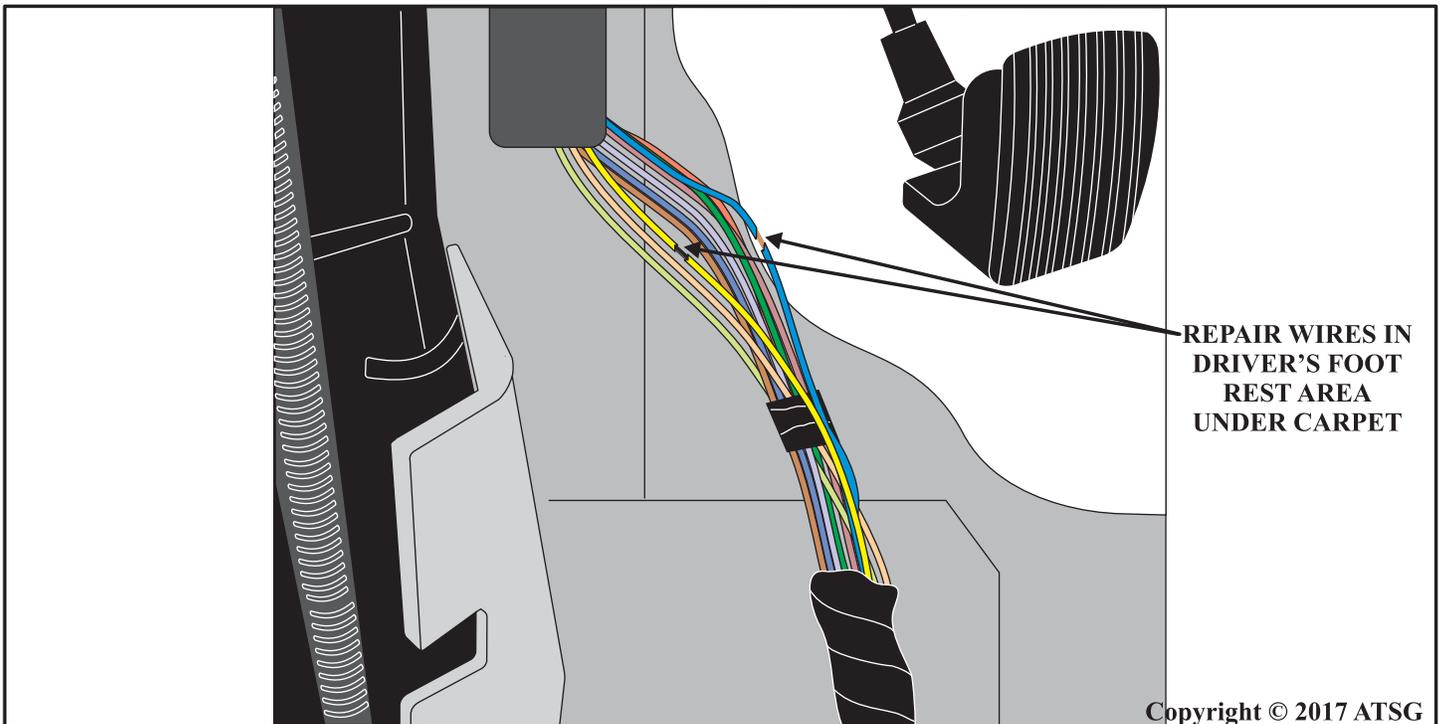
Figure 4

- (1) The Brake Light Switch is Faulty.
- (2) The wiring that supplies power to the Brake Light Switch under the driver's foot rest has been damaged.

- (2) Pull back the carpet on the driver's side and repair the wire damage that is found (figure 4). It could be crushed from the driver's heel or there could be corrosion from water intrusion.

**REPAIR WIRES IN
DRIVER'S FOOT
REST AREA
UNDER CARPET**
