## CHEVROLET AVEO HARSH ENGAGEMENTS & NO OVERDRIVE

**COMPLAINT:** A 2009 to 2011 Chevrolet Aveo may have a complaint of harsh engagements and no 3-4 shift. In addition, wherever the throttle pedal was positioned, it made no difference in shift timing. Trouble codes U0101 and U0073 were present for ‘Lost Communication With TCM’ and ‘Control Module Bus OFF’. The scan tool would communicate with the TCM for approximately 20 seconds after which communication would fail. A key cycle would return communication for the same time period. As a side note, the vehicles 12 Volt battery would drain overnight. A check of TCM power and grounds indicated no problem. Voltage checks on the GMLAN communication system proved to be within specifications.

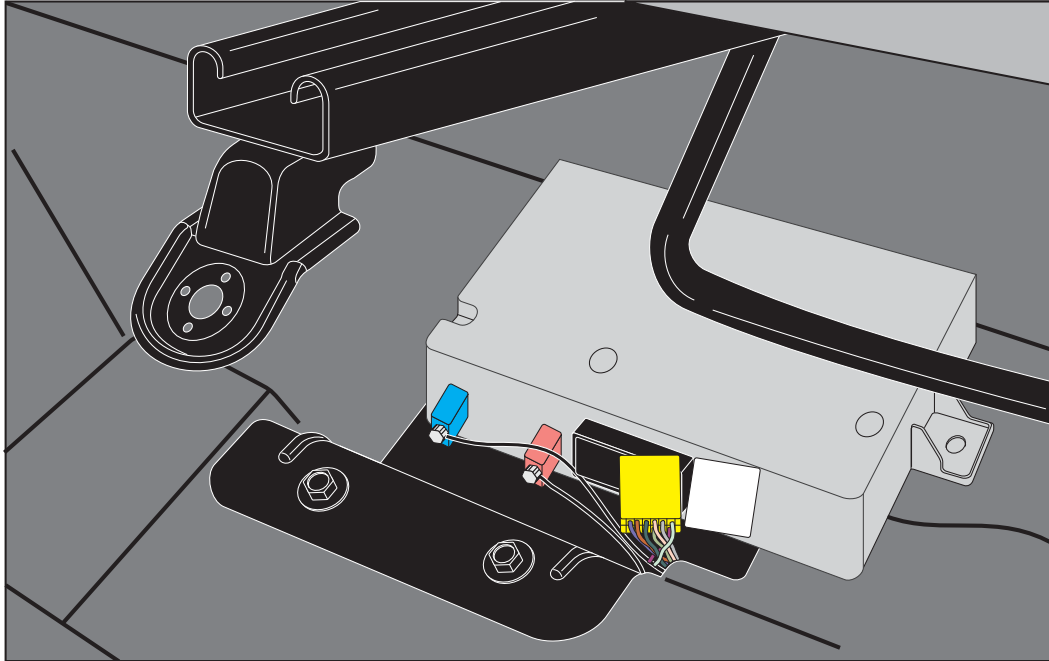
Figure 1

**CAUSE:** This vehicle was equipped with GM OnStar. After some research into this problem, it appears that vehicles that are equipped with this option are also equipped with a Vehicle Communication Interface Module (VCIM). In some instances this module has been known to cause these complaints. The VCIM is located under the passenger seat as seen in figure 1. Before the module was removed, it was checked for parasitic draw where it was found to be drawing 400ma when the vehicle was turned OFF. With the module completely disconnected, the amp draw dropped to 8ma which indicated that this module definitely had a problem.

### VEHICLE COMMUNICATION INTERFACE MODULE

UNDER PASSENGER SEAT

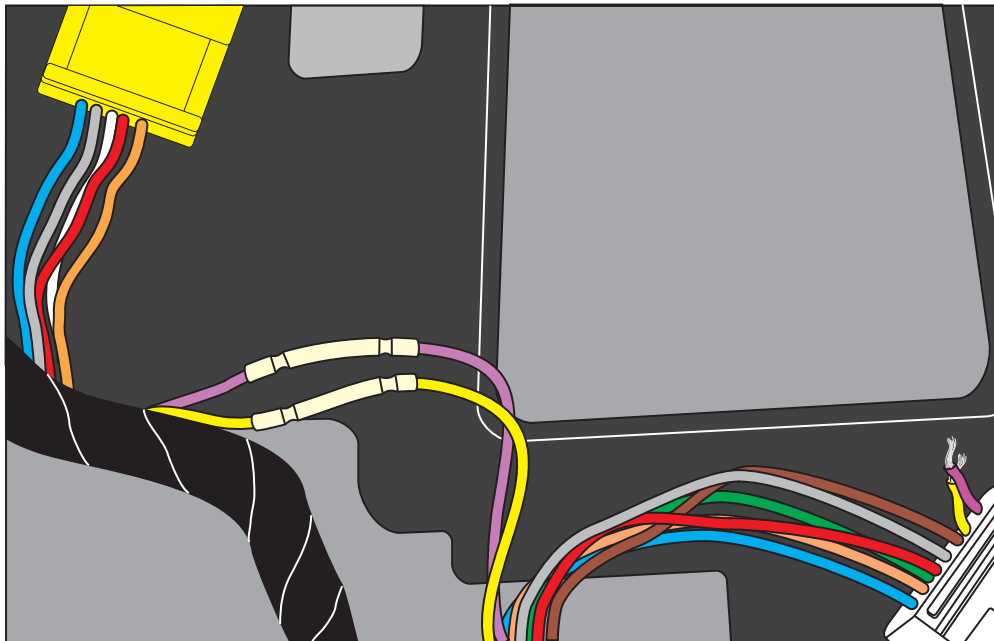
Figure 2

*The GMLAN Communication Wires Were Cut From The VCIM And Spliced Together*

**CORRECTION:** With the customers approval, the VCIM was not replaced which means the GMLAM communication wires could not be left open which would cause communication issues. The GMLAM communication wire from the VCIM were spliced together eliminating the problematic module entirely as seen in figure 2. These wires are yellow and purple at the TCM which can be seen in the wiring diagram in figure 3. These wires also are routed to the VCIM which can be seen in figure 4. The wires were separated from their respective connectors and spliced together yellow to yellow and purple to purple.

After this repair the codes were cleared, communication was restored and the shift complaints were gone. As a side note, the vehicles 12 volt battery no longer went dead overnight.
