Technical Service Information

FORD 5R110W

NO MOVEMENT

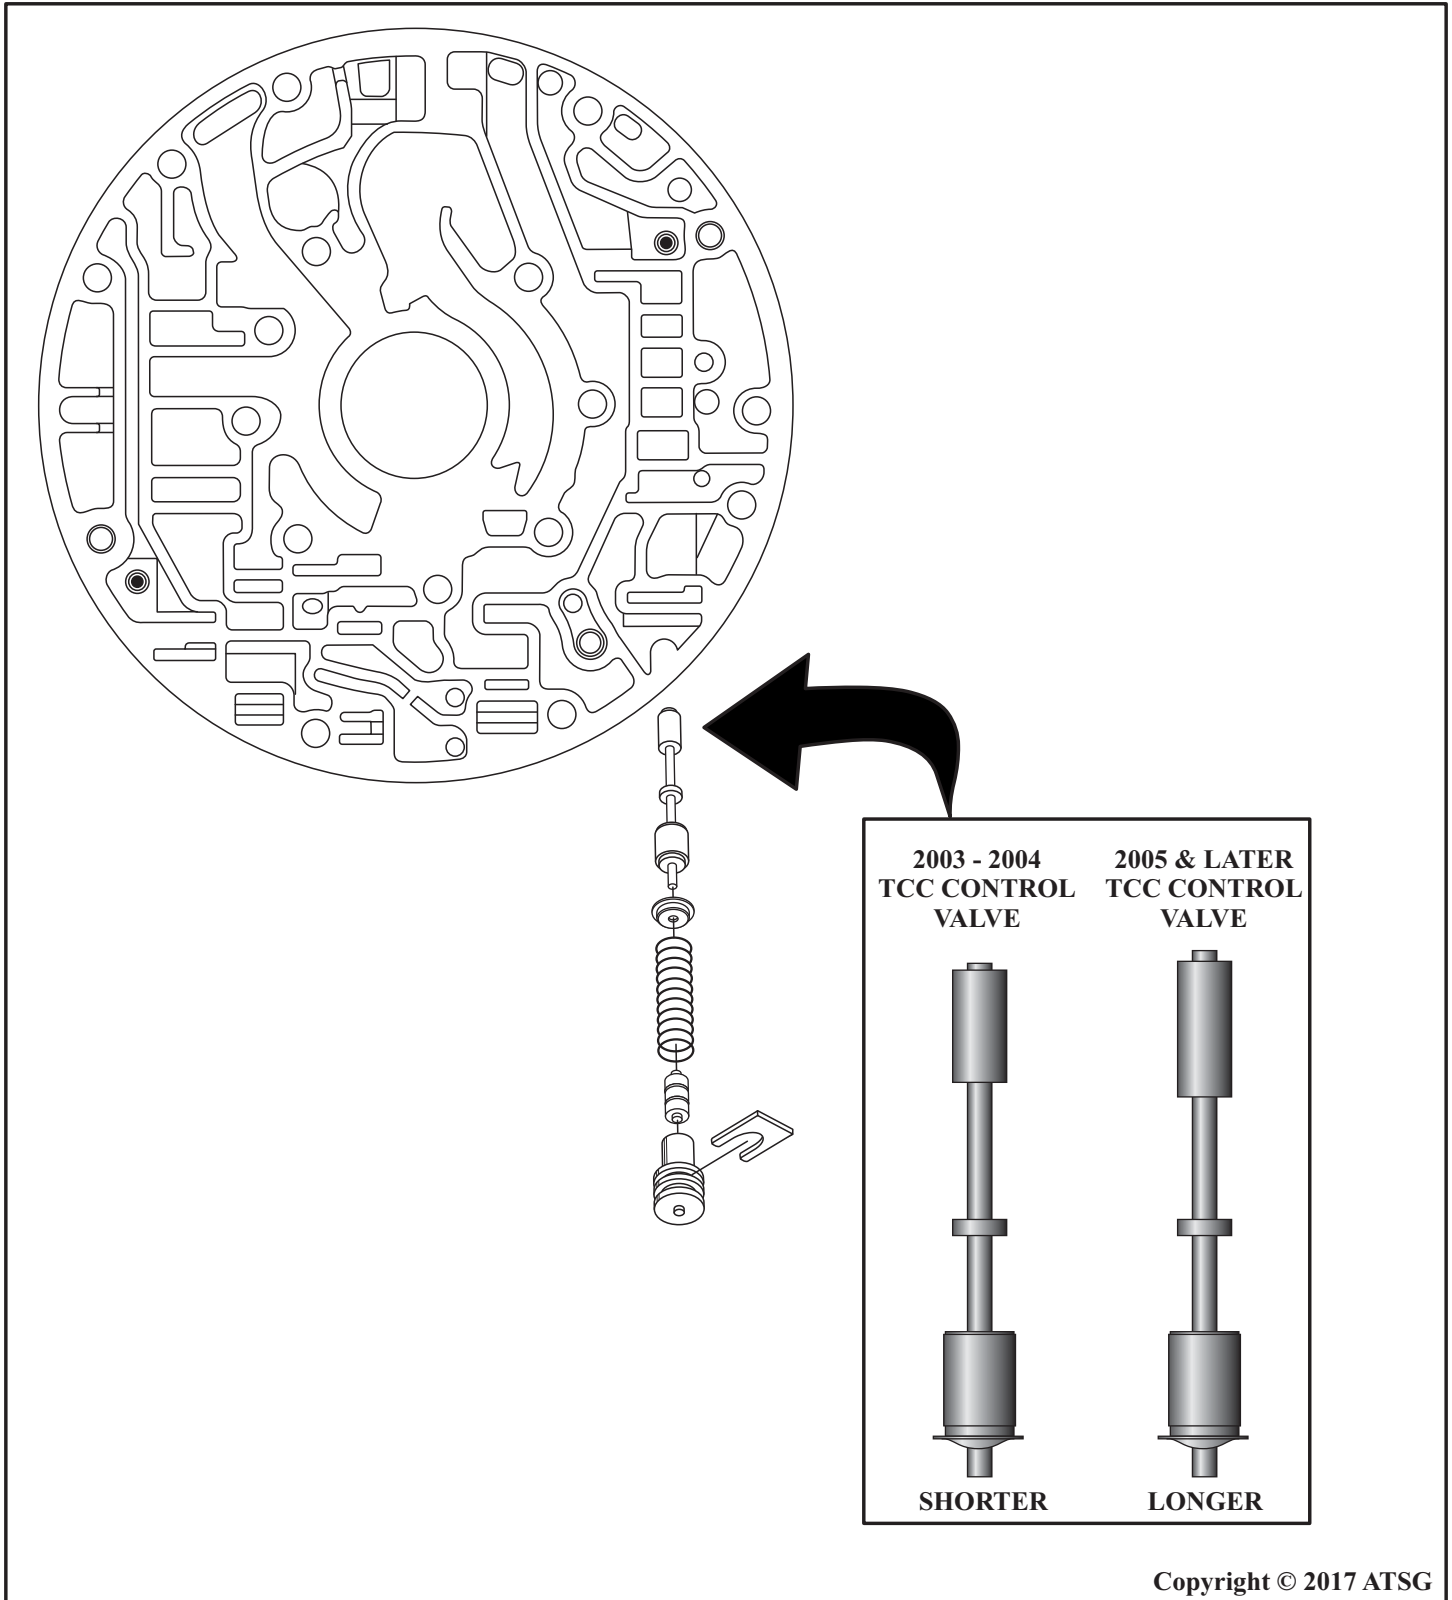
Figure 1

COMPLAINT: (1) After overhaul the vehicle has no movement. Transmission removal reveals that the torque converter has not been filled with fluid.

(2) After overhaul the transmission exhibits a sluggishness or engine stall.

CAUSE: A 2005 or Later longer Converter Clutch Control Valve installed into a 2003 - 2004 pump cover can cause the above two possible complaints (see figure 1).

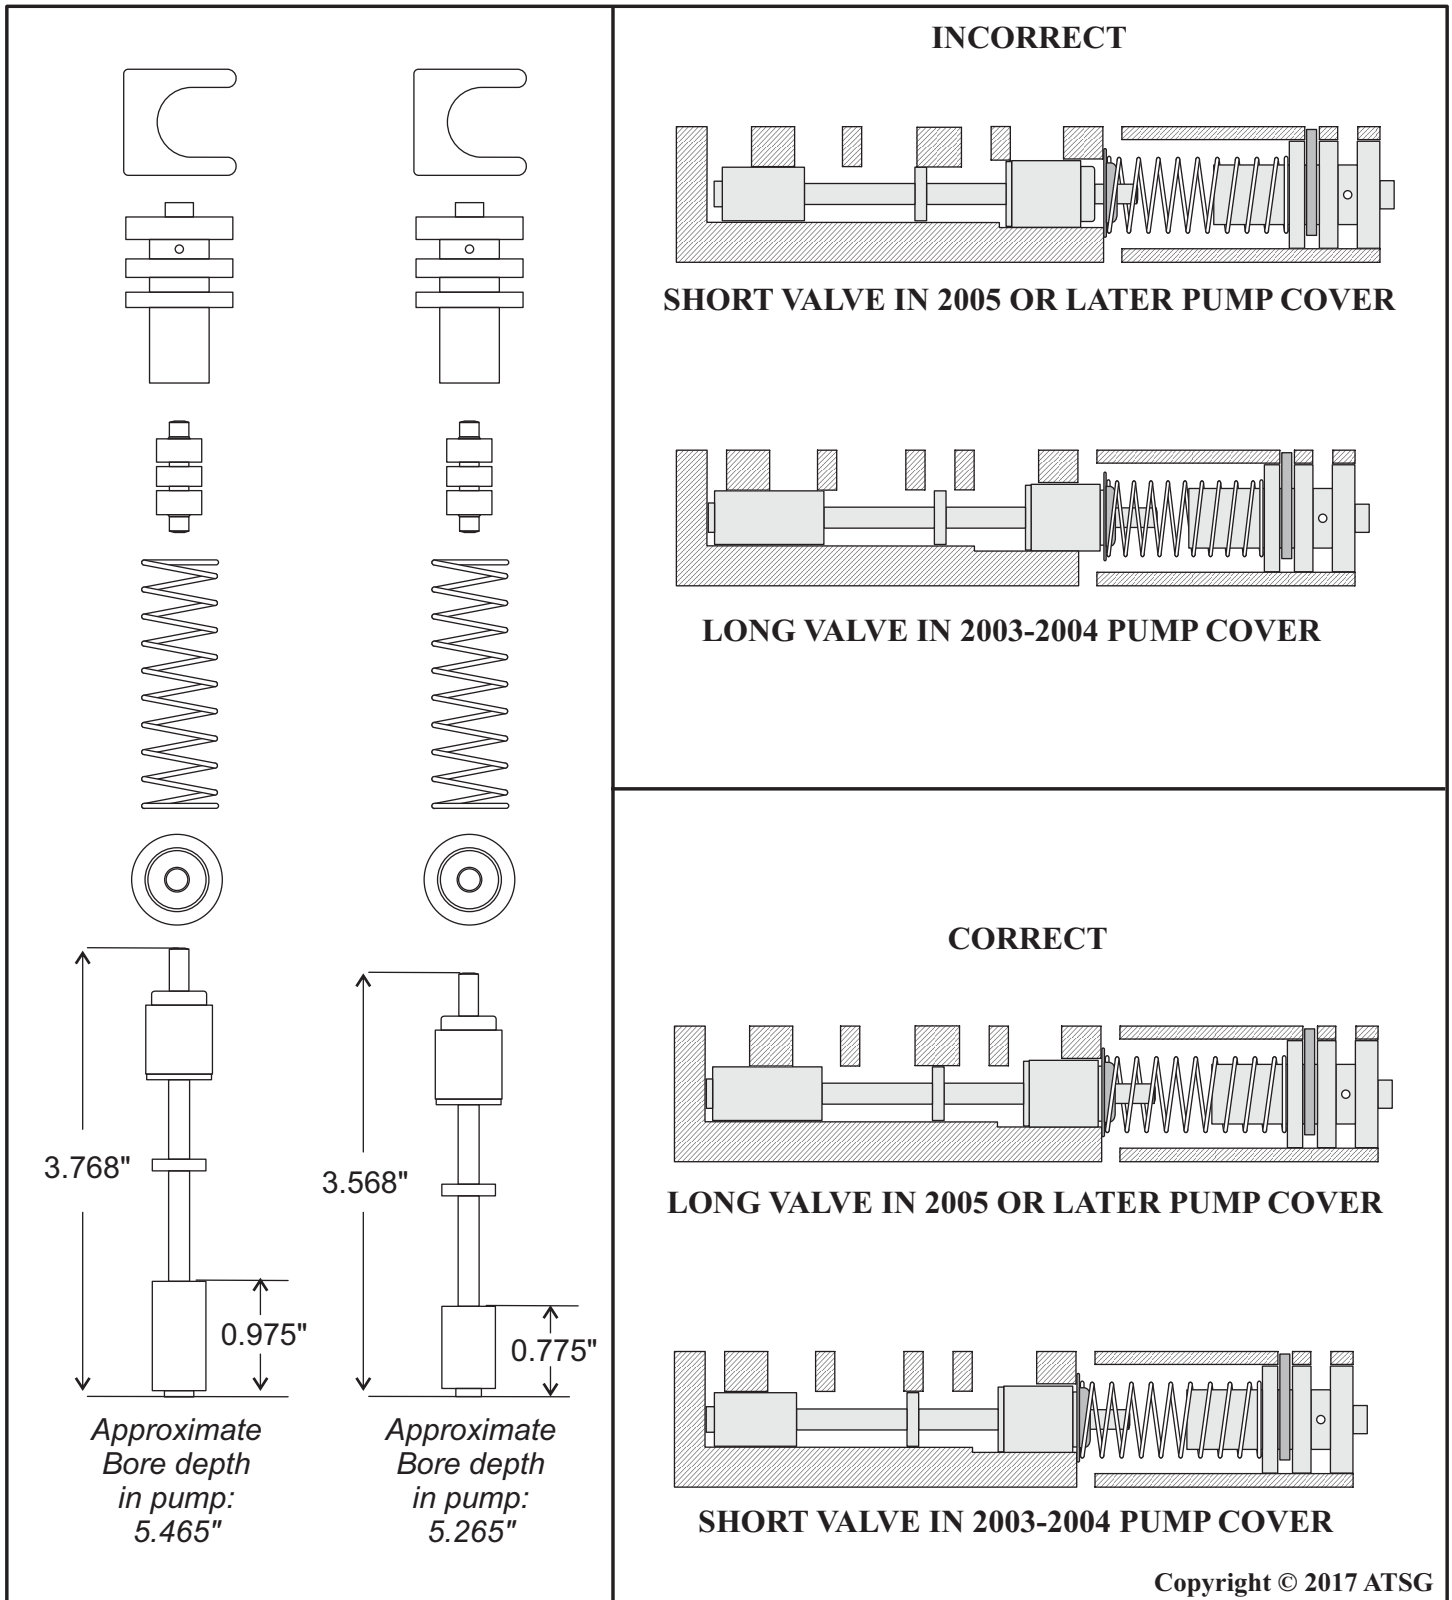
Figure 2

SUMMARY: There are two different length converter clutch control valves for the 5R110W.

2003-2004 transmissions have a valve that has an overall length of 3.568" and has a valve bore depth of 5.265".

2005 and Later has a converter clutch control valve that has an overall length of 3.768" and has a valve bore depth of 5.465" (figure 2).

It is the valve spool opposite the spring that makes the difference, the 2003-2004 valve spool has a length of .775" while the 2005 and Later has a valve spool length of .975" (figure 2).

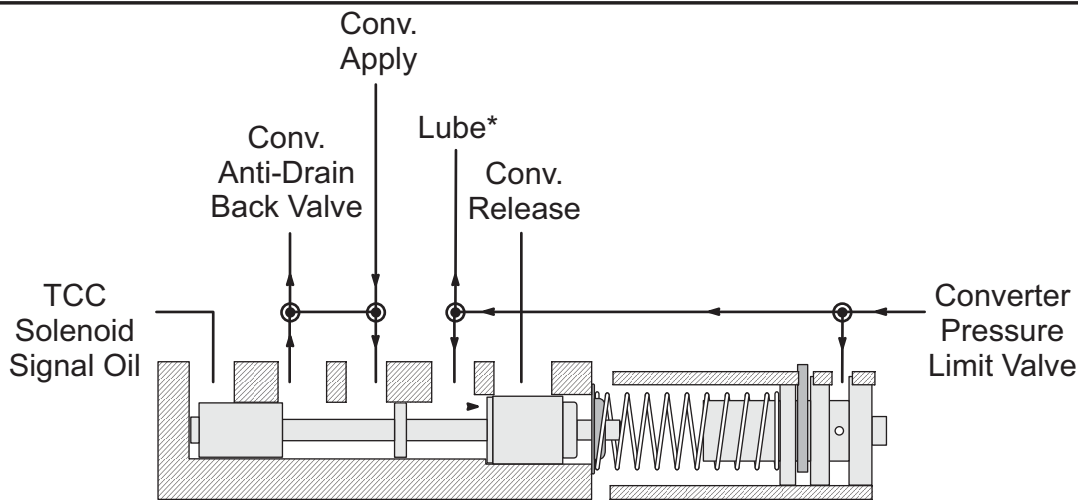
2005 Pump with the 2003-2004 Converter Clutch Control Valve

The shorter valve in the longer bore allows the valve to float between the spring retainer and the bottom of the bore (figure 3). THIS WILL CAUSE NO MALFUNCTION!

The shorter valve in the longer bore allows the valve to float between the spring retainer and the bottom of the bore. When the engine shuts off, the valve will drop to the bottom of the bore. When the engine is restarted, converter supply oil will lift the valve against the spring seat while charging the converter clutch release oil circuit.

THIS WILL CAUSE NO MALFUNCTION!

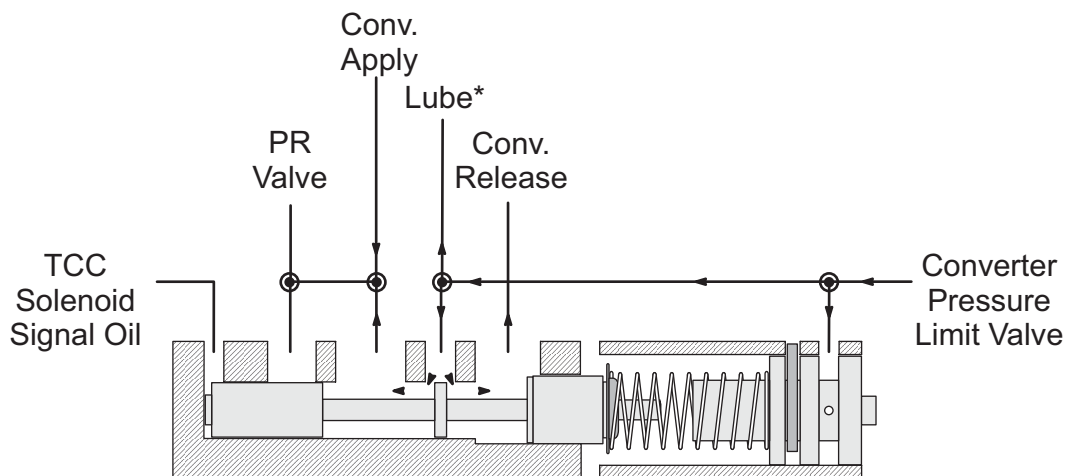
2003-2004 Pump with the 2005 Converter Clutch Control Valve

The longer valve in the shorter bore would result in no converter fill causing no engagements and consequently no movement. The converter may also become slightly air bound causing a sluggish feel and could possibly allow the converter clutch to stall the engine.

The longer valve in the shorter bore will have the #3 land open to converter apply oil circuit but is not quite closed at the converter release oil circuit. TC oil is being applied to both oil circuits at the same time. This causes the converter to become air bound which prevents converter clutch application, however, if the air were able to escape then converter clutch would apply and kill the engine.

Initially the symptoms caused by this TCC Valve mixup would be no engagement and no movement due to no converter charge.
