# Technical Service Information

## HONDA ODYSSEY LOSS OF SOLENOID POWER

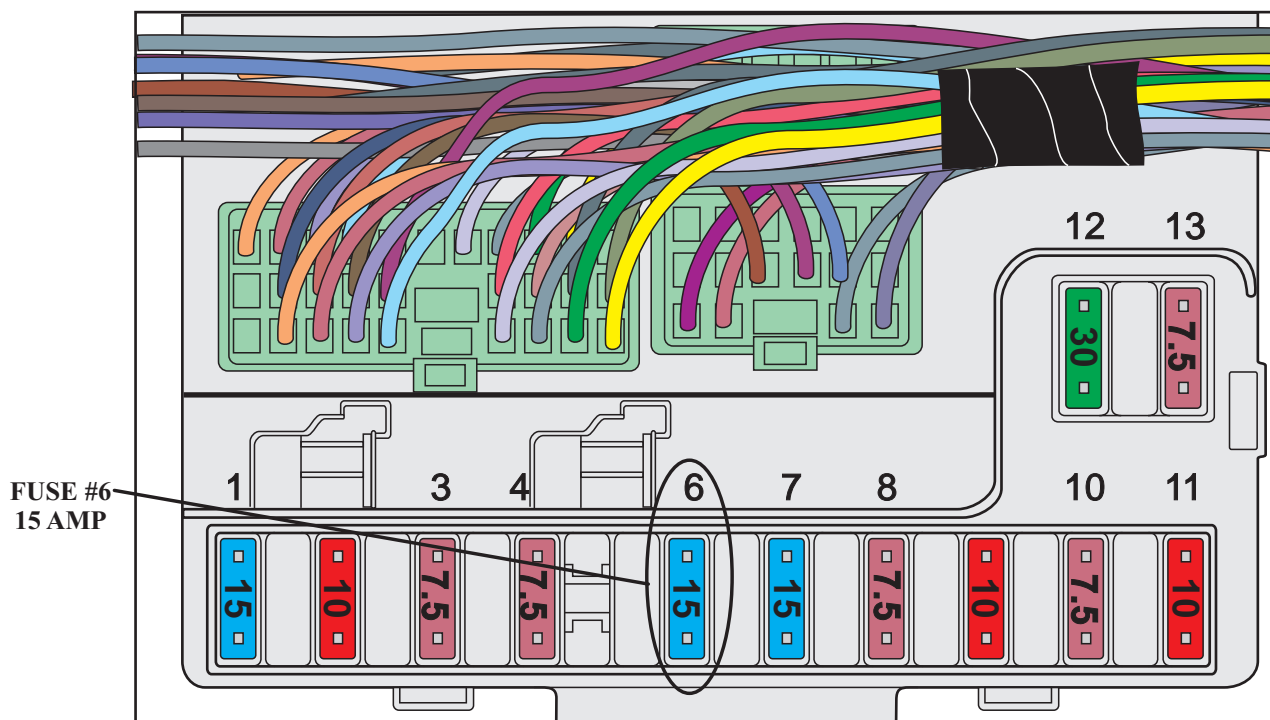
Figure 1

**CAUSE:** Instead of replacing the PCM which would seem to be the likely suspect, the technician consulted a wiring diagram and noticed that solenoid power came from a fused circuit to the PCM and then out of the PCM to the solenoid. The wiring diagram indicated the #6 fuse in the under-dash driver side fuse box is the solenoid power supply and this fuse was blown. After replacing the #6 fuse, it didn't take very long for it to blow again.

There are some fuse numbers molded into the fuse box housing. The # 6 fuse can be seen in figure 1 which is the 15 amp fuse that is blowing. Looking at the inside fuse box cover, it should identify this fuse as: "ECU/Cruise Control". This power supply wire is located at PCM in connector D5 for 1999 to 2000 models and in connector B24 for 2001 models (figure 2). The PCM location can be seen in figure 3.

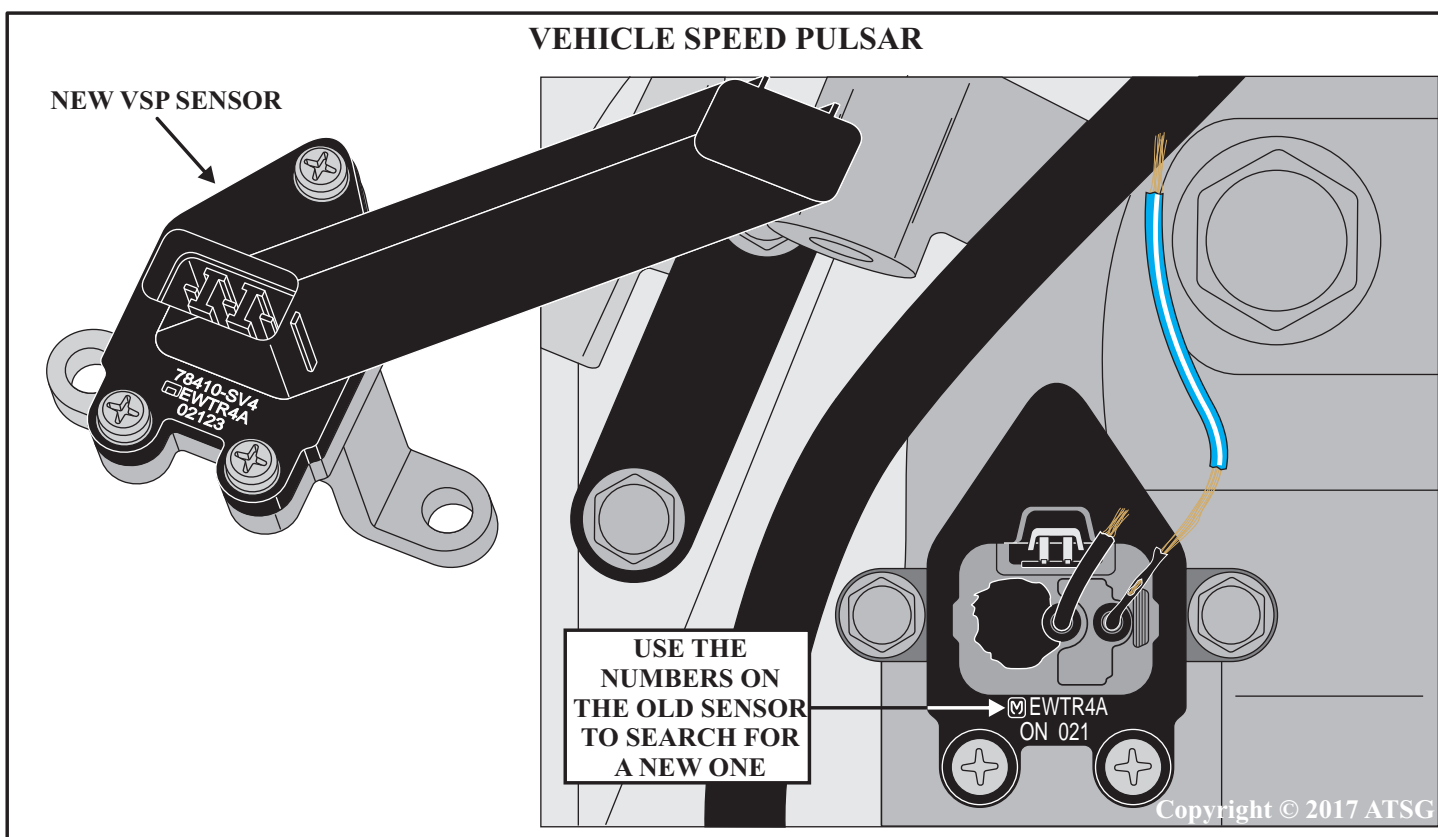
Figure 4

The component that caused the #6 Fuse to blow was the Vehicle Speed Pulsar (VSP) Sensor. This sensor is located where a VSS would normally be in these vehicles. This type of sensor is used ONLY if the vehicle has the optional navigation system. The sensor and it's wiring have shorted which caused the #6 fuse to blow. Use the numbers from the old VSP Sensor to search for a new one as shown in figure 4.

**CORRECTION:** Replace the VSP Sensor and repair it's wiring which should allow the related trouble codes to be erased and restore solenoid power to the PCM.

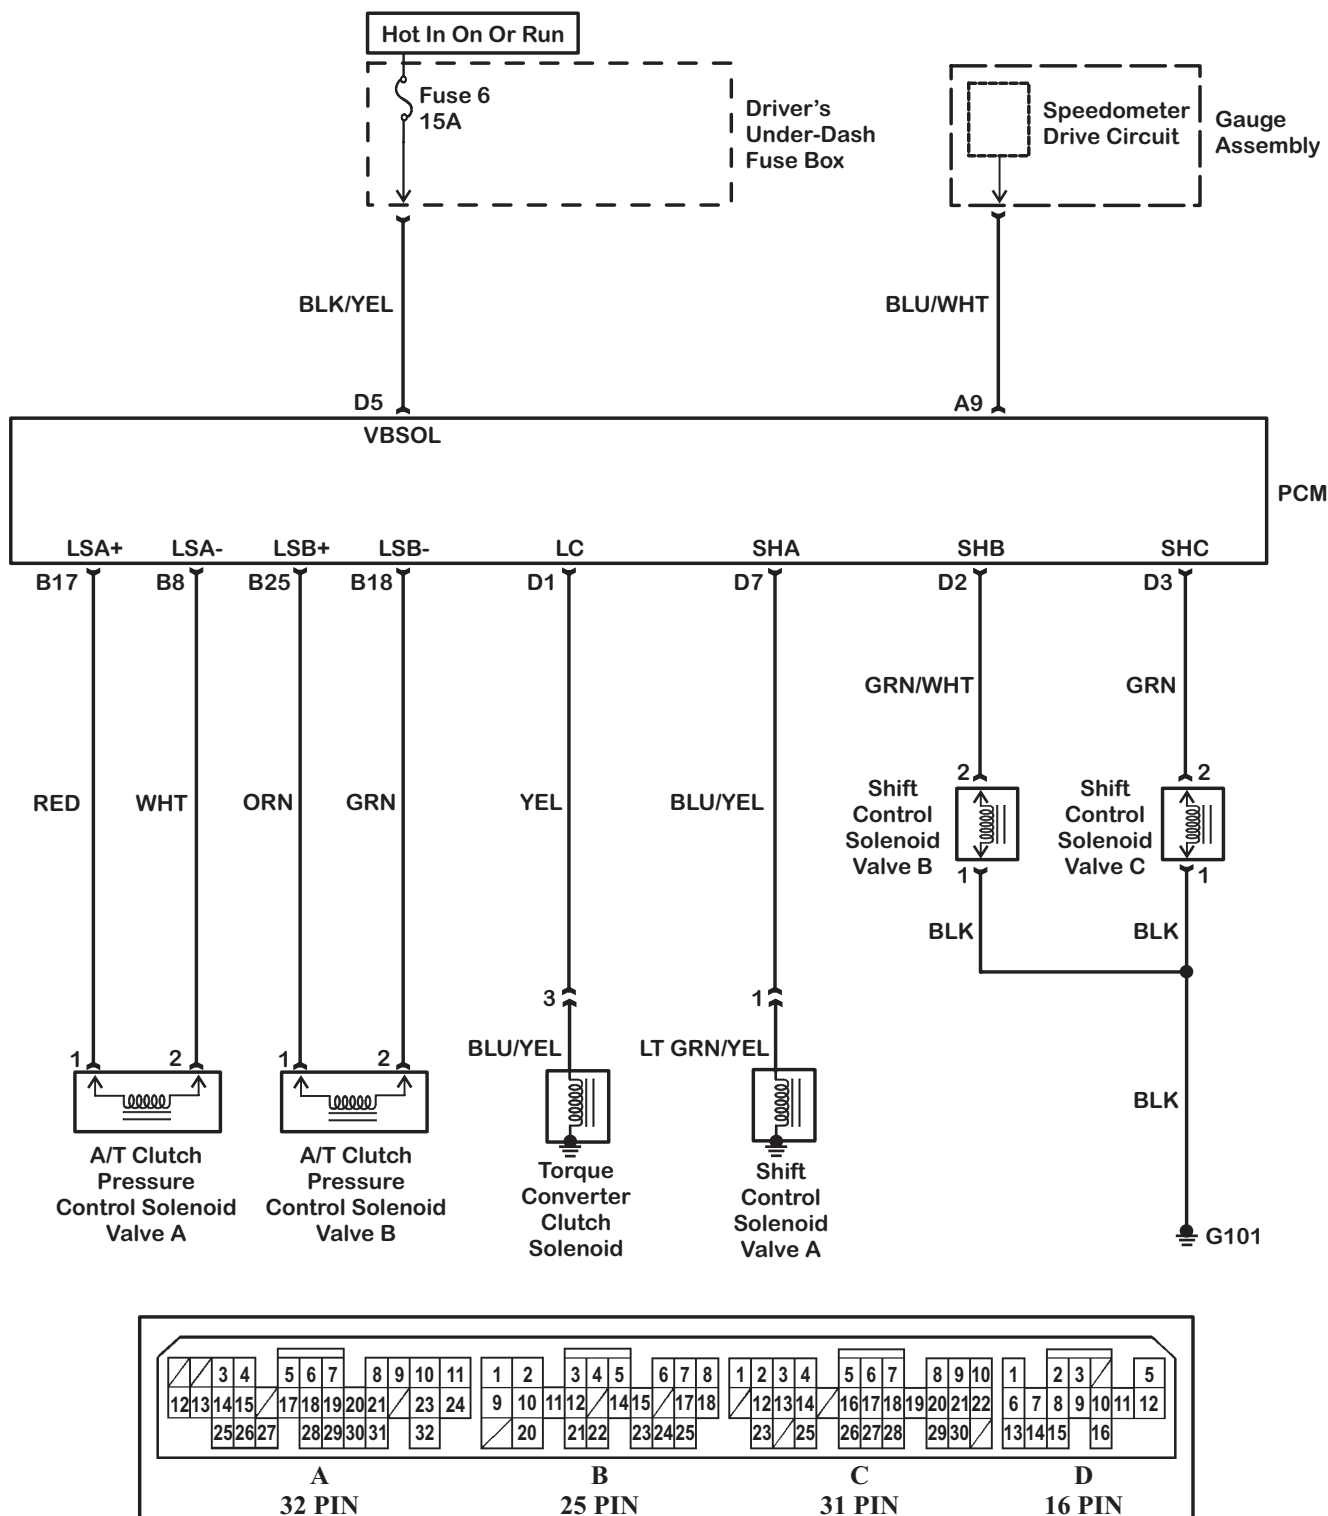
Figure 5

The wiring diagram and PCM connector terminal identification for the 1999 to 2000 models can be seen in figure 5.

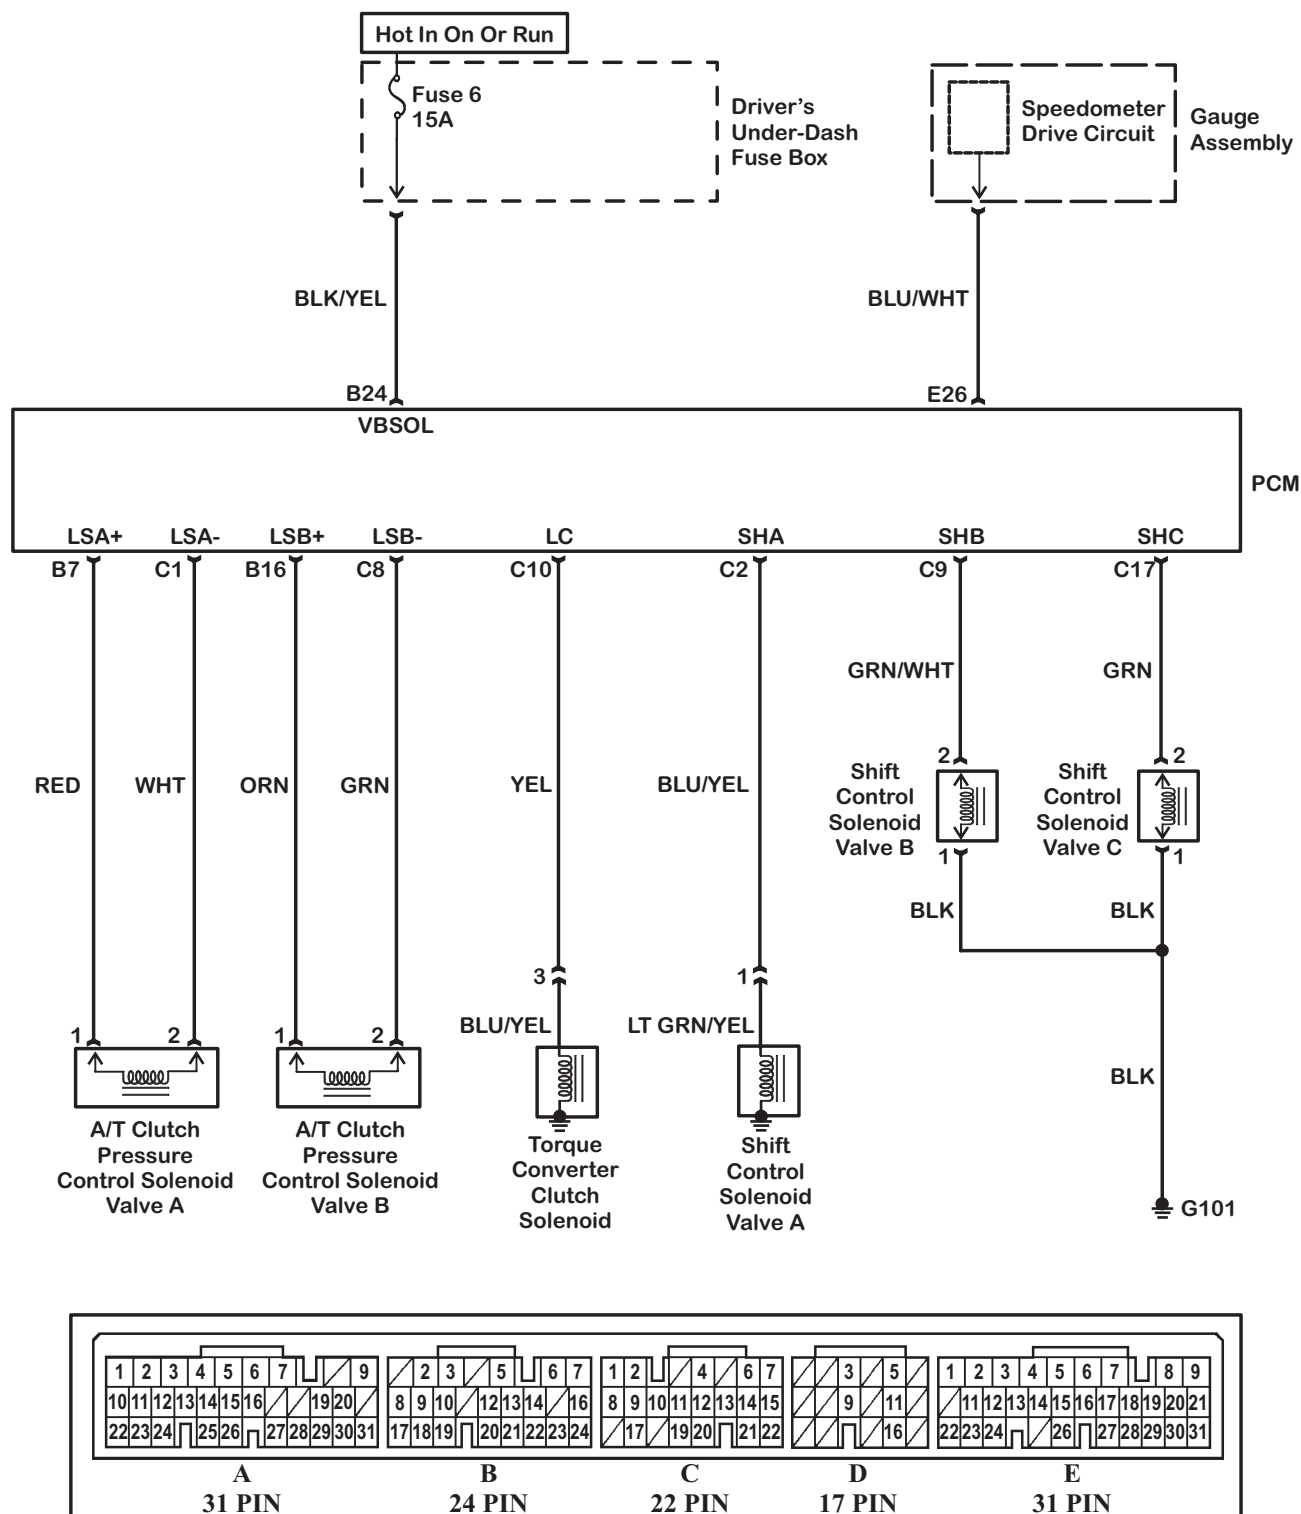
Figure 6

The wiring diagram and PCM connector terminal identification for the 2001 model can be seen in figure 6.

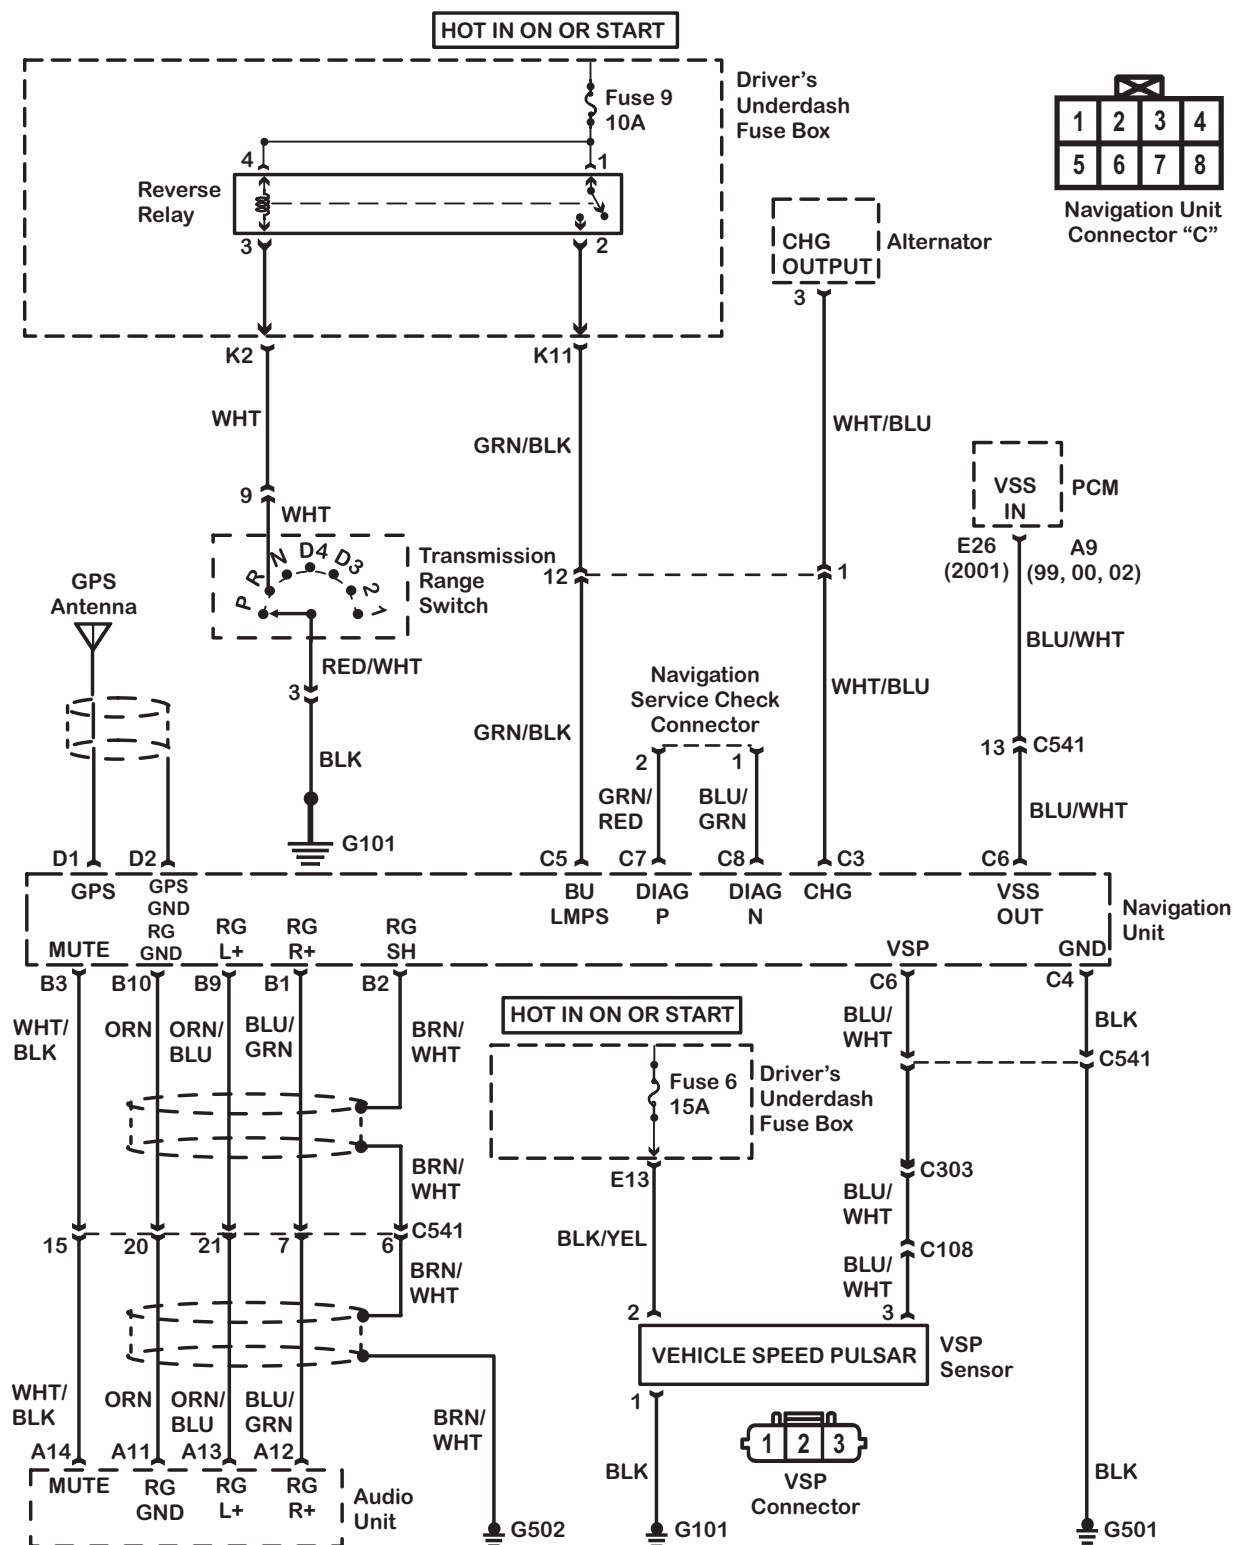
Figure 7

The wiring diagram for the 1999 to 2001 model navigation system showing the vehicle speed pulsar can be seen in figure 7. Notice that the VSP Sensor is providing the vehicle speed signal for the PCM to distribute where needed.
