Technical Service Information

FORD 6R80 OUTPUT SPEED SENSOR FAILURE

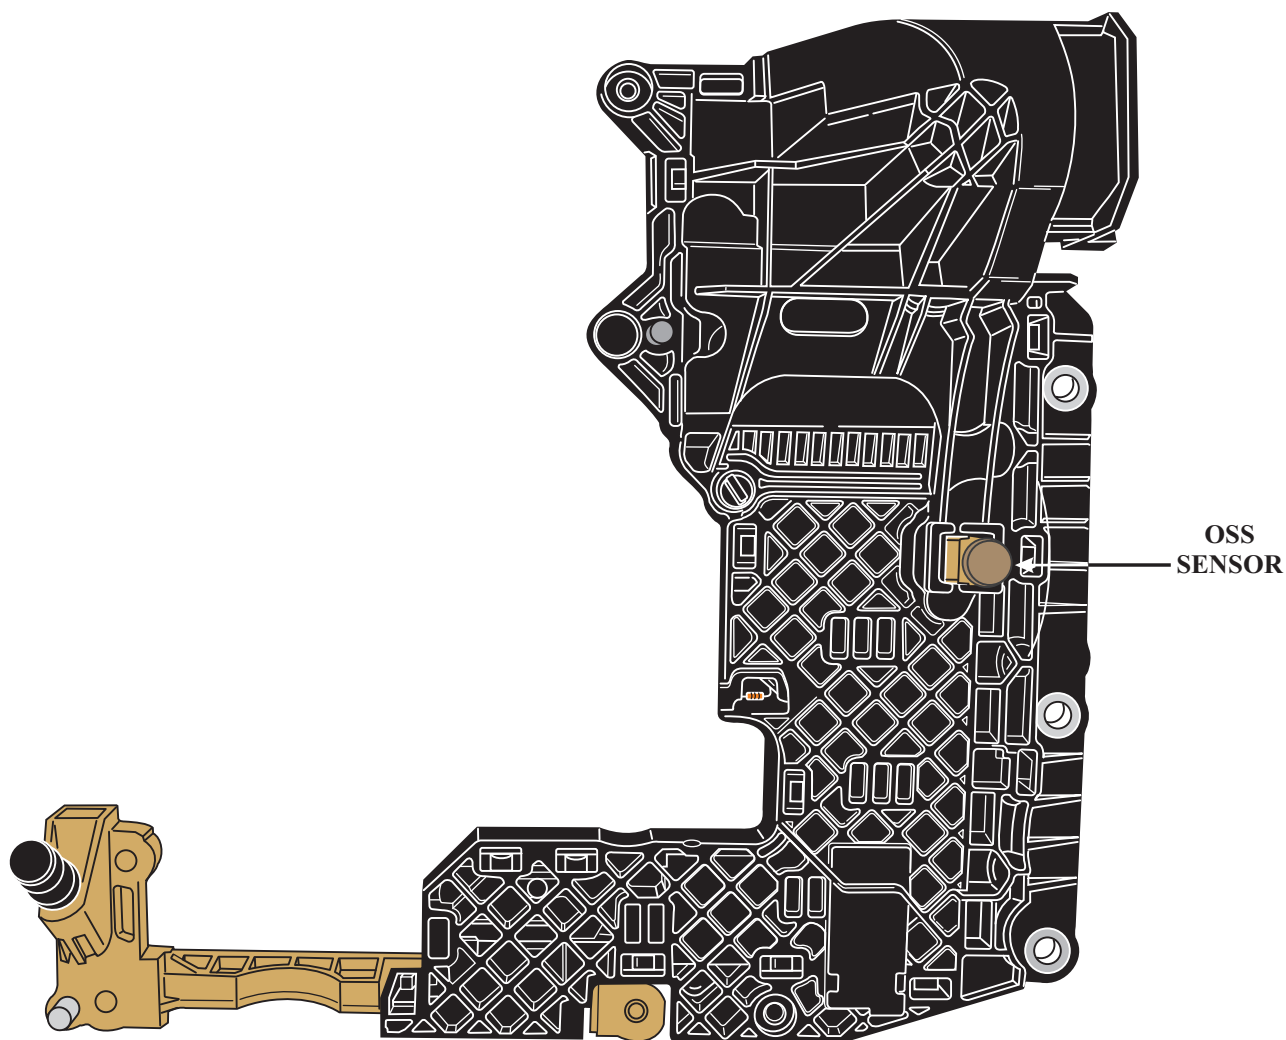
Figure 1

CAUSE: A defect in the molded wire frame assembly (figure 1).

MOLDED WIRE FRAME

CORRECTION: This molded wire frame assembly replacement is covered under a Ford customer satisfaction program **16N02**.
