# Technical Service Information

## FORD 6R80

### ONE-WAY CLUTCH BIAS SPRING

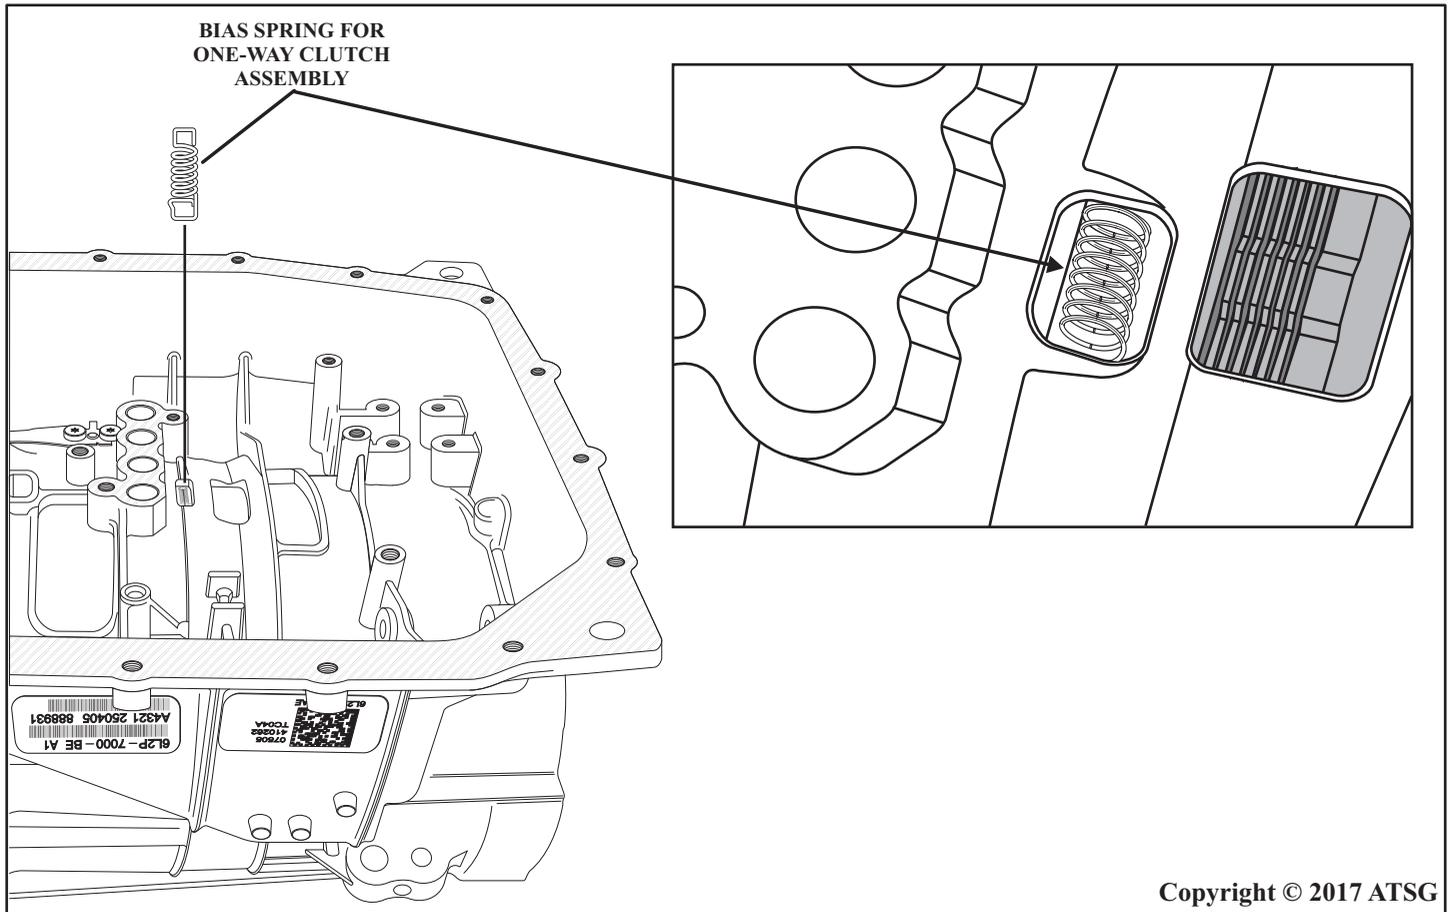
Figure 1

**COMPLAINT:** When the transmission pan is removed from a 6R80, the technician notices an odd looking spring laying in the bottom of the pan. No one seems to know where this spring came from or where it goes (figure 1).

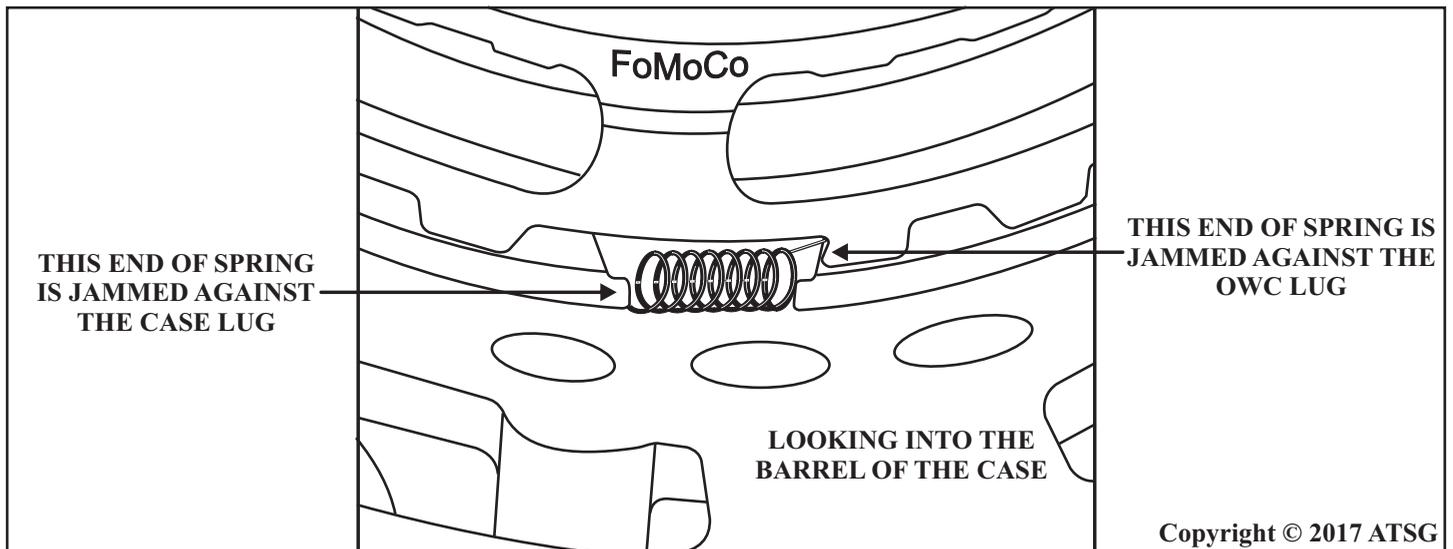
Figure 2

**CAUSE:** When the 6R80 was updated during the 2010 model year, a one-way diode style clutch was installed. The Bias Spring goes between a lug of the one-way clutch and the transmission case (figure 2). This puts tension on the diode assembly to keep it from “clunking” during transmission operation.

**CORRECTION:** Install the bias spring as shown in figure 2 on all 6R80 transmission that are equipped with a one-way clutch.
