# Technical Service Information

## **DODGE RAM 2500 4x4 ERRATIC TRANSFER CASE OPERATION**

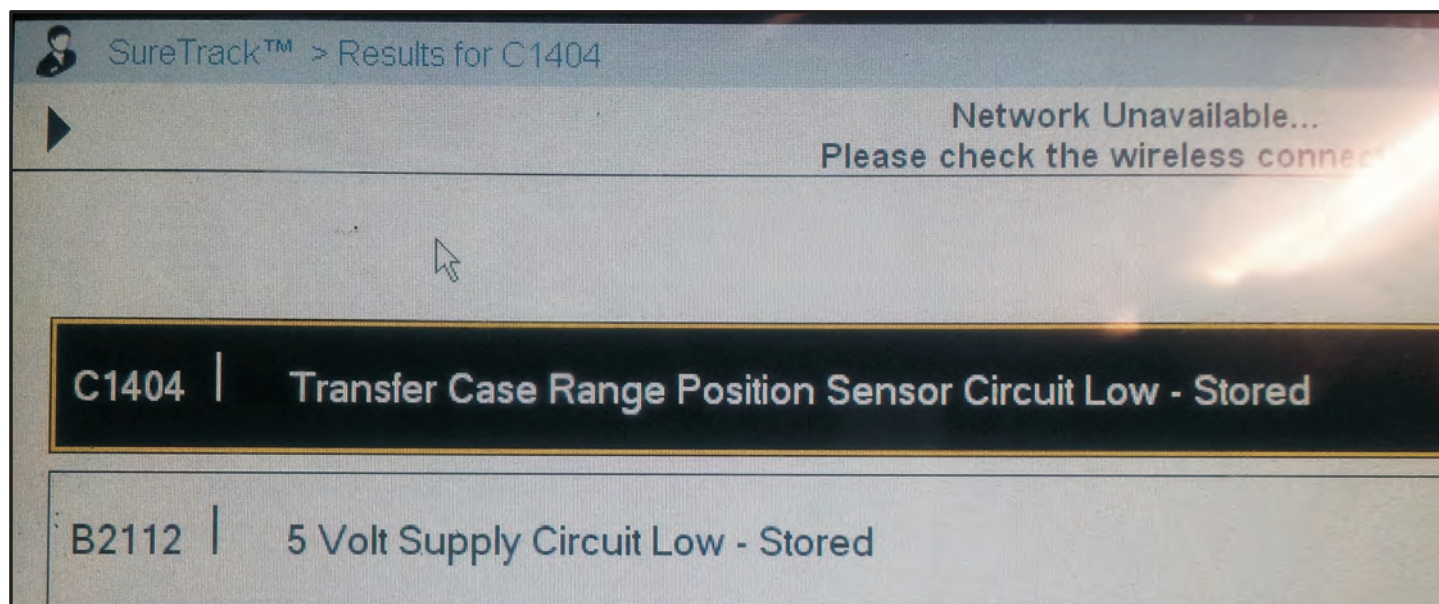
Figure 1

The Transfer Case Control Module (TCCM) functionality now resides in the Totally Integrated Power Module (TIPM). The TIPM controls the 4X4 transfer case shift functions via the actuation of a shift motor and utilizing the feedback of a mode sensor assembly. Communication is via the CAN bus. Inputs include user selectable 4X4 modes that include 2WD, AWD, 4HI, 4LO, and Neutral (selections vary with the specific transfer case). For this reason, TF case codes will be found in the TIPM and you may also find codes in the Cluster Module. The codes that were pulled was C1404 which is a TF case range position 5 volt supply wire sensor circuit low and B2112 which is also a 5 volt supply circuit low code (figure 1).

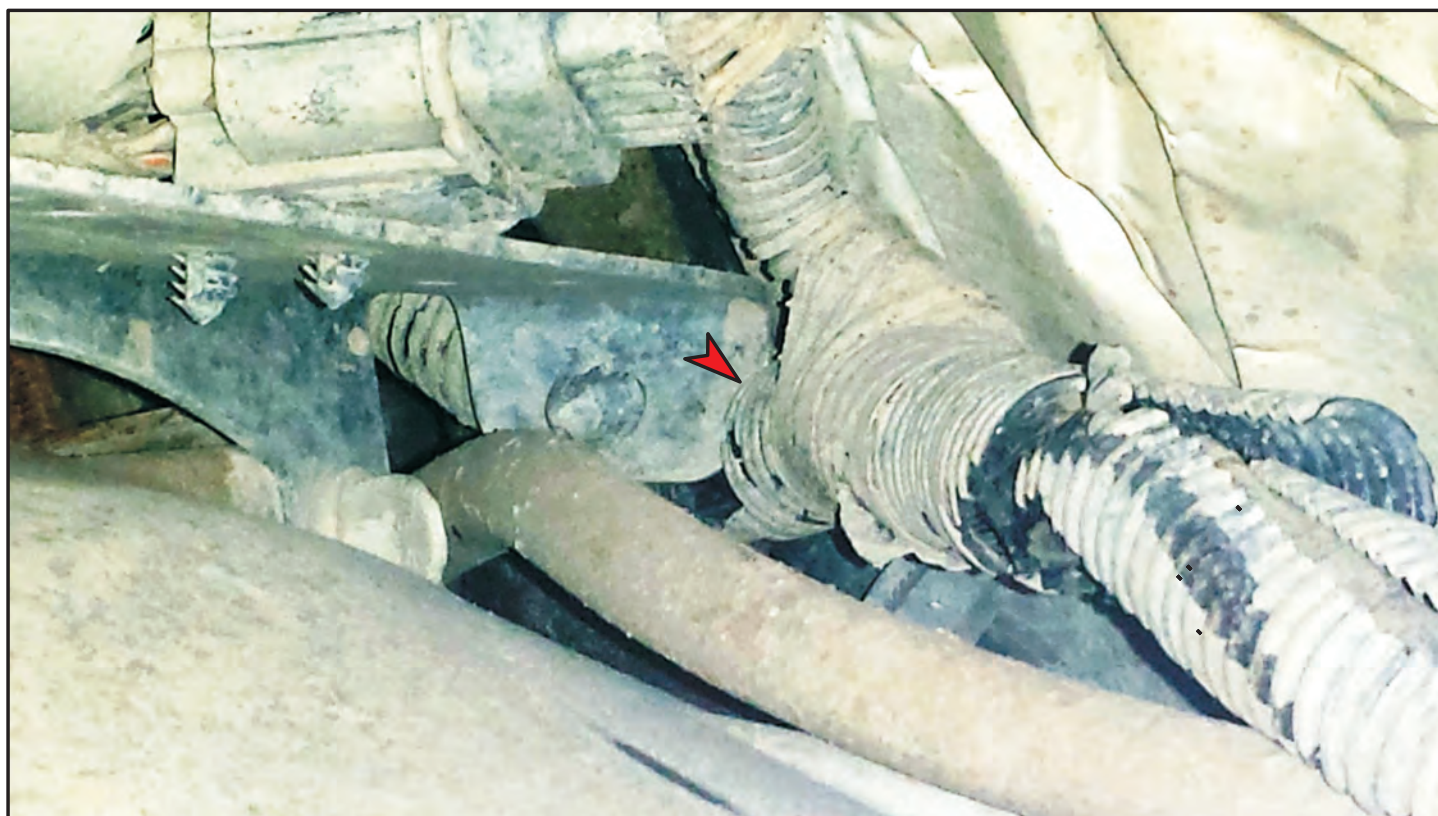
Figure 2

**CAUSE:** Once it was determined that this vehicle did not have a TCCM, wiring diagrams were pulled for the TIPM. This revealed a yellow with an orange tracer colored wire as being the 5 volt supply wire going to the TF case range position sensor from terminal 9 in the TIPM's C4 connector. When this wire was traced, it was discovered that it went through a loom down to the transmission. When this loom was viewed from underneath, a harness bracket was seen which was bolted down by a right side converter housing bolt (figure 2). A careful inspection in this area found that this bracket had dug itself into the wire loom piercing through a yellow wire with an orange tracer shorting it to ground (figure 3).
