MAZDA 6 - AW6A-EL

STUCK IN HIGH GEAR FAILSAFE

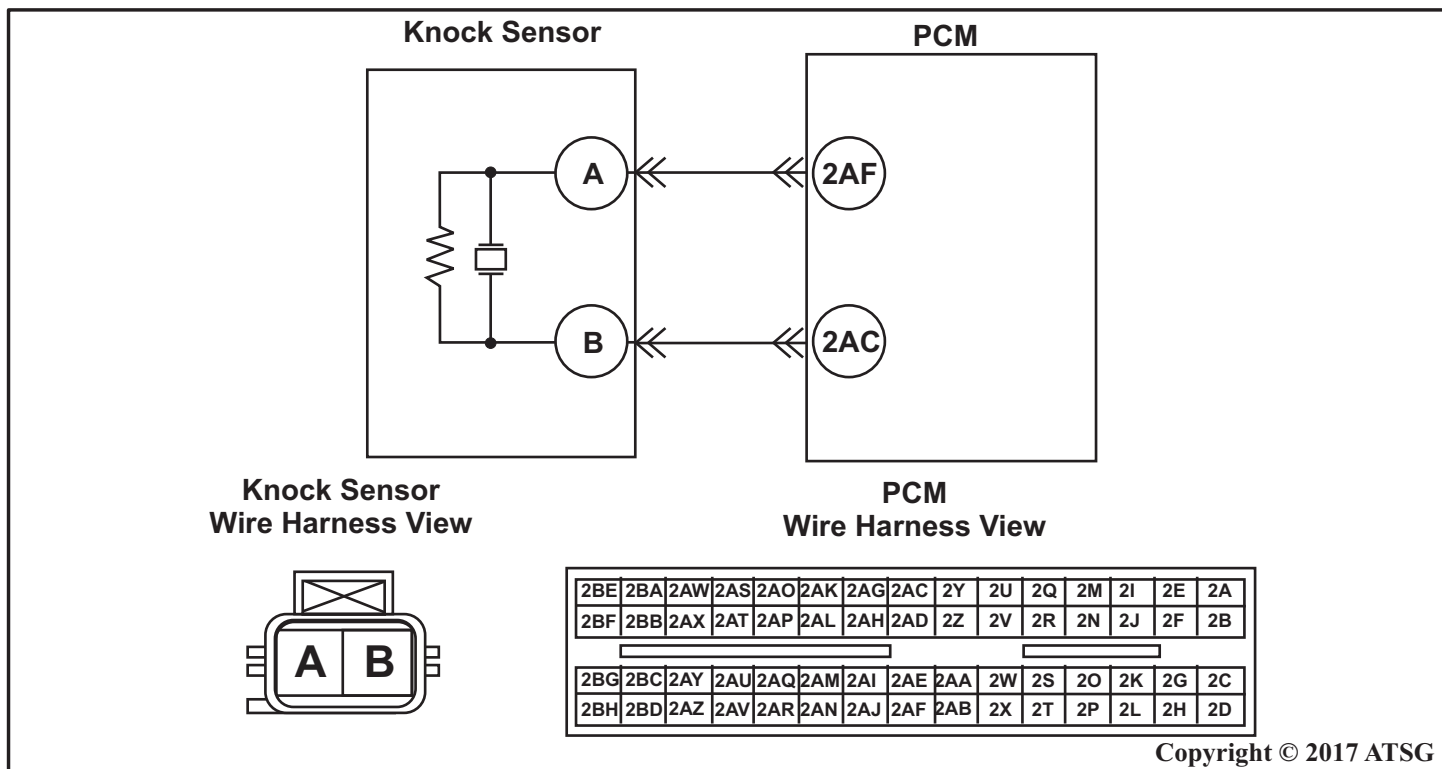
Figure 1

CAUSE: Typically, when a knock sensor indicates a problem, the PCM will retard the spark timing to avoid pre-detonation. In this case, engineers decided to write a program to failsafe the transmission should it think there is a hard failure with the wiring or the sensor itself.

CORRECTION: This two wire sensor is being monitored by the PCM. Should it see voltage go above 4.79 volts, the PCM considers this a hard circuit malfunction. Failure could be related to the sensor itself or related wiring from the connector to the PCM. When the car is raised on the lift, this sensor is located on the engine block below the rear cylinder head area. Inspect the condition of the knock sensor, connector and wiring and correct or replace where necessary.
