Technical Service Information

CHEVROLET COBALT TCC CYCLING

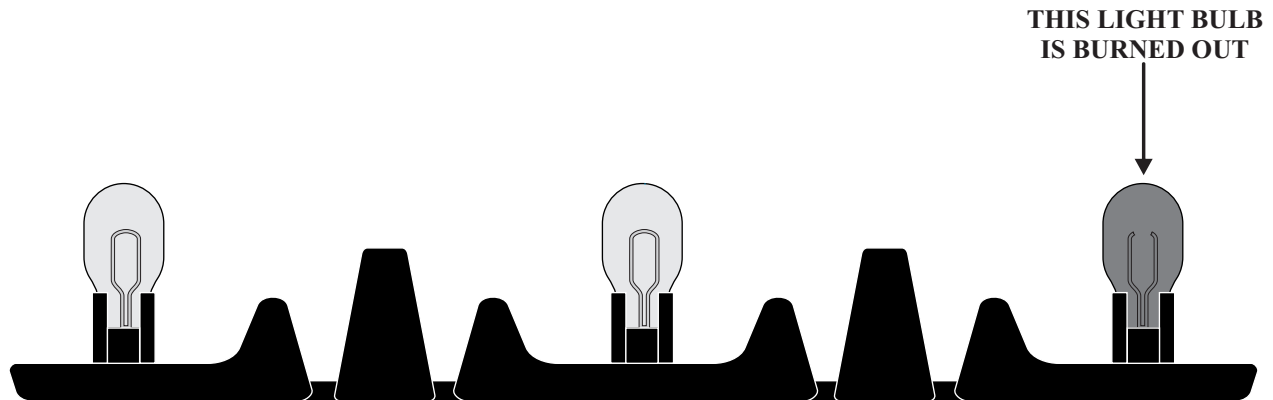
Figure 1

CAUSE: The Center High Mount Rear Stop Light (CH/MSL) assembly had a burned out light bulb, refer to figure 1.

CENTER HIGH MOUNT STOP LIGHT ASSEMBLY

CORRECTION: When the light bulb was replaced all complaints vanished and the vehicle performed normally.

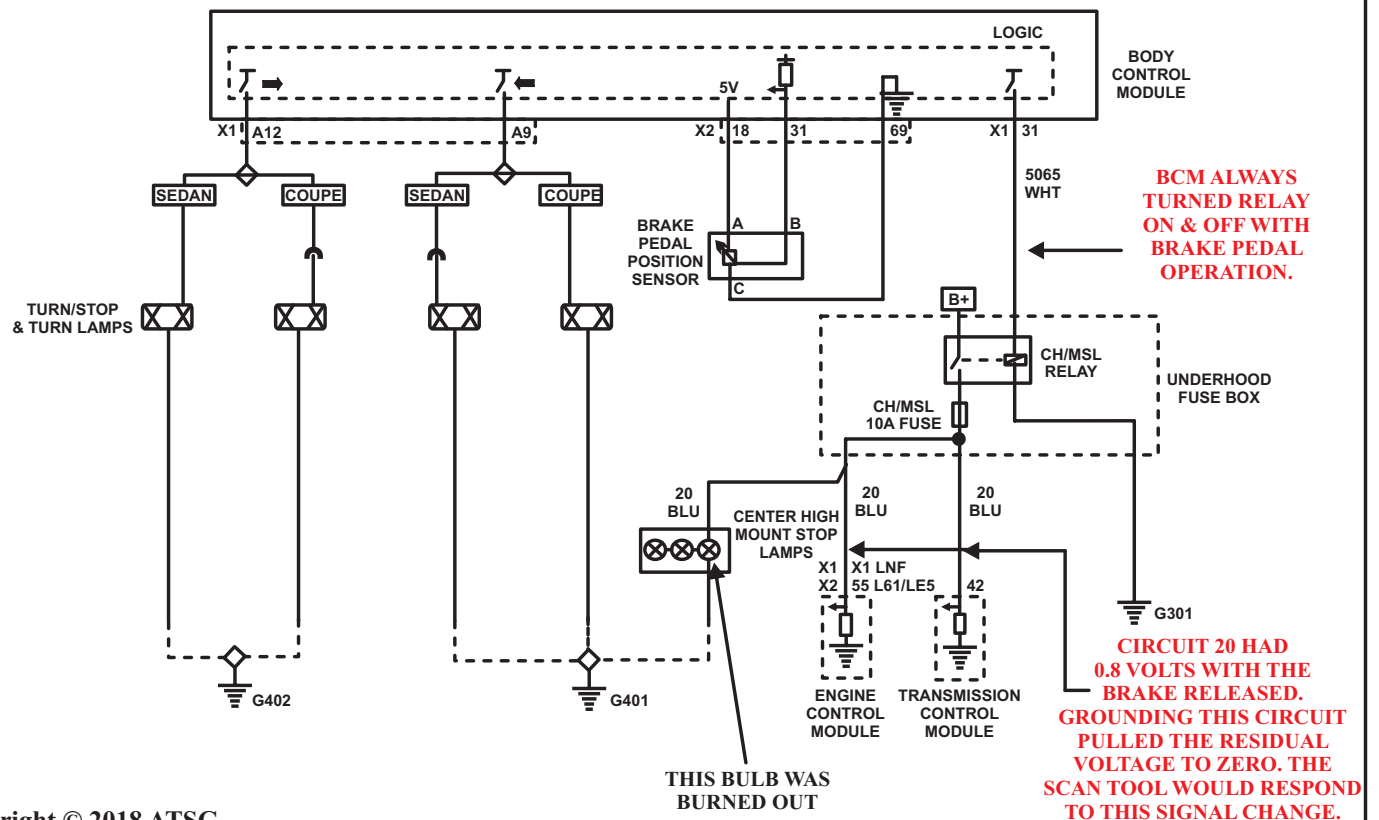
Figure 2

SUMMARY: The burned out light bulb in the center high mount brake light assembly allowed residual voltage of approximately 0.8 to 0.9 volts to remain on circuit 20 when the brake pedal was released (figure 2). This residual voltage could be mistaken for a compromised G401 stop lamp ground or ECM/TCM ground, but this was not the case.

A volt meter revealed that the CH/MSL relay 5065 circuit (figure 2) always responded to the apply and release of the brake pedal. It displayed zero volts when the brake pedal was released and 12 volts when the brake pedal was applied. This meant that the Body Control Module properly recognized the BPPS operation. When the 5065 circuit operates the relay, 12 volts is then supplied to the TCM, ECM and the brake bulbs on circuit 20.

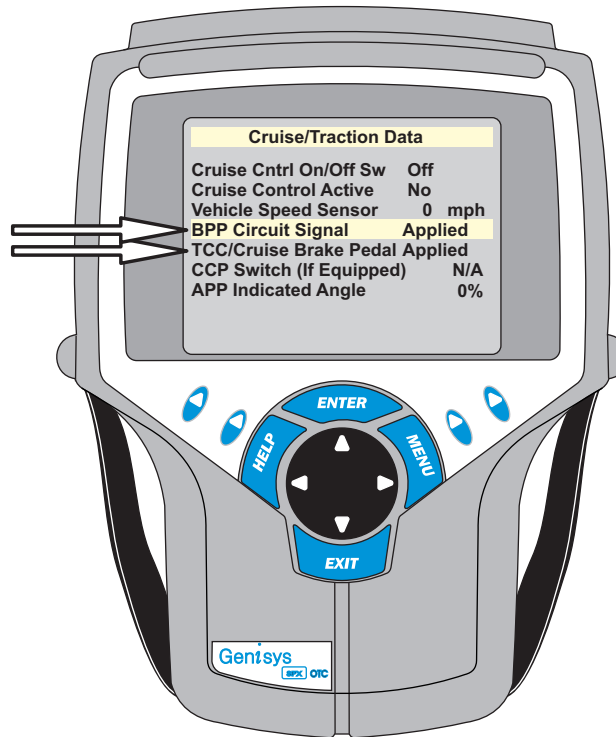
Figure 3

Circuit 20 should have zero volts when the brake pedal is released and 12 volts when the brake pedal is applied. The 0.8 residual voltage seen on circuit 20 when the brakes were not applied, was due to the TCM/ECM providing that residual voltage so as to monitor the stop light circuits. With the brake bulb being blown, it opened the circuit preventing that residual voltage from being drawn to ground which would provide a 0 volt reading. This became apparent when testing this circuit by manually grounding circuit 20. When it was grounded, the scan tool said the brake was released. When the ground was lifted, the scan tool said the brakes were applied. The 0.8 - 0.9 volts due to the blow brake bulb was enough to cause the TCC complaints as well as the BPPS status showing applied when it was not (figure 3).

BRAKE PEDAL NOT APPLIED - BULB BURNED OUT

The Brake Pedal is not applied yet the scan tool indicates that it is applied

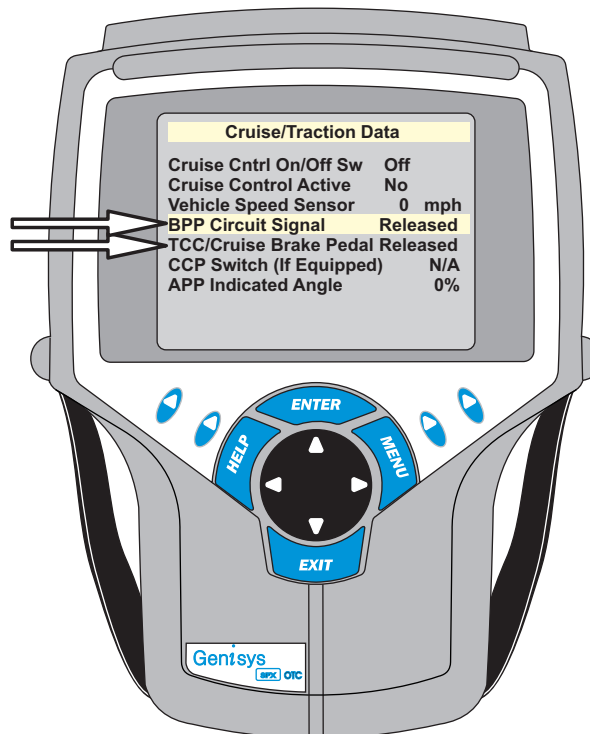
Figure 4

Once the brake bulb was replaced the scan tool parameters for the BPP Signal and the TCC Brake Signal displayed correctly as shown in figure 4.

BRAKE PEDAL NOT APPLIED - BULB REPLACED

Once the brake bulb was replaced, the brake signal functioned correctly
