# Technical Service Information

## **CHRYSLER 41TE DELAYED ENGAGEMENT**

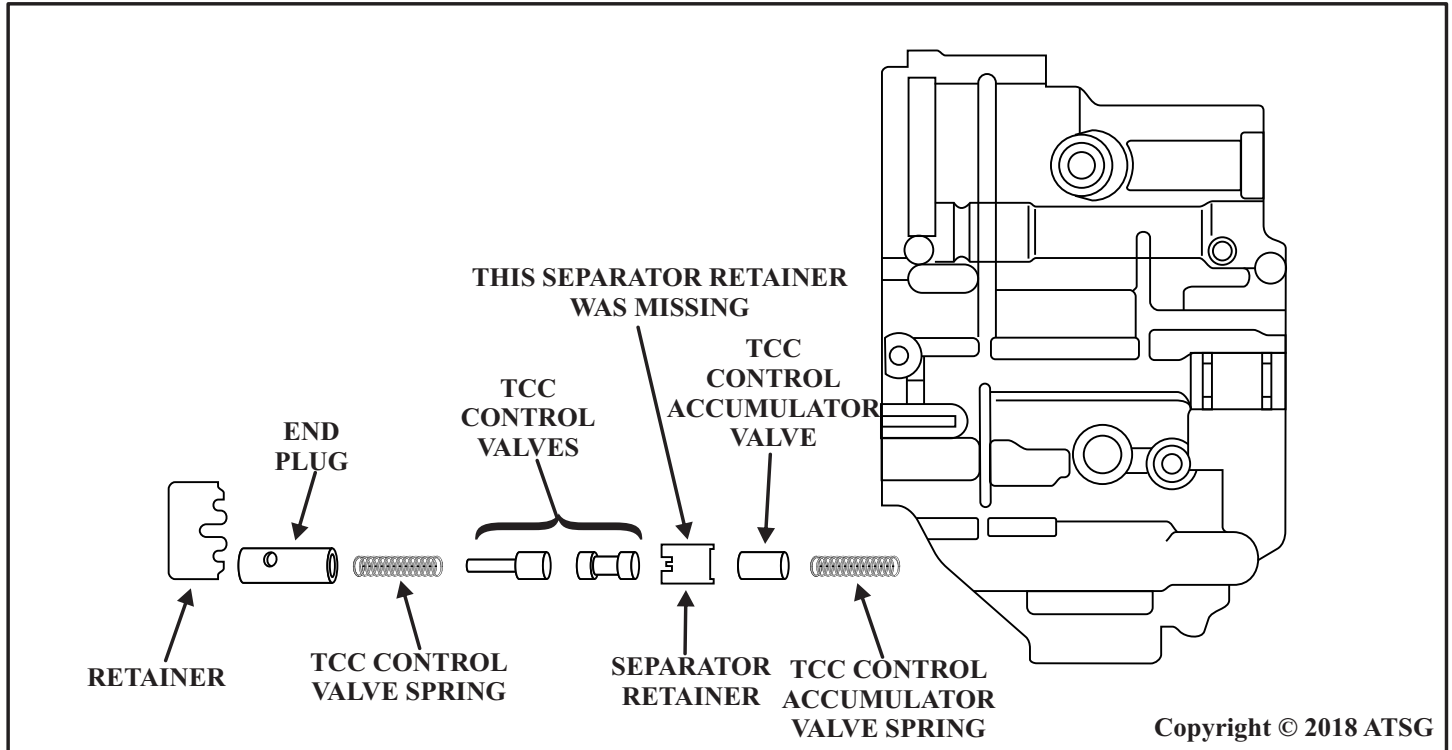
Figure 1

**CAUSE:** The retainer that separates the Lockup Control Valve and the TCC Accumulator Valve was missing, refer to figure 1.  
The first gear hydraulic seen in figure 2 will show that without the retainer in place, the Lockup Control Valve will be forced to the left by the TCC Accumulator Valve Spring which will block tcc charge oil until it can loop around to the spring side of the Lockup Control Valve resulting in a delay in filling the torque converter.

**CORRECTION:** Install the retainer between the Lockup Control Valve and the TCC Accumulator Valve.
