Technical Service Information

FORD 5R110W

SETTING VARIOUS TRANSMISSION & ENGINE CODES

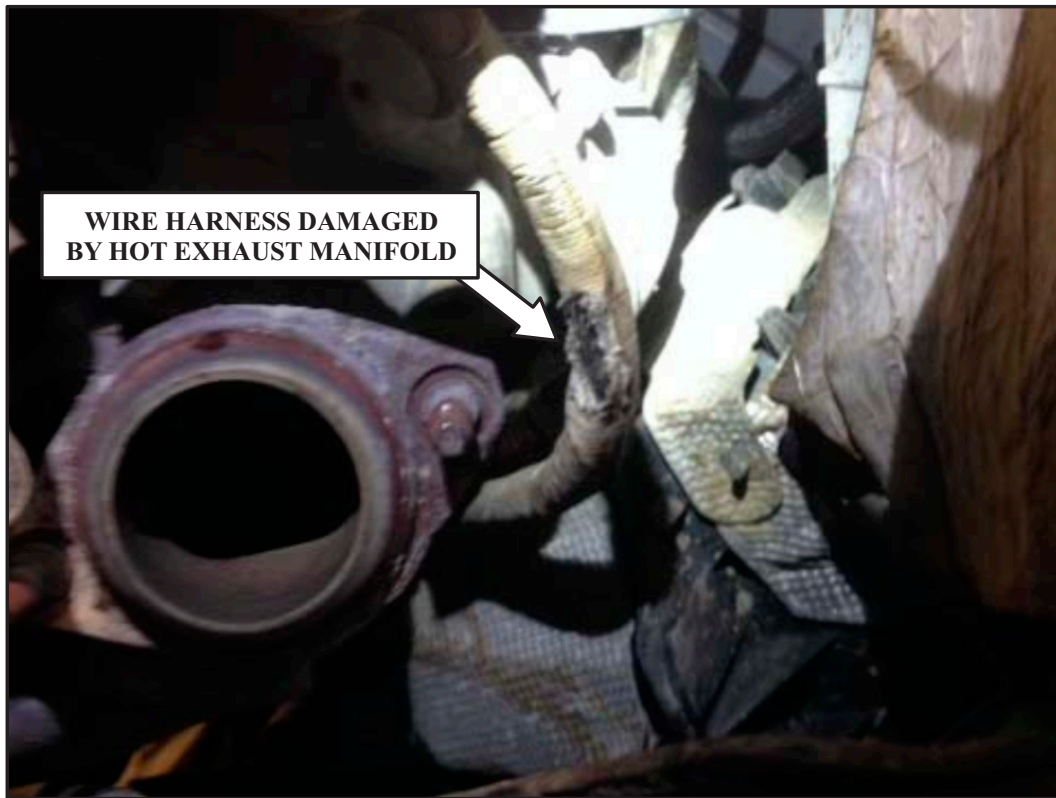
Figure 1

CAUSE: When the transmission was removed this time it was noticed that the wiring harness was close to the exhaust manifold, refer to figure 1. After further inspection, the wire harness was found to be burned through by coming in contact with the hot exhaust manifold, refer to figure 2 which resulted in a number of wires being damaged, refer to figure 3. The plastic harness holder the attaches to the filler tube with black electrical tape was dried out which allowed the harness to come in contact with the hot exhaust manifold. This problem probably started to develop after the first transmission removal procedure and proceeded to allow the wire harness to come close to the hot exhaust manifold.

CORRECTION: The wire harness was repaired and secured out of harms way. All codes were cleared after transmission installation and the truck was given a thorough road test. The transmission operated normally with no driveability issues.
