FORD CAST IRON FMX

2-3 FLARED SHIFT

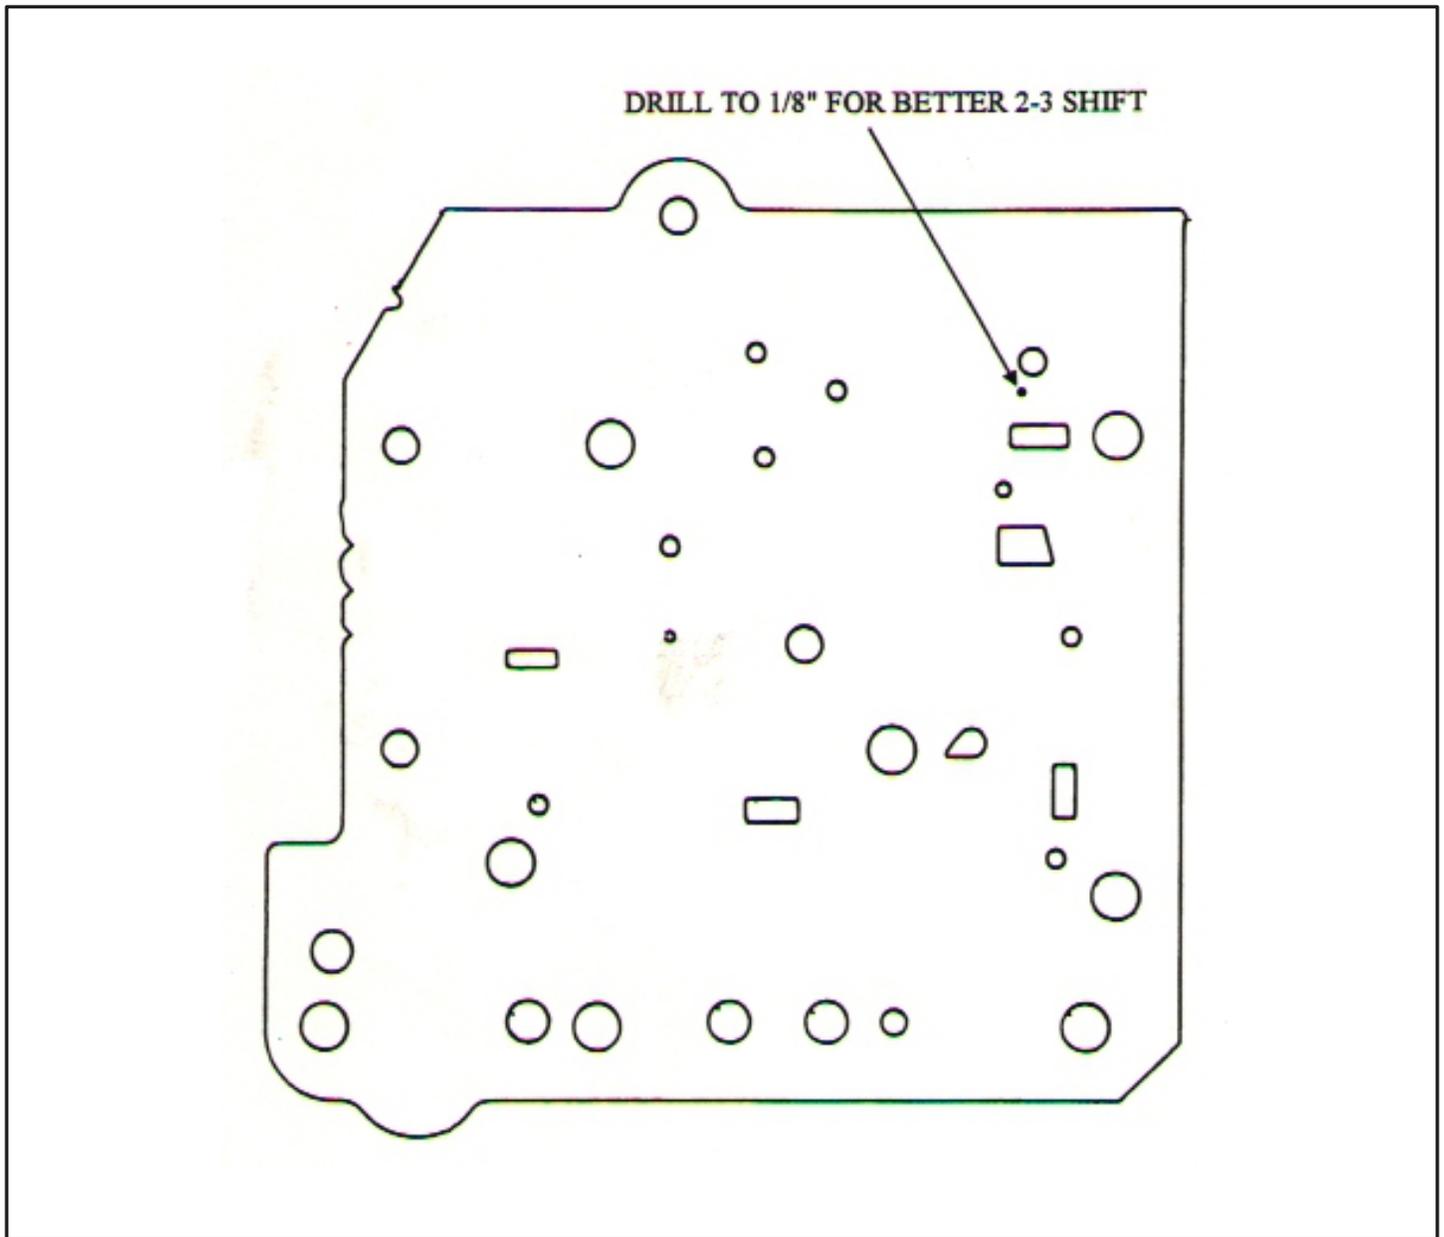
Figure 1

After overhaul an FMX transmission may have a 2-3 flared shift. The main valve body spacer plate has a small hole over the 2-3 orifice check ball as seen in figure 1. Drill this hole out to 1/8".
