Technical Service Information

JEEP GRAND CHEROKEE TCM HARNESS DAMAGE

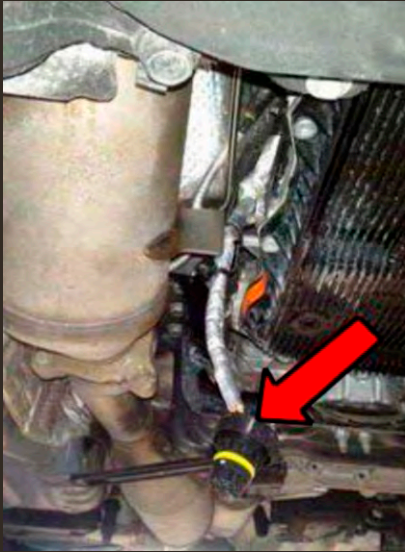
Figure 1

Disconnect Transmission Wire Harness.

- 4 - Remove the six (6) transmission crossmember bolts.
 - 5 - Remove the transmission crossmember.
 - 6 - Remove the transmission wire harness connector from the rear of the transmission as seen in figure 1.

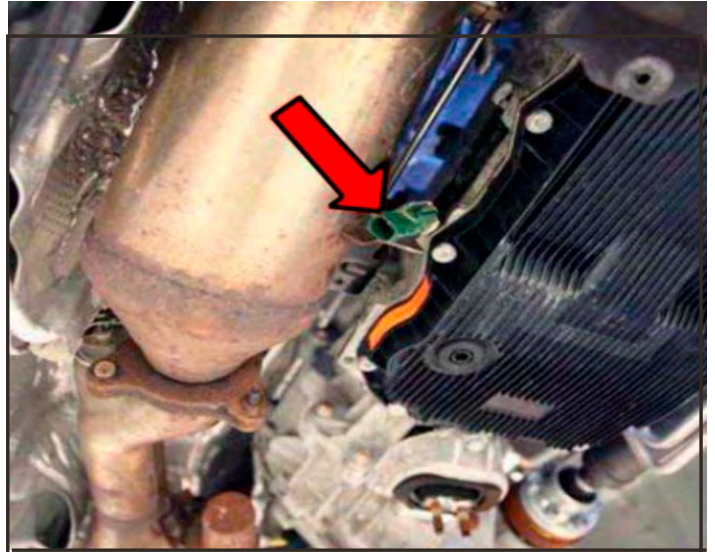
Figure 2

Disconnect The Exhaust Gas Temperature Sensor.

- 7 - Disconnect the green diesel particulate filter exhaust gas temperature sensor connector as seen in figure 2.
 - 8 - Disconnect the transmission wire harness from two (2) fasteners.

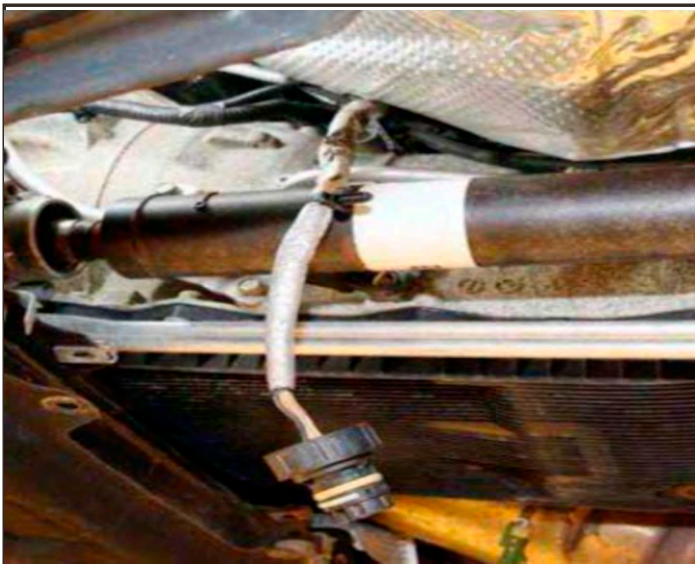
Figure 3

Swing Wire Harness To Left Side Of Vehicle For Access.

- 9 - Reposition the transmission wire harness up and over the transmission to the left side of the vehicle in order to allow adequate room to perform the wire repair as seen in figure 3.

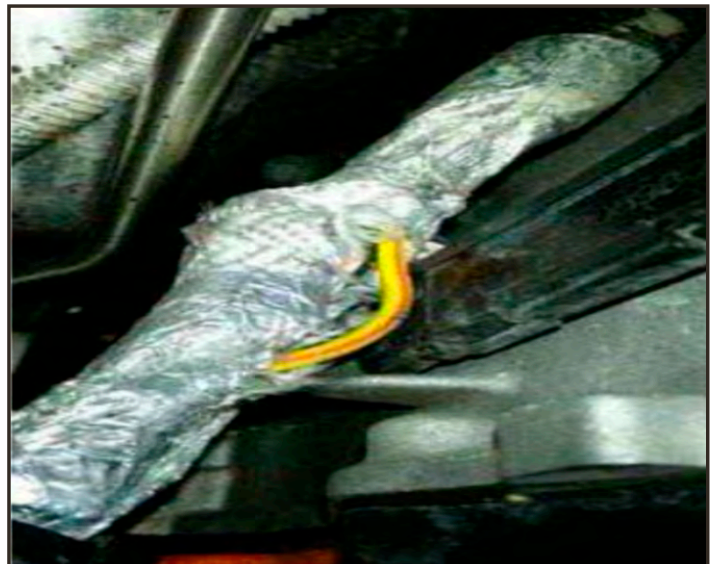
Figure 4

- CAUSE:** The transmission wire harness has been damaged by a heat shield.
- CORRECTION:** The following steps in this bulletin will show the procedure to reroute and repair the transmission wire harness using the available repair kit part number shown under service information.

Transmission Wire Harness Damage From Heat Shield.

- 10 - The transmission wiring harness damage from contact with the heat shield can be seen in figure 4.
 - 11 - Remove and discard fastener #20098 if present as seen in figure 5.
