## GM 6T40 SERIES TRANSMISSIONS REPEAT TORQUE CONVERTER FAILURE

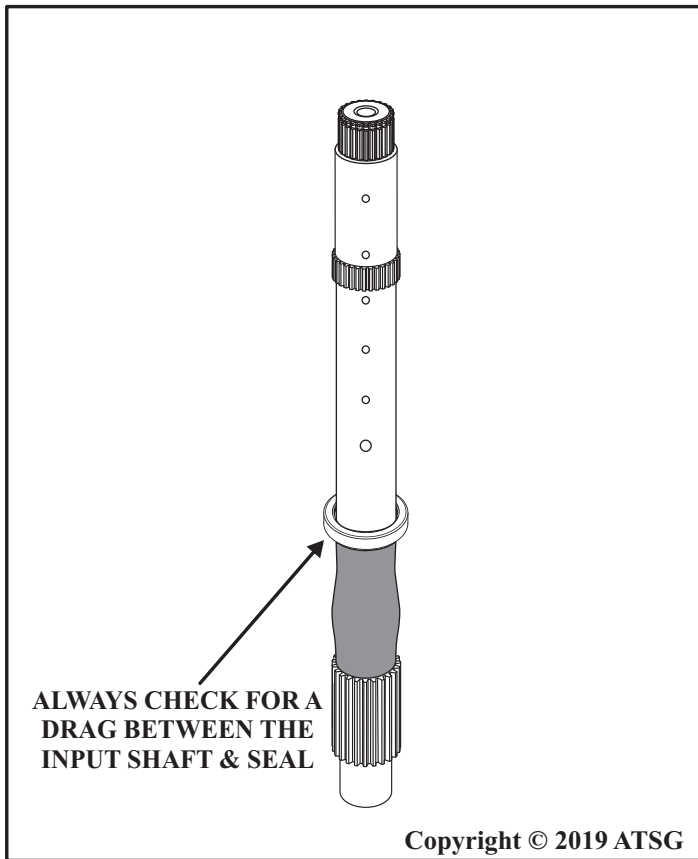
Figure 1

**CAUSE:** The technician slid the input shaft into the input shaft seal in the back of the pump cover and did not like the fit. There was practically no drag on the seal. The technician recalled the last 6T40 he had built and that seal had a drag on the input shaft. This means the converter clutch was applied just enough to drag but not enough to kill the engine. This would explain the overheat condition and the converter failure.

**CORRECTION:** A new input shaft seal was installed and the fit to the input shaft was checked and it had a drag on the shaft. Always check the fit of the new seal on the input shaft for drag as shown in figure 1. Press the new seal in place, refer to figure 2, do not use a hammer which could deform the seal causing the above complaints.

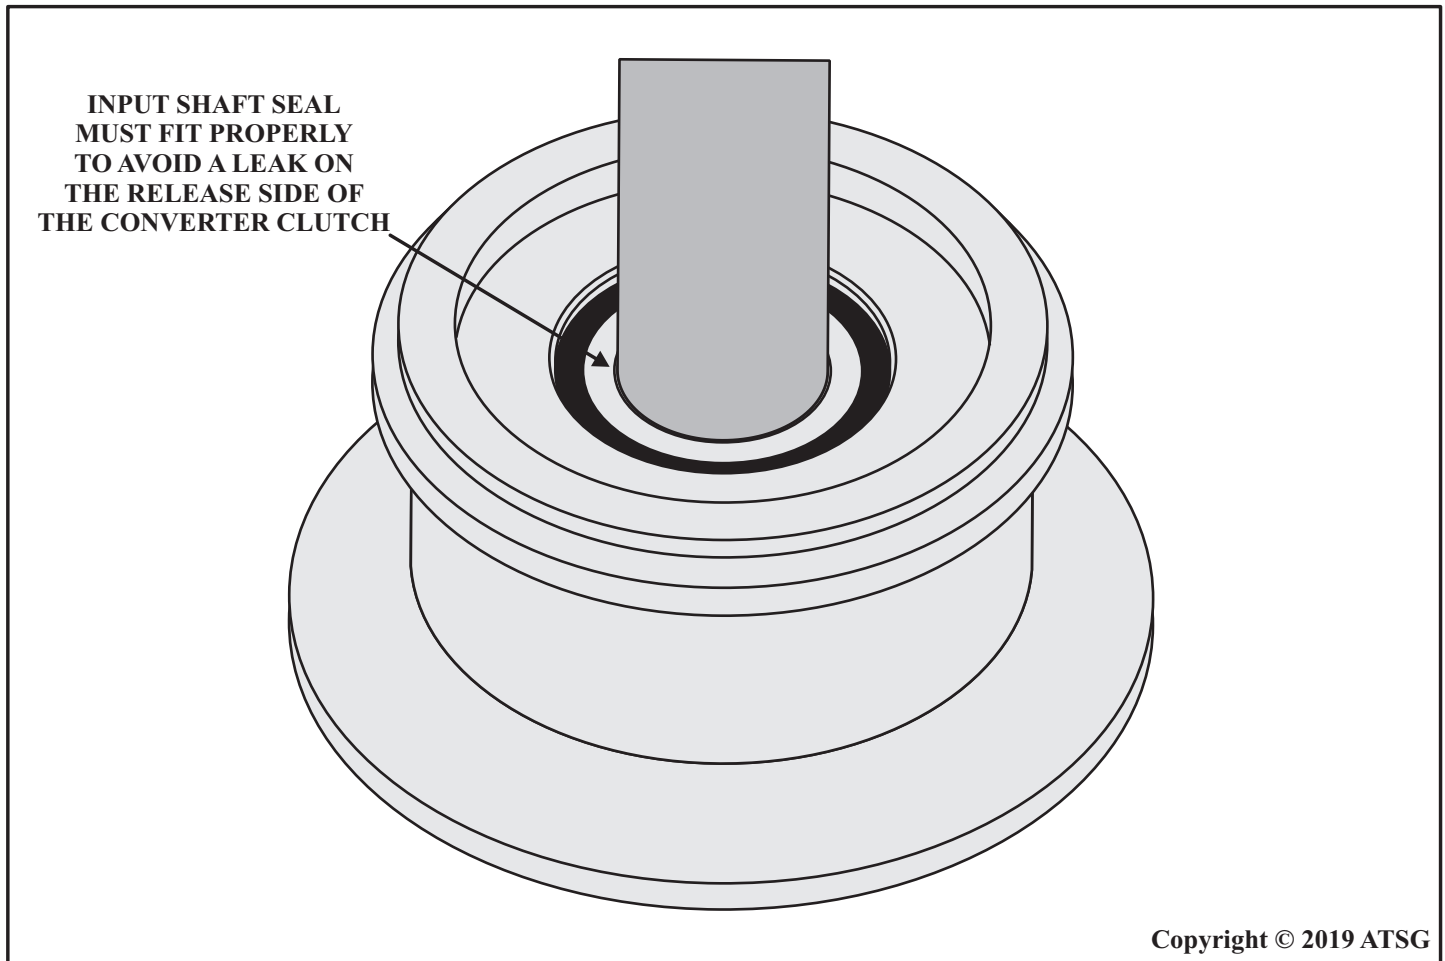
Figure 4

The input shaft seal must not be deformed in any way so it fits the input shaft properly to avoid a leak on the release side of the converter clutch as seen in figure 4.
