GM 6T40 SERIES TRANSMISSIONS DELAYED ENGAGEMENTS AFTER OVERHAUL

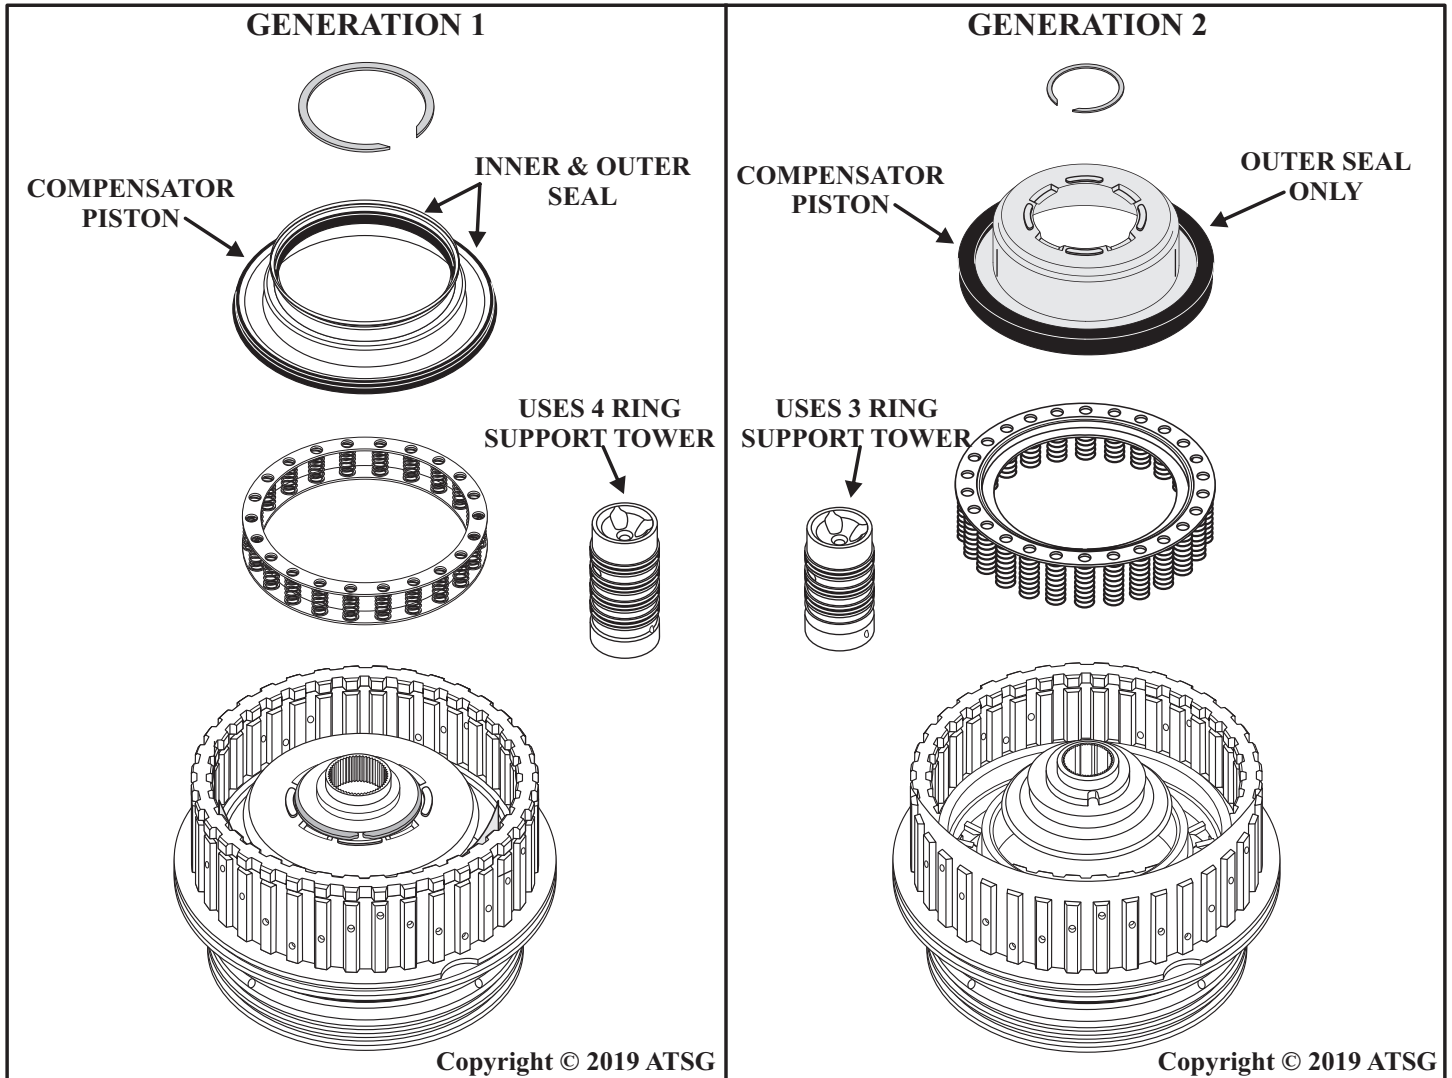
Figure 1

The Generation 1 compensator piston seen in figure 1 has an inner and an outer lip seal. This is designed to seal regulated compensator oil. This requires a four (4) ring support tower.

CORRECTION: Install a Generation 1 4-5-6 Clutch Housing components and four (4) ring support tower in a Generation 1 transmission.

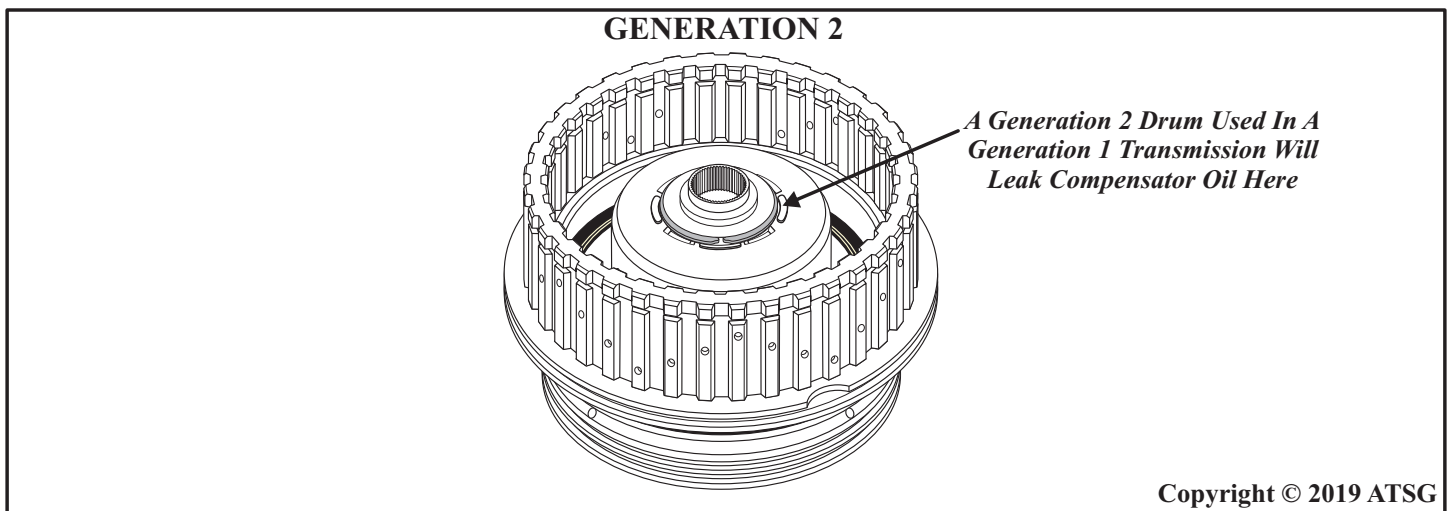
Figure 3

The Generation II compensator piston seen in figure 2 has only an outer lip seal. This requires a three (3) ring support tower. In a Generation II transmission there is no compensator circuit, it uses a backfill circuit instead. This is why the Generation 1 transmission had the delay due to compensator oil leaking past the inner diameter of the compensator piston as shown in figure 3. In addition, loss of oil past the compensator piston causes a lack of sufficient pressure to fully stroke the compensator valve which allows line pressure to leak past the missing seal and ring as seen in the hydraulic in figure 4. The compensator oil leak was significant enough to lower line pressure to the point where it affected overall transmission performance.

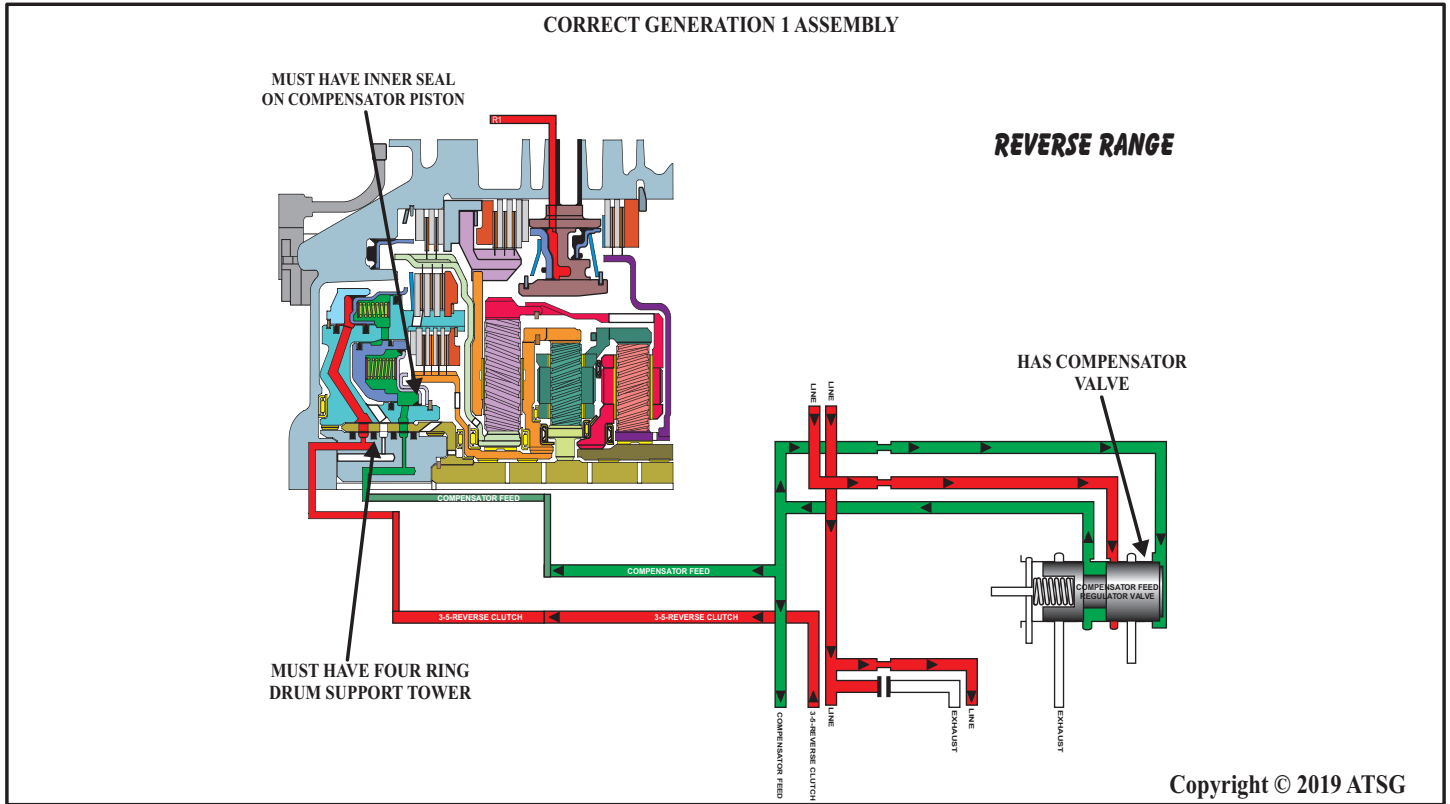
Correct 3-5-Reverse Clutch Application - Generation 1 - Figure 4

Line pressure is fed to the Compensator Feed Regulator Valve which then feeds the compensator feed circuit (green). Compensator oil enters between the top two rings on the four (4) ring support. This is why a four (4) ring tower is needed. The oil then seals on both the inner and outer seals on the piston.

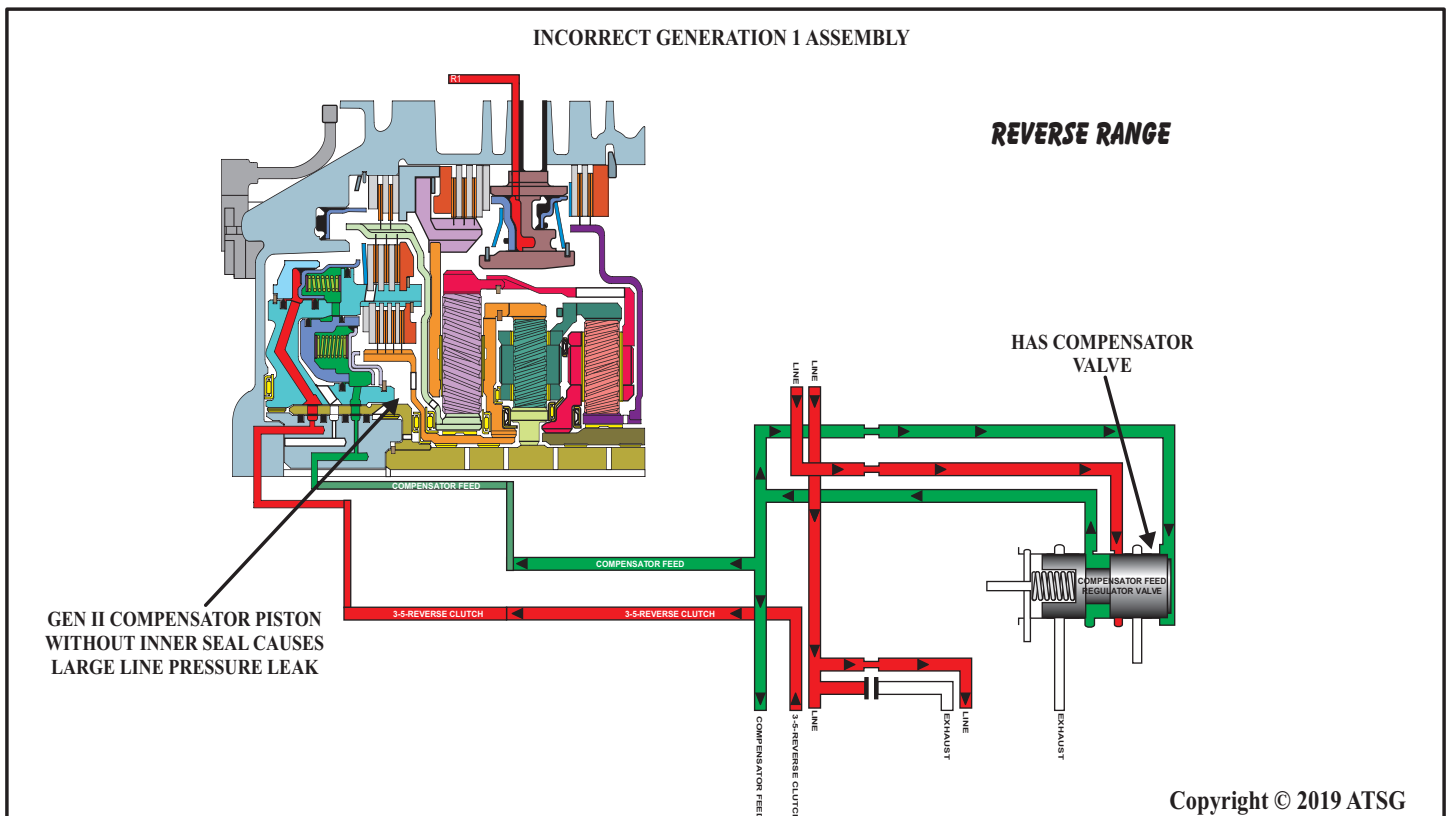
Incorrect 3-5-Reverse Clutch Application - Generation 1 - Figure 5

When a GEN II clutch housing is used, the compensator oil from the GEN 1 valve body leaks at the top of the ring tower and at the piston due to a missing seal. This large leak closes the compensator regulator valve all the way trying to compensate for the leak. The result is line pressure is fed into a huge leak lowering overall line pressure which then affects all ranges. The transmission may even fall out of gear at a stop.

NOTE: The vehicle may perform normally on a road test as long as pump volume can overcome the leak. Once the pump can't overcome the leak, the above mentioned complaints will occur.
