FORD 5R110W

NO MOVE CONDITION

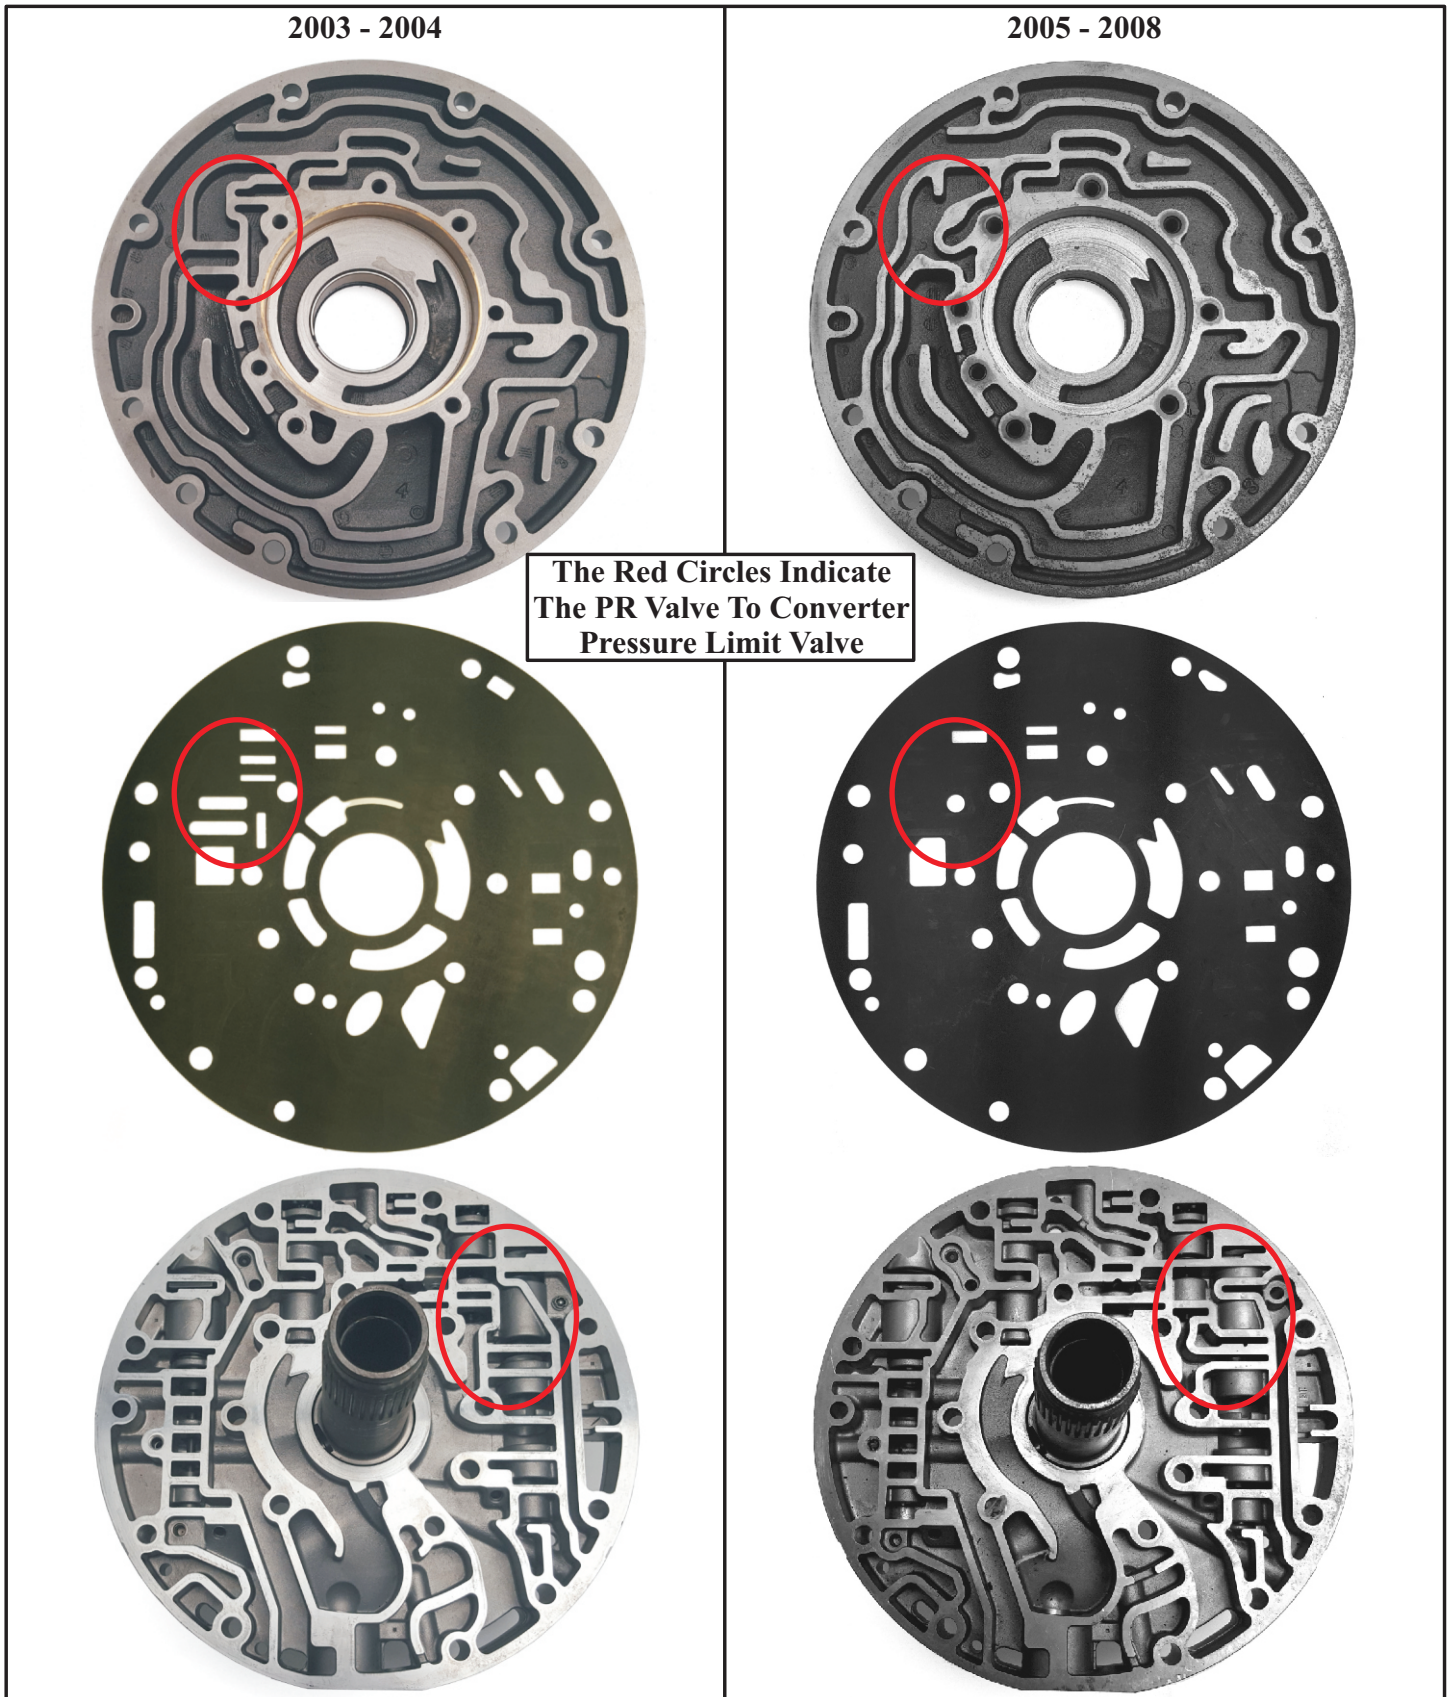
Figure 1

CAUSE: The replacement pump came in separate pieces which were incompatible, the differences between the 2003 - 2004 pump components as compared to the 2005 - 2008 pump components can be seen in figure 1. The pump cover and spacer plate was a 2005, while the pump body was a 2003 component. This combination allows the pressure regulator valve to feed limit valve passage to be blocked causing the converter not to fill. The 2003 - 2004 pump cover hydraulics indicates a CRDB oil circuit that is between the pressure regulator valve and the converter pressure limit valve as shown in figure 2. The 2005 to 2008 pump cover does not have that circuit as shown in figure 3.

CORRECTION: A 2005 pump cover was obtained which now allowed the converter to fill resulting in vehicle movement.
