# Technical Service Information

## ALLISON 1000/2000 SERIES

### ERRATIC SHIFTS

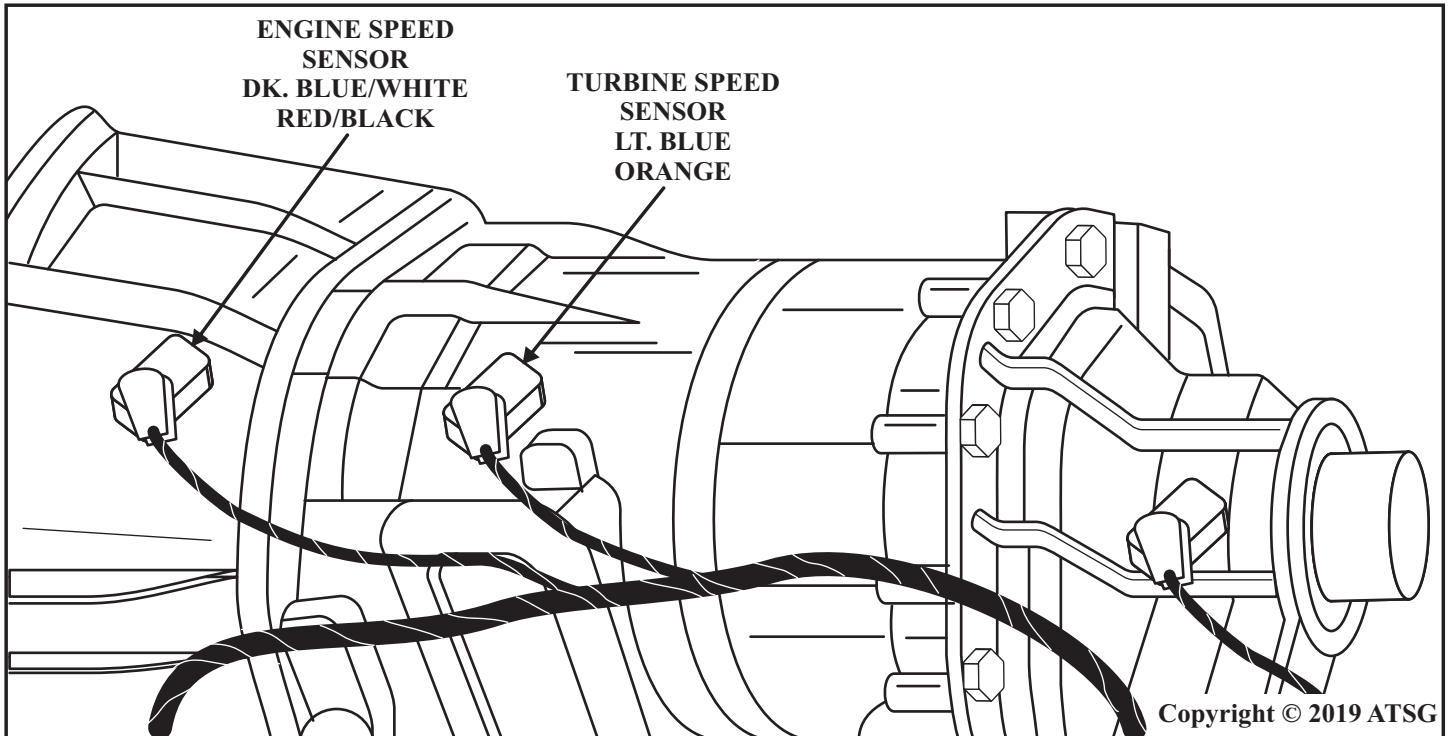
Figure 1

**CAUSE:** The Engine Speed Sensor and the Turbine Speed Sensor connectors were swapped. When speed sensor operation was checked on the scan tool the engine rpm went to zero and the turbine rpm indicated an rpm reading when the transmission was shifted into drive.

**CORRECTION:** From the 2001 model year to the 2014 model year connect the Engine Speed Sensor to the Dark Blue/White and Red/Black wire connector. The Turbine Speed Sensor connector is Light Blue and Orange, refer to figure 1.
